School District of Philadelphia
Office of Environmental Management Services
440 North Broad St.
Philadelphia, PA 19030

Mold Design Data Collection (DDC)

Name of Building: Cook Wissahickon ES

Address: 201 E. Salignac St. ULCS # 6410

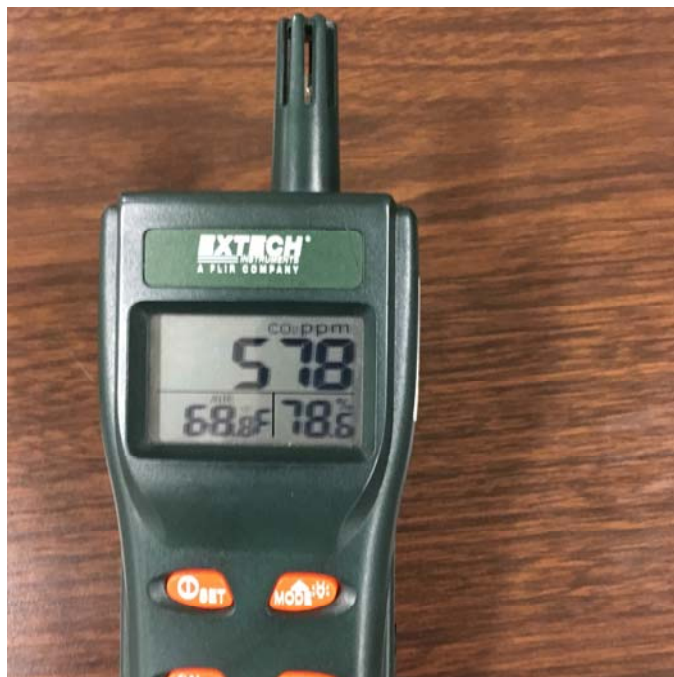
Photo 2 –Cafeteria
The humidity was elevated at 78%.

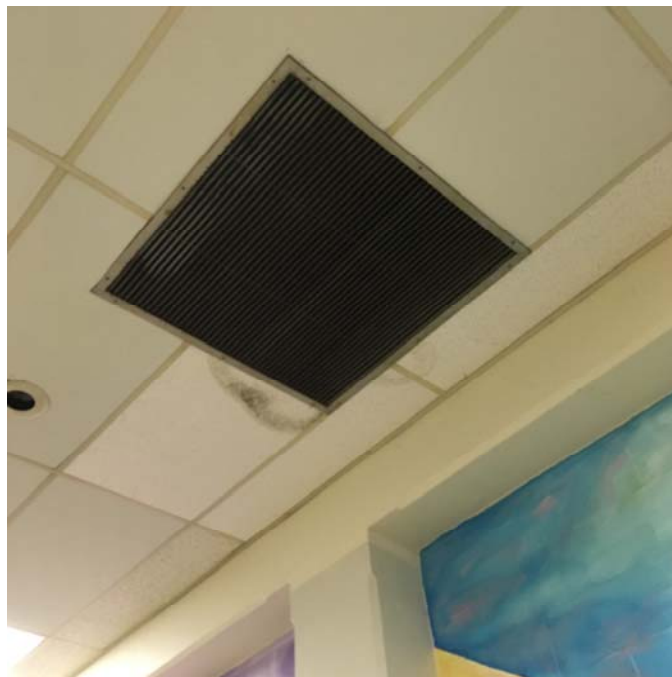
Photo 4 – Cafeteria

Particulate accumulation on the return air grille and a moldy ceiling tile was observed.

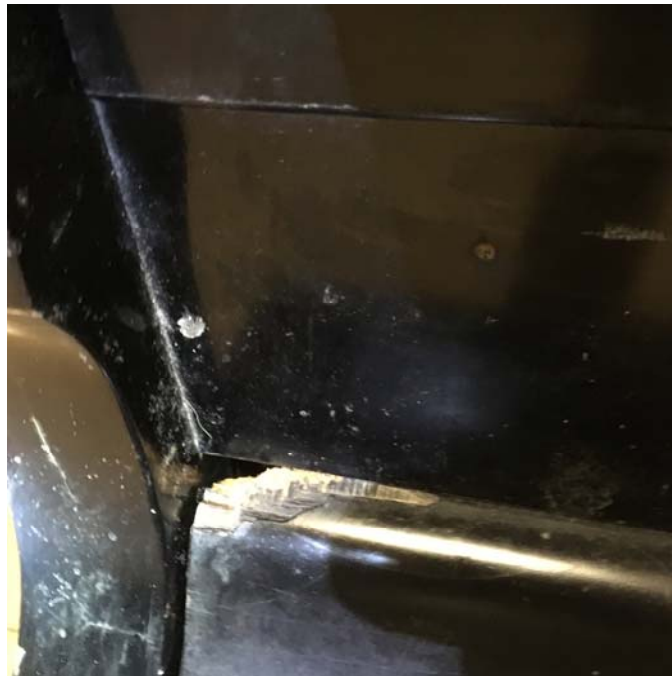
Photo 6 – Cafeteria
Mold growth was observed in crevasses of the piano.

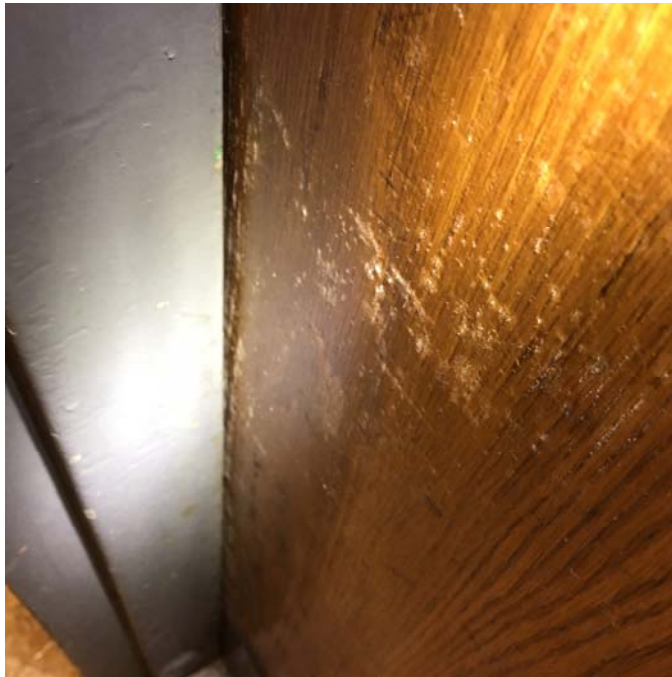
Photo 7 – Cafeteria

Mold growth was observed on the wooden doors and metal door frames.

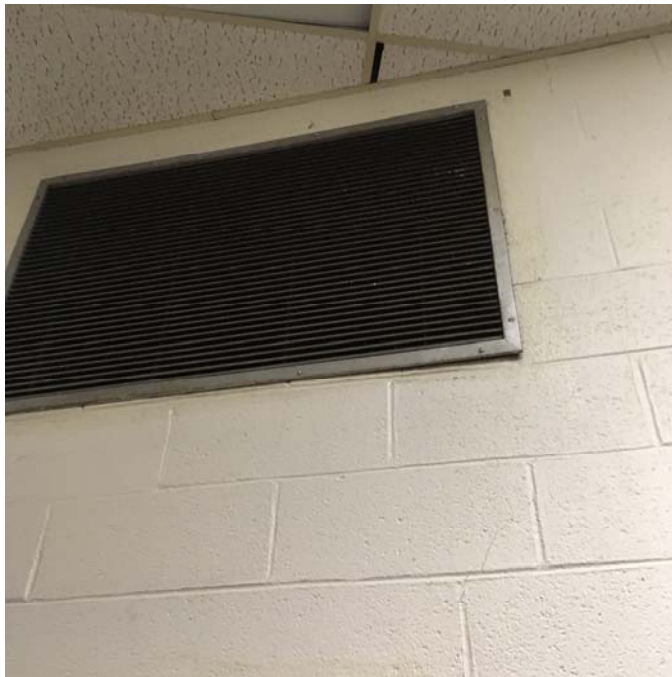
Photo 8 – Cafeteria

Particulate accumulation was observed on the return air grilles.

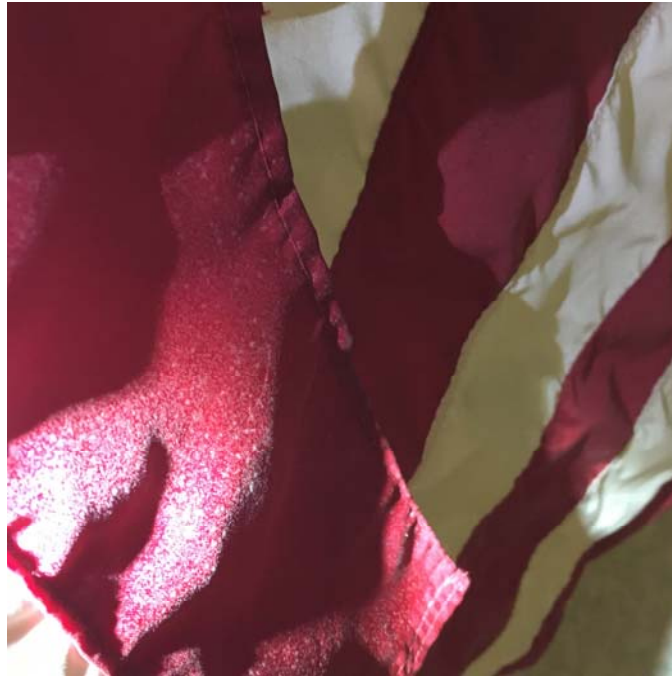
Photo 9 – Stage
Suspect mold growth was observed on the flag.

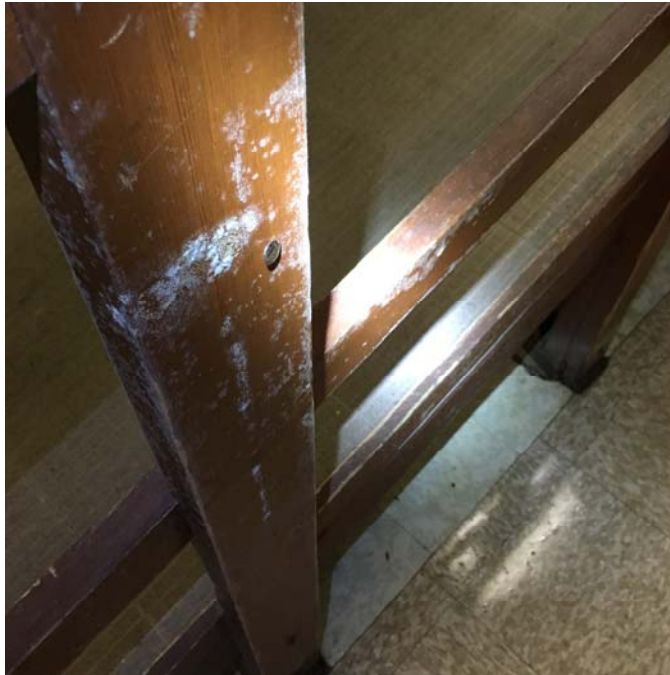
Photo 11– Cafeteria
Mold growth was observed on the handicap ramp.

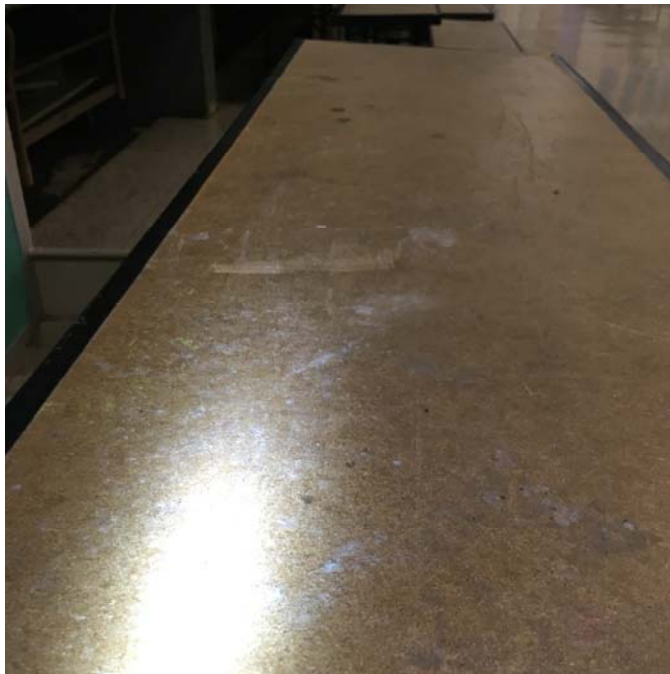
Photo 12 – Cafeteria
Mold growth was observed on the portable steps in from of the stage.

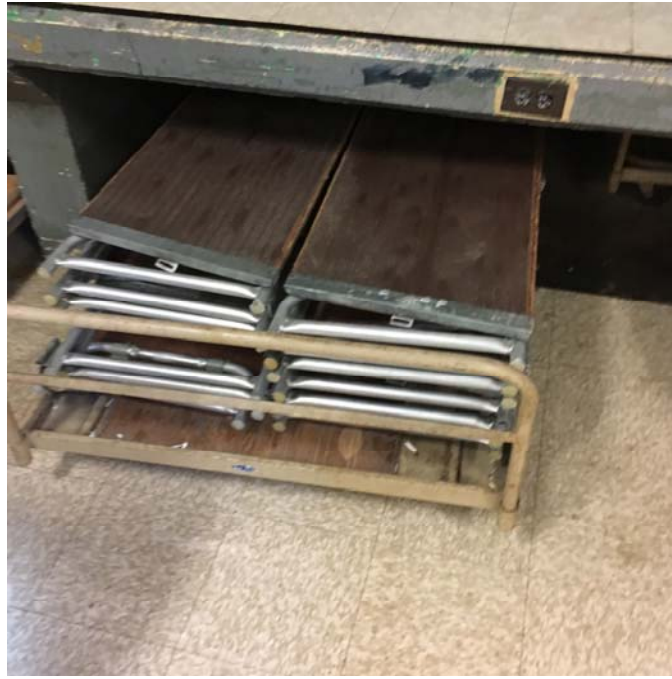
Photo 13 – Cafeteria

Mold growth was observed on the cart and storage platforms under the stage.

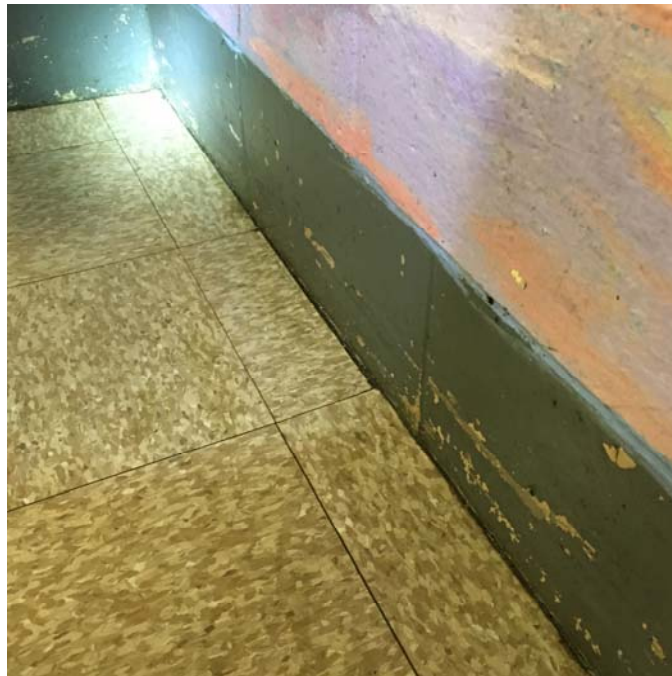
Photo 14 – Cafeteria

Mold growth was observed on section of lower cinder block walls.

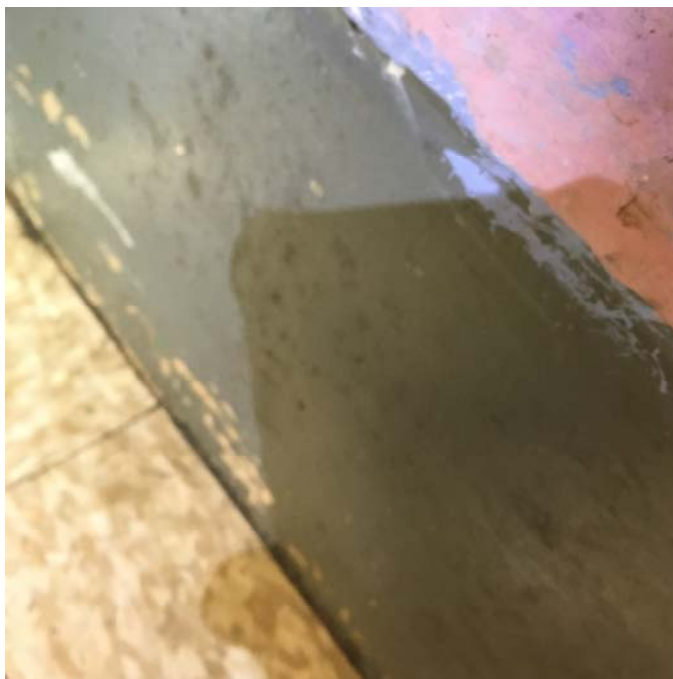
Photo 15 – Cafeteria
Mold was observed on sections of the lower cinder block walls.

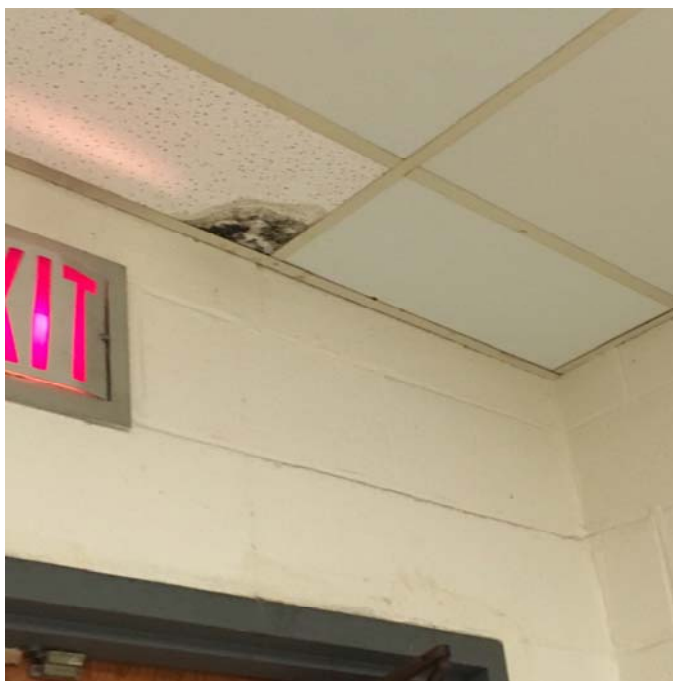
Photo 16 – Cafeteria
A mold ceiling was observed by the 2nd grade exit door.

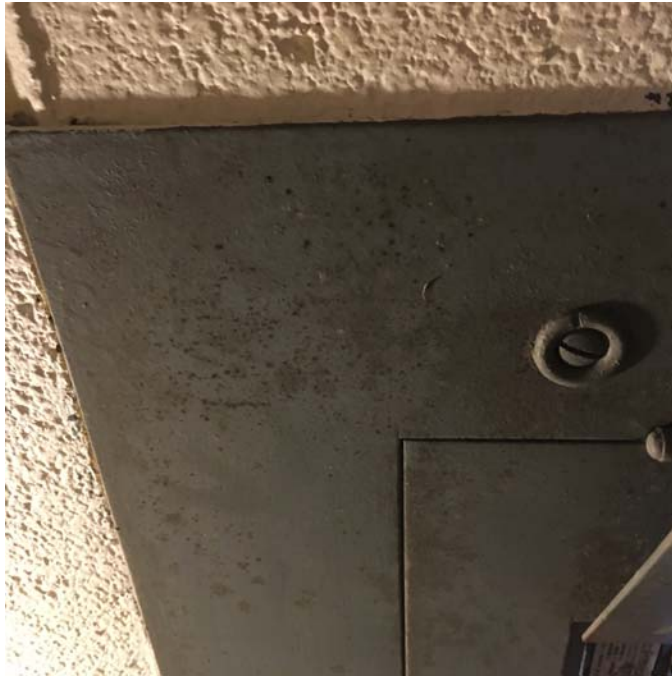
Photo 17 – Stage
Mold growth was observed on the electrical panel covers.

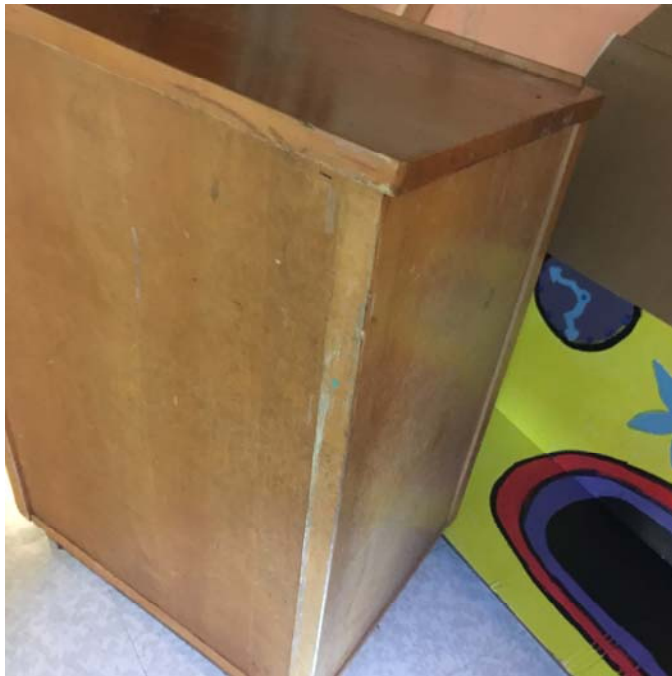
Photo 18 – Stage
Mold growth was observed on the podium.

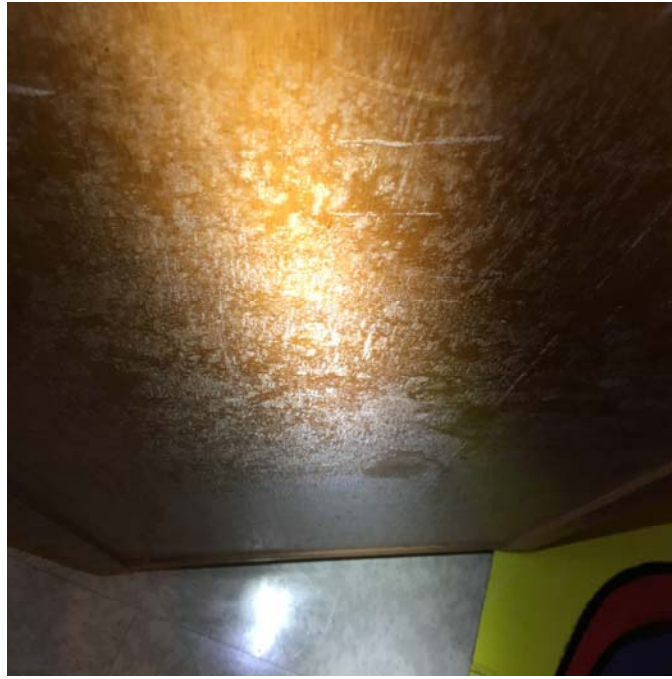
Photo 19 – Stage
Mold growth was observed on the podium.

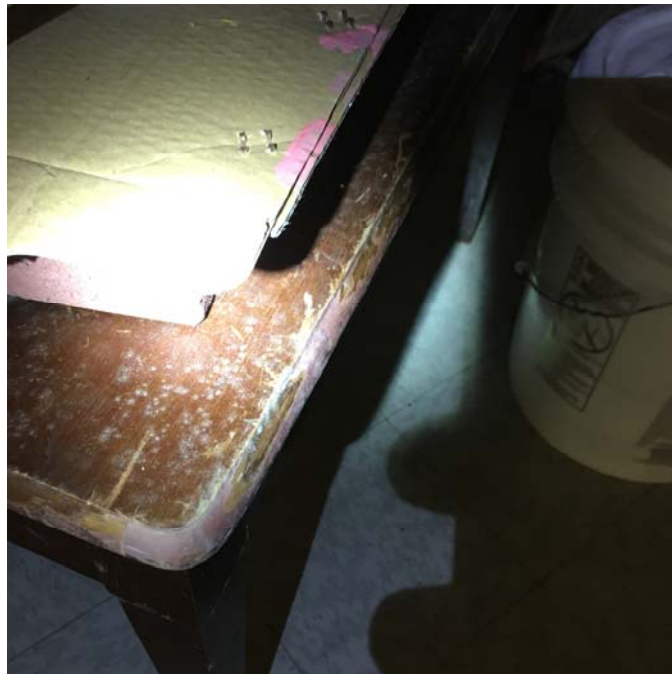
Photo 20 – Stage
Mold growth was observed on the piano seat.

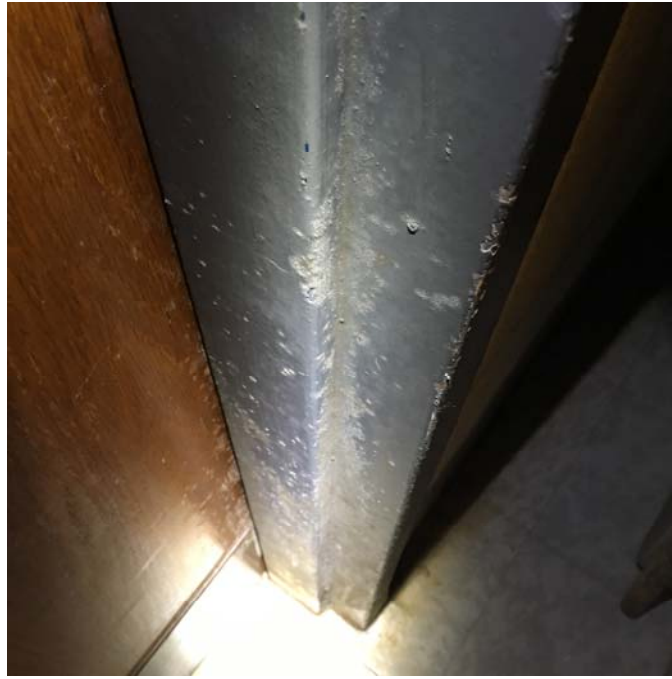
Photo 21 – Stage
Mold growth was observed on the wooden door and metal door frame.

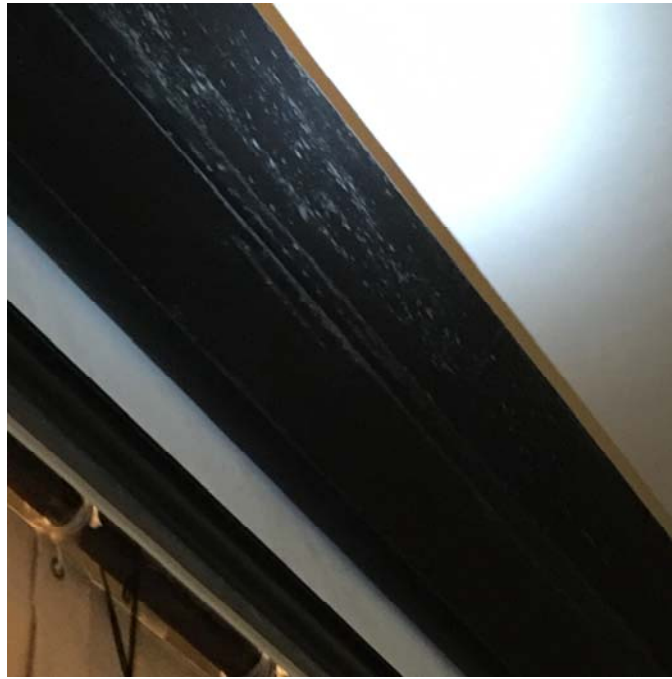
Photo 23 – Stage

Mold growth was observed on the overhead map housing and bottom of the map.

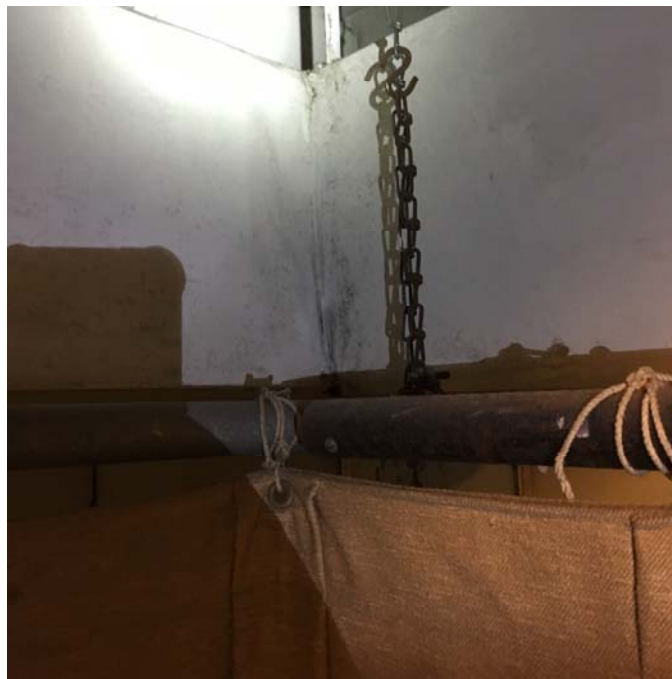
Photo 24 – Stage

Mold growth was observed on the fiberglass duct work.

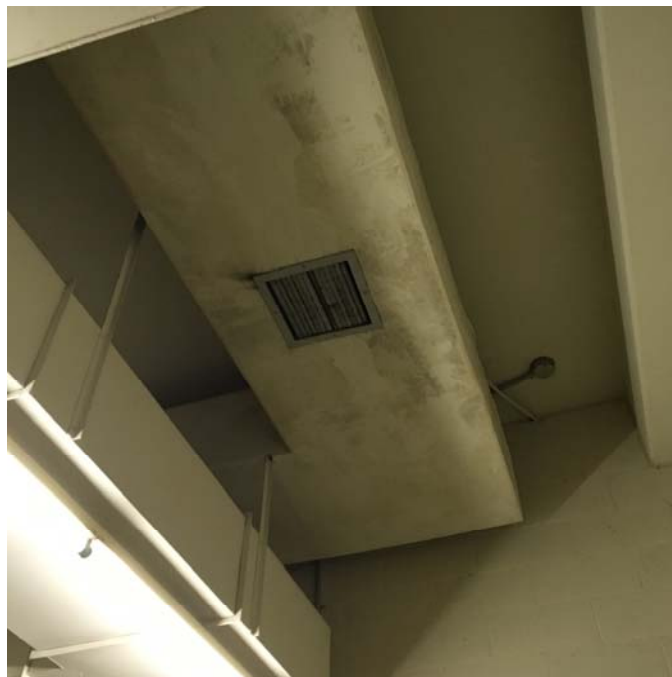
Photo 26 – Small Staff Lunch Room
Mold growth was observed on the fiberglass duct work.

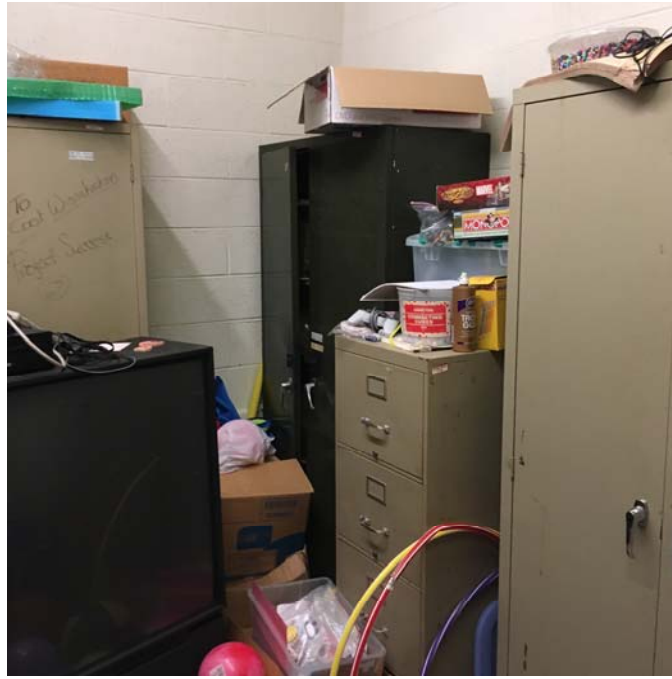
Photo 27 – Small Teacher's Storage Room
Mold growth was observed on the metal storage cabinets, shelving and TV.

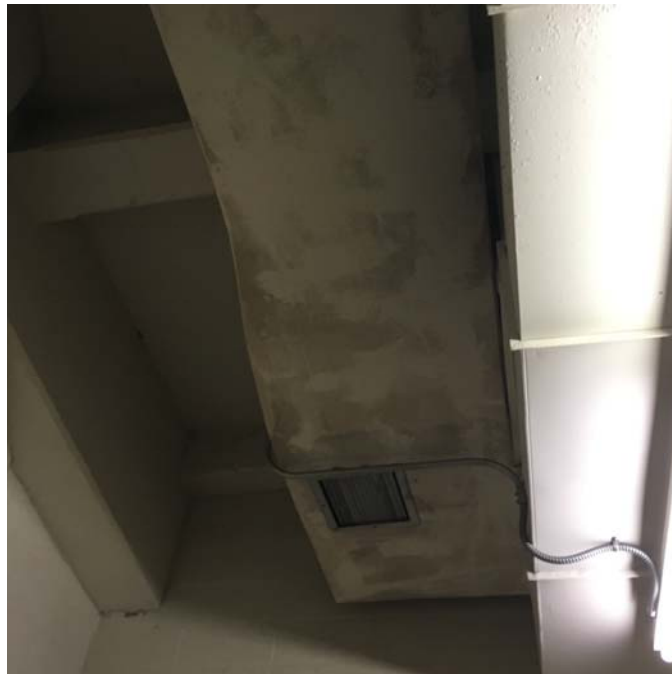
Photo 28 – Small Teacher's Storage Room
Mold growth was observed on the fiberglass duct insulation.

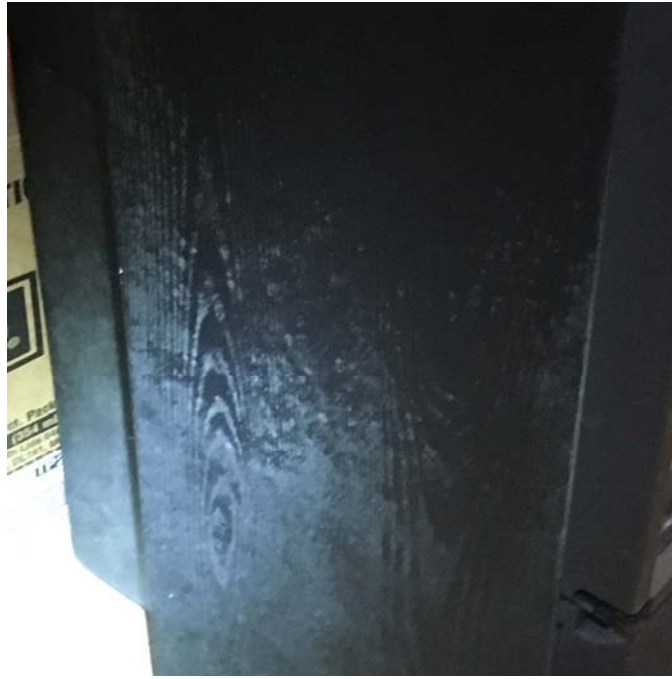
Photo 29 – Small Teacher's Storage Room
Mold growth was observed on the TV cabinet.

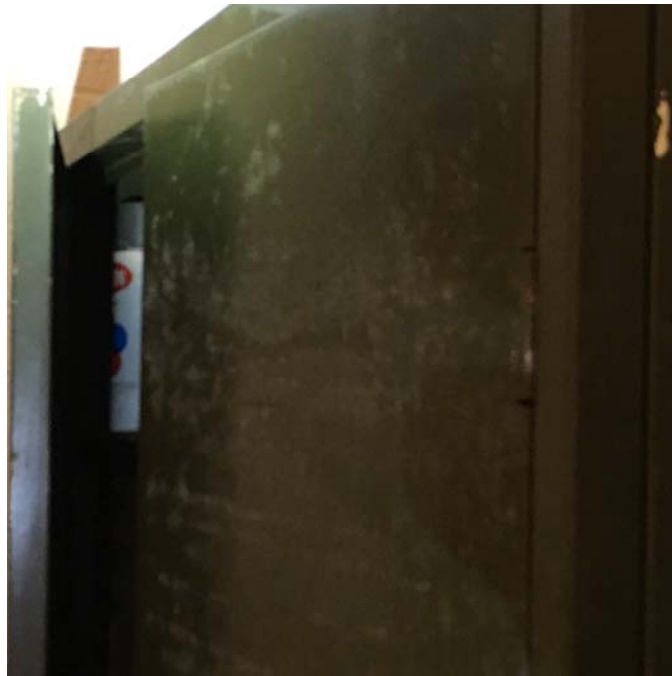
Photo 30 – Small Teacher's Storage Room
Mold growth was observed on the metal storage units.

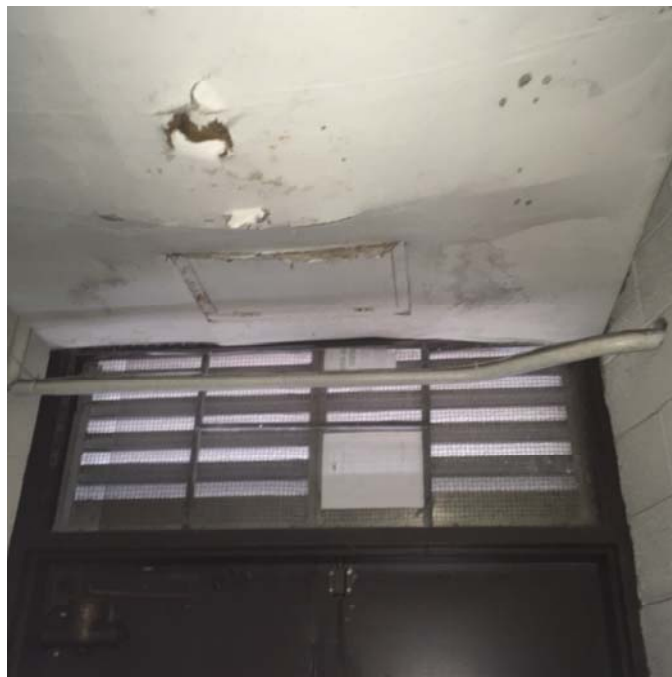
Photo 32 –Operations Storage Room
Mold growth was observed on the fiberglass duct insulation.

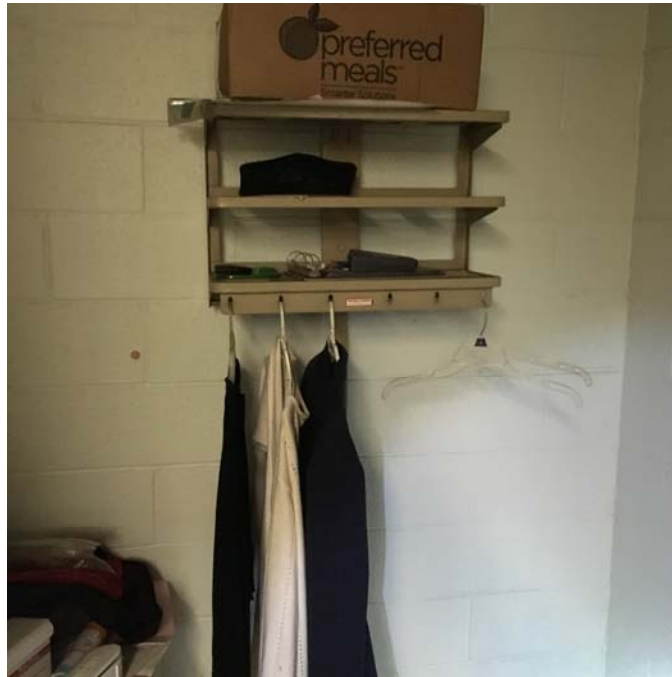
Photo 33 – Kitchen Staff Area
Mold growth was observed on the coat rack.

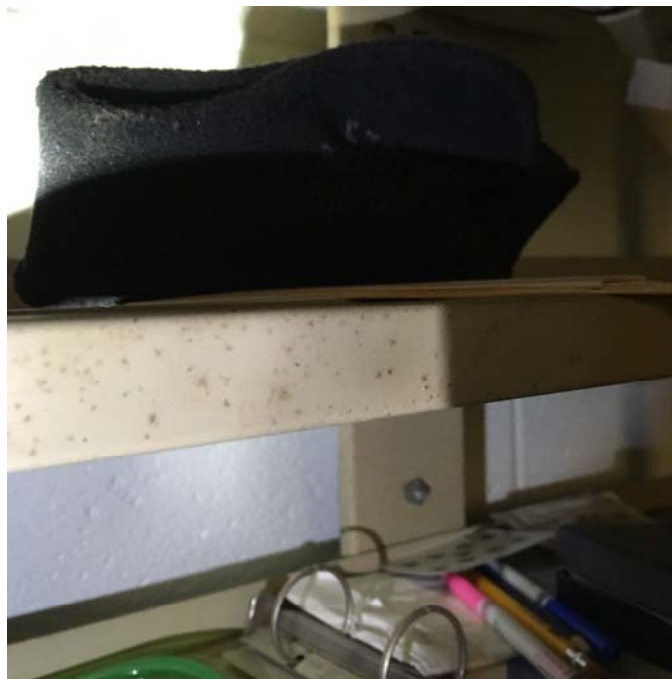
Photo 34 – Kitchen Staff Area
Mold growth was observed on the coat rack.
