School District of Philadelphia
Office of Environmental Management Services
440 North Broad St.
Philadelphia, PA 19030

Date Inspected:
9/9/16

Mold Design Data Collection (DDC)

Name of Building: Cook Wissahickon ES

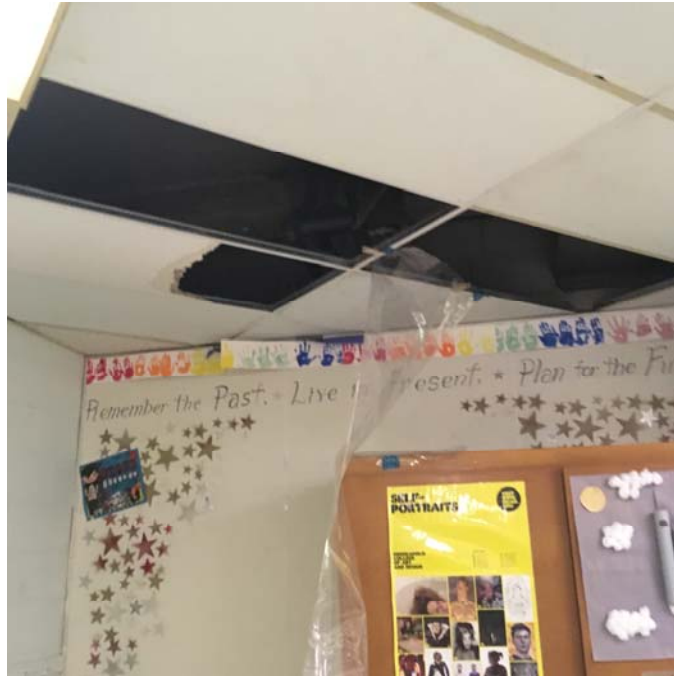
Photo 3 – Art Room 6
Condensation was leaking from the ceiling.

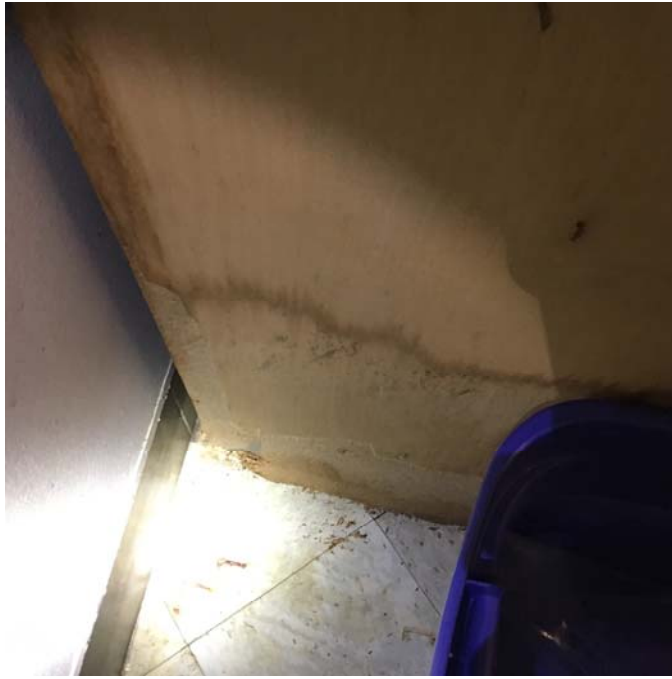
Photo 5 – Art Room 6
Mold growth was observed on the wooden cabinetry.

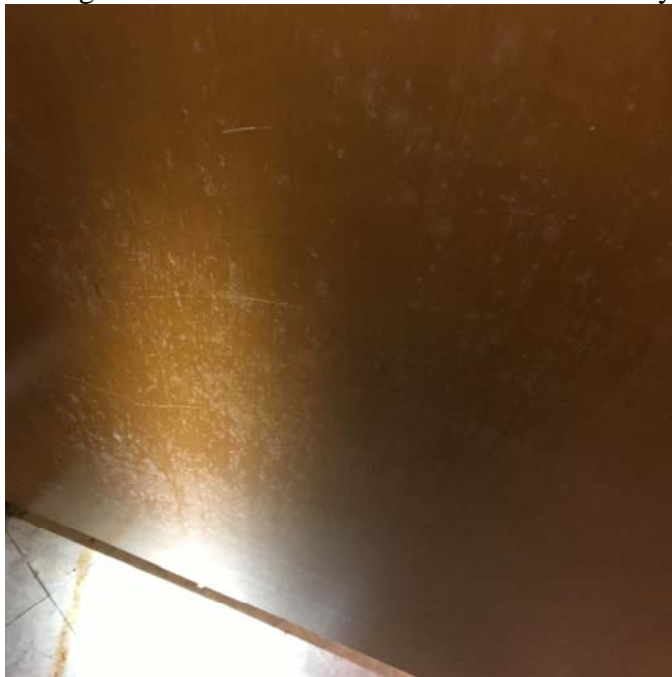
Photo 6 – Art Room 6
Mold growth was observed on the wooden cabinetry.

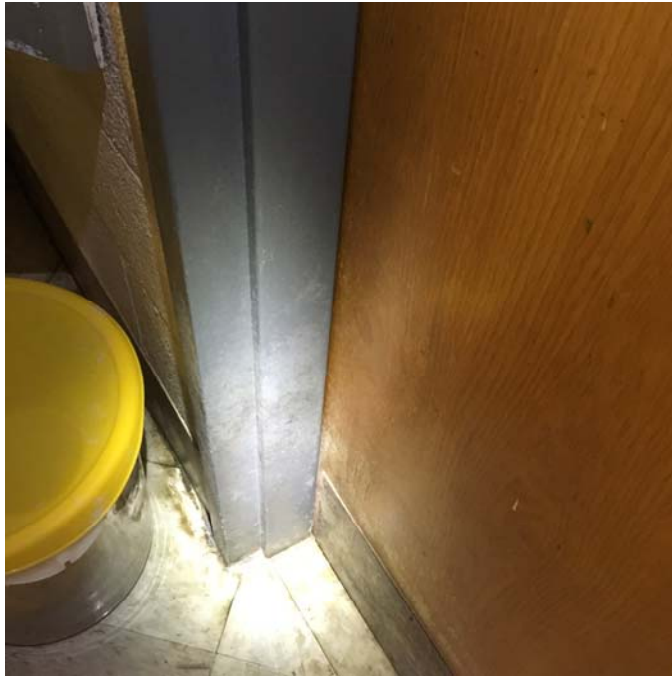
Photo 7 – Art Room 6
Mold growth was observed on the wooden doors and metal frames.

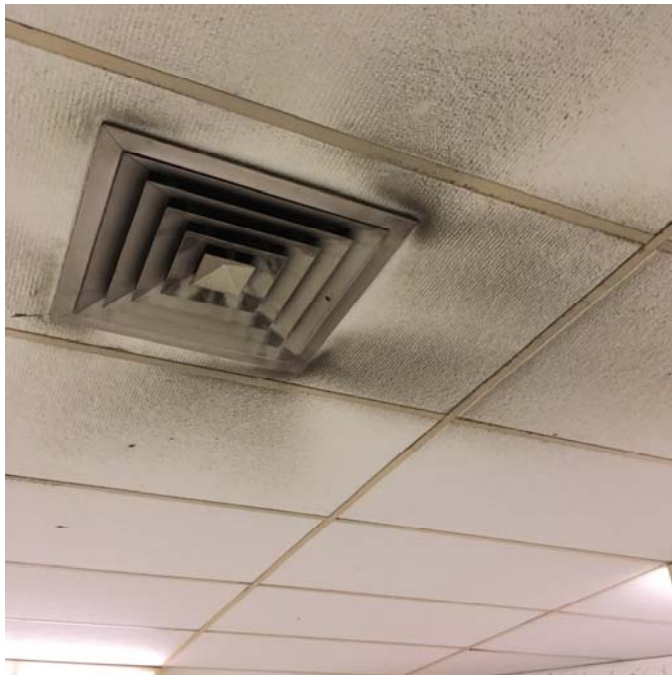
Photo 8 – Art Room 6
Particulate accumulation was observed on the supply diffuser and ceiling tiles.

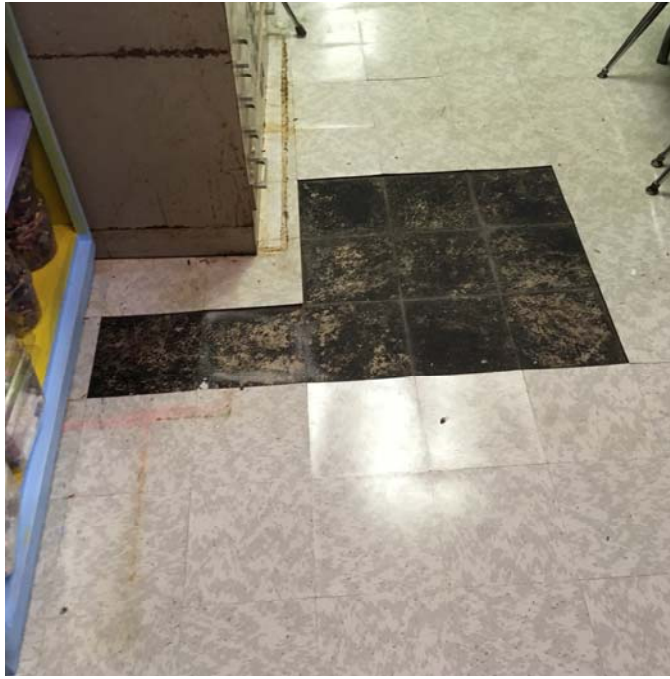
Photo 9 – Art Room 6
Delaminated 9"x9" floor tile was observed.

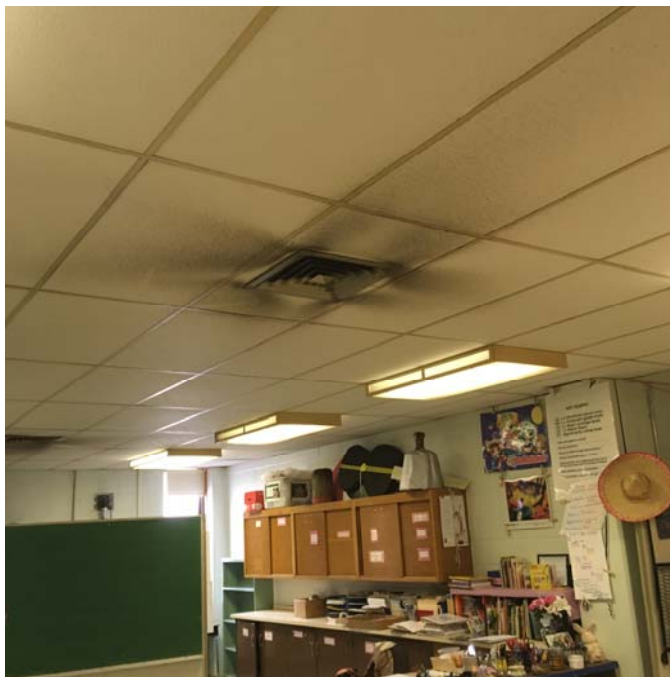
Photo 10 – Art Room 6
Particulate accumulation was observed on the supply diffusers and ceiling tiles.

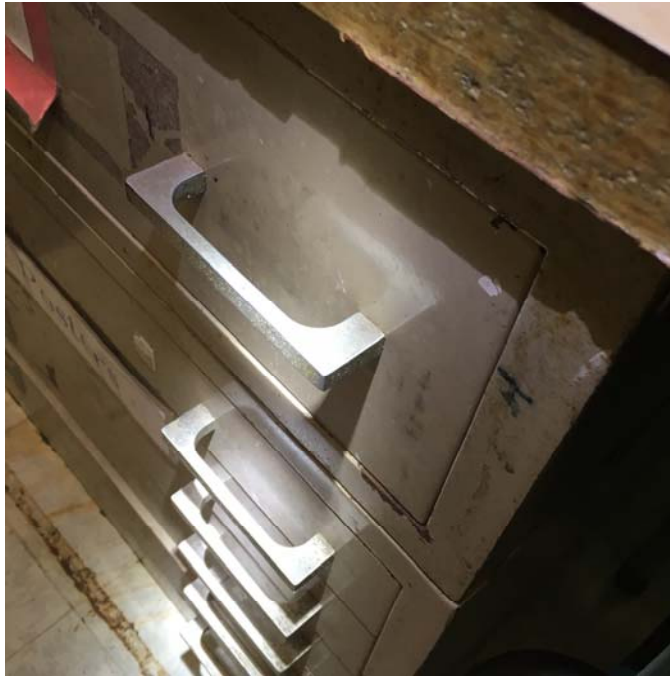
Photo 11 – Art Room 6
Mold growth was observed on the metal cabinetry.

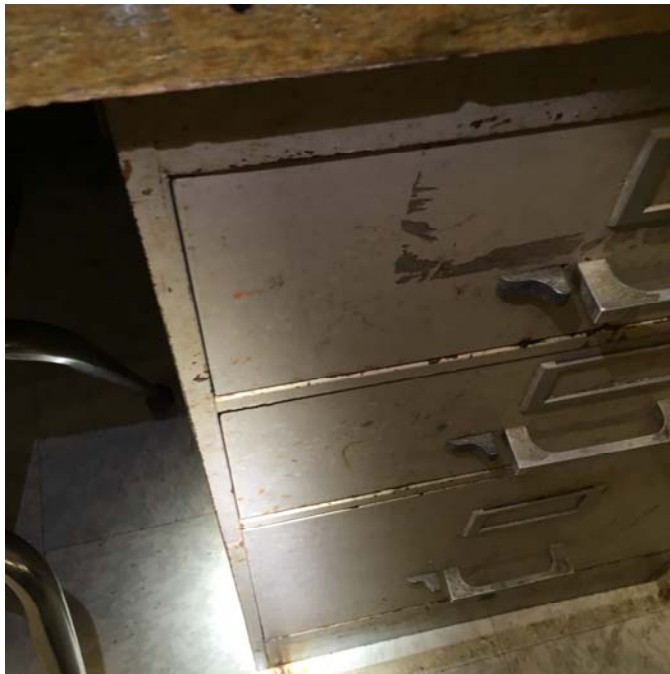
Photo 12 – Art Room 6
Mold growth was observed on the metal cabinetry.

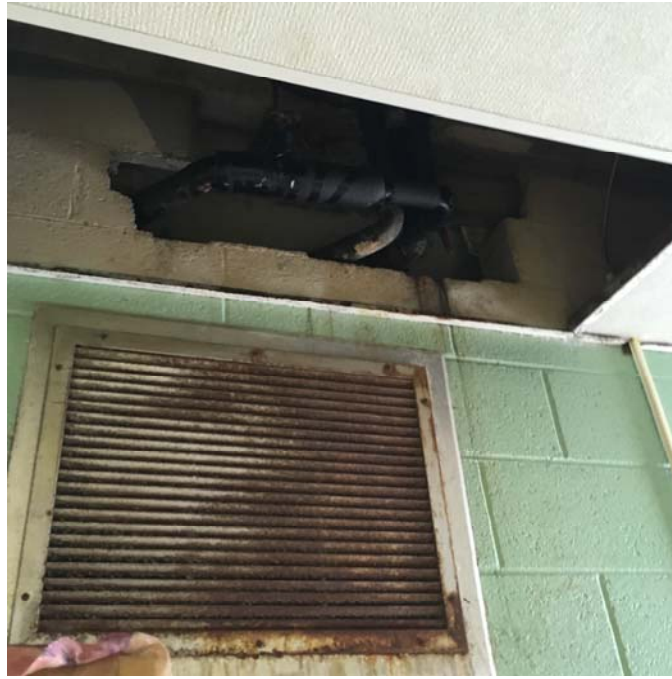
Photo 13 – Art Room 6
Condensation was leaking from the ceiling.

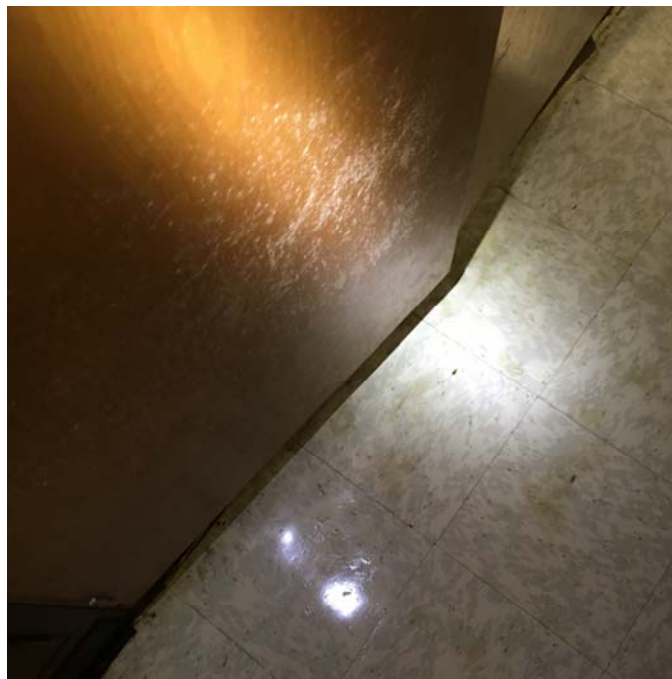
Photo 14 – Art Room 6
Mold growth was observed on the wooden cabinetry.

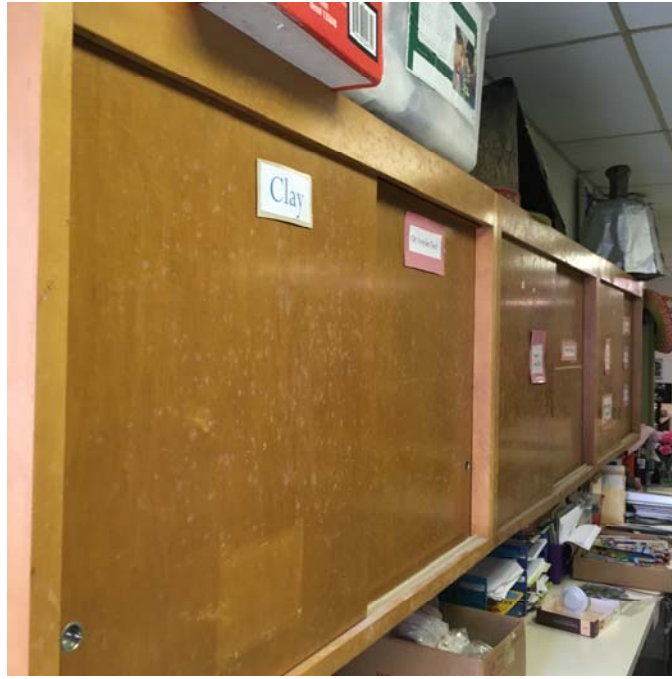
Photo 15 – Art Room 6
Mold growth was observed on the wooden cabinetry.

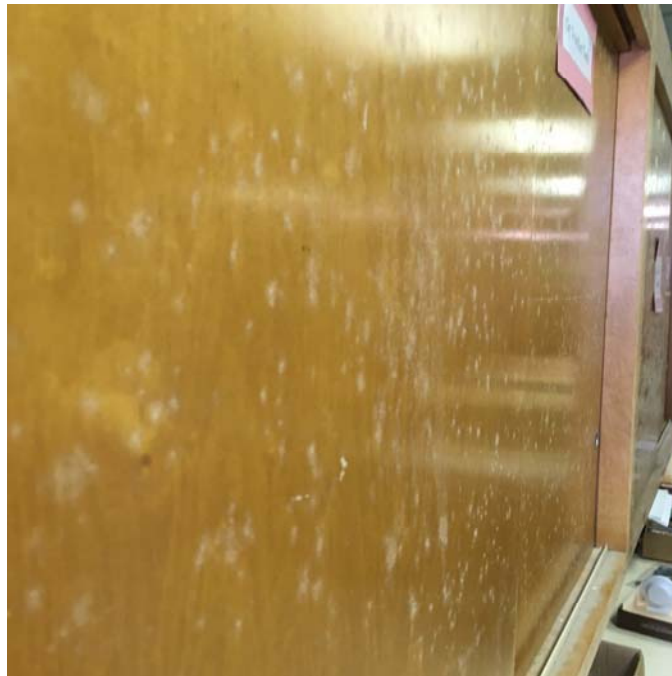
Photo 16 – Art Room 6
Mold growth was observed on the wooden cabinetry.

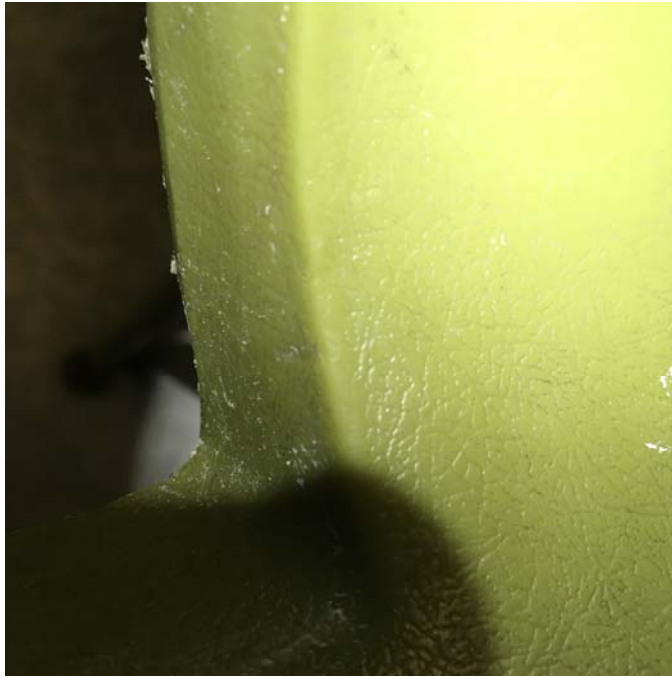
Photo 17 – Art Room 6
Mold growth was observed on the plastic chairs.

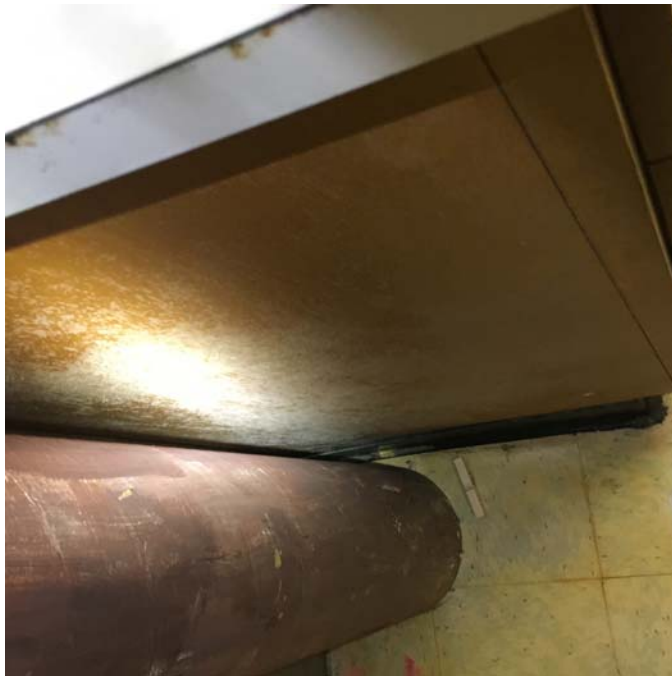
Photo 18 – Art Room 6
Mold growth was observed on the wooden cabinetry.

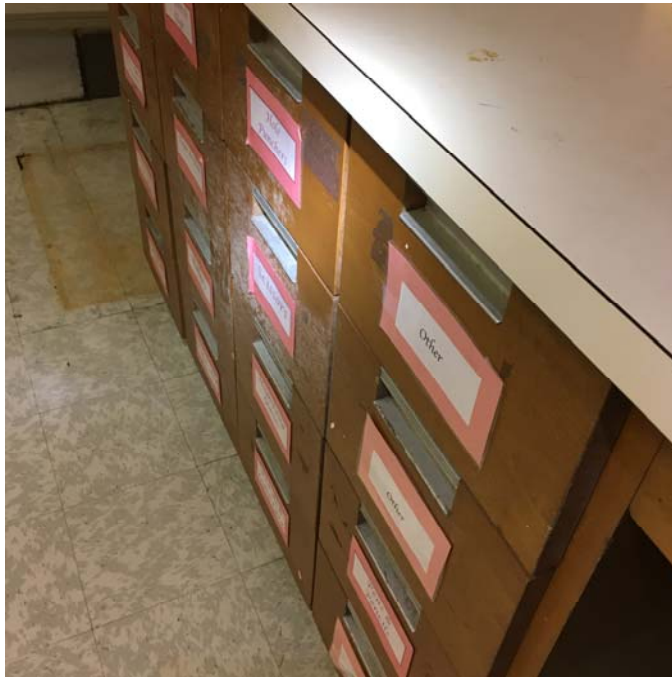
Photo 19 – Art Room 6
Mold growth was observed on the wooden cabinetry.

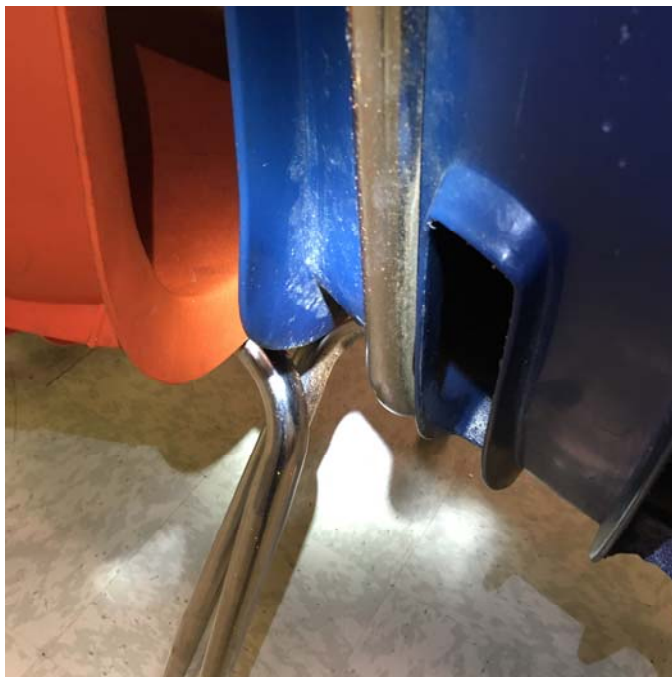
Photo 20 – Art Room 6
Mold growth was observed on the plastic chairs.

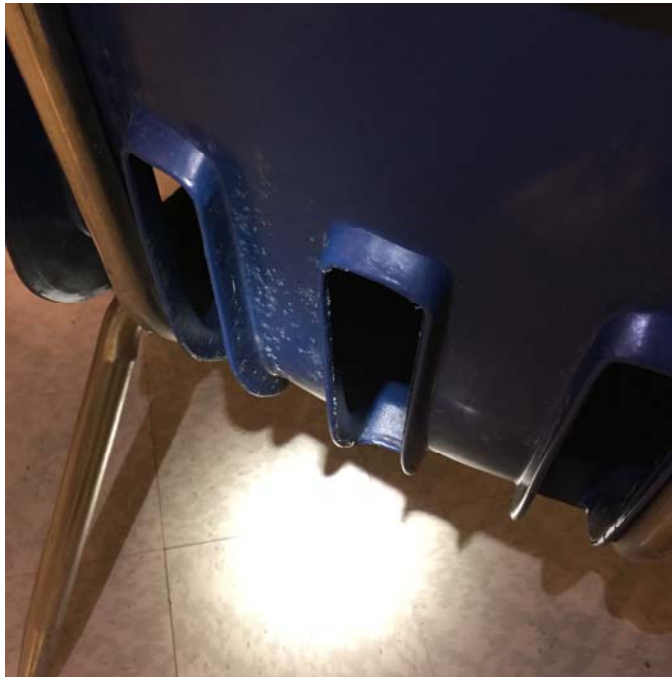
Photo 21 – Art Room 6
Mold growth was observed on the plastic chairs.

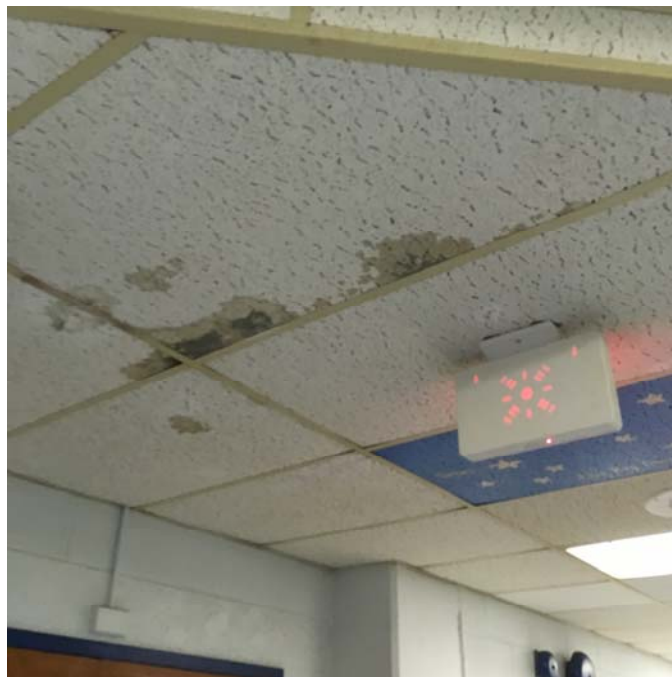
Action Item	Affected Material(s)	Total Quantity	Remediation*	Source of Moisture	Comments/Condition (i.e. dry/wet)
13	Mold growth was observed on several ceiling tiles in the basement hallway	12 EA	RPL	Condensation from piping located above the ceiling.	Replace the impacted ceiling tiles.

Photo 26 –Basement Hallway
Water stained and moldy ceiling tiles were observed.

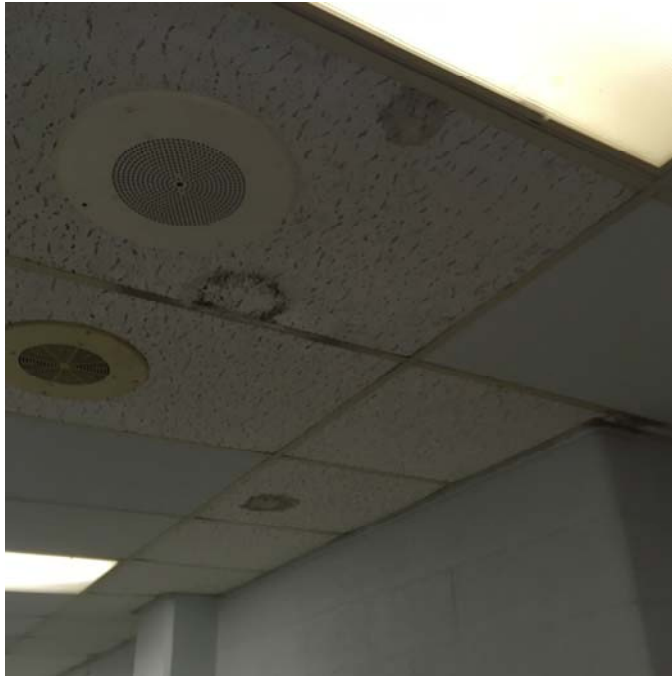
Photo 27 – Basement Hallway
Water stained and moldy ceiling tiles were observed.
