School District of Philadelphia  
Office of Environmental Management Services  
440 North Broad St.  
Philadelphia, PA 19030

Date  
Inspected:  
9/19/16

## Mold Design Data Collection (DDC)

Name of Building: Lincoln High School

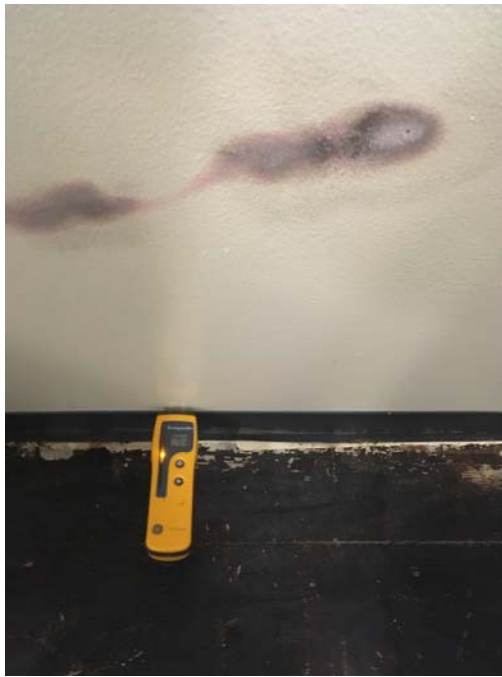
Photo 1 – Room 102

| Action Item | Affected Material(s) | Total Quantity | Remediation* | Source of Moisture | Comments/Condition (i.e. dry/wet) |
|---|--|---|---|---|---|
| 1 | Mold growth was observed on the wallboard to the right of the unit ventilator. | 1 SF | RMV, RPL | Leak from CUV | Remove the section of impacted wallboard. Removal beyond the specified may be required if additional mold growth is discovered on the unfinished side of the wallboard. The wall cavity section should be HEPA vacuumed, cleaned and encapsulated as needed prior to replacement. |

Mold growth was observed on the wallboard to the right of the unit ventilator.

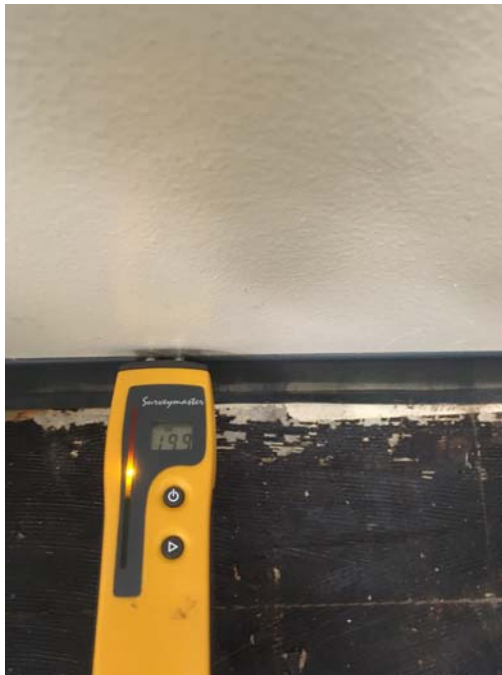
Photo 2 – Room 102

Elevated moisture content was detected on the wallboard below the section of mold growth.

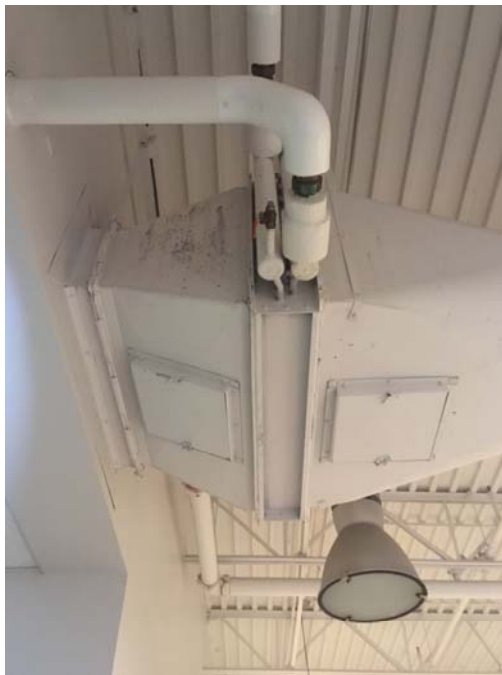
Photo 4 –IMC

| Action Item | Affected Material(s) | Total Quantity | Remediation* | Source of Moisture | Comments/Condition (i.e. dry/wet) |
|---|---|---|---|---|--|
| 2 | Approximately 90 SF of mold growth was distributed over 180 LF of the exposed HVAC supply branches. | 90 SF | CLN | Condensation from A/C | All surfaces of the exposed ducts including the diffusers should be HEPA vacuumed and cleaned. |

Mold growth was observed on sections of the exposed duct work.

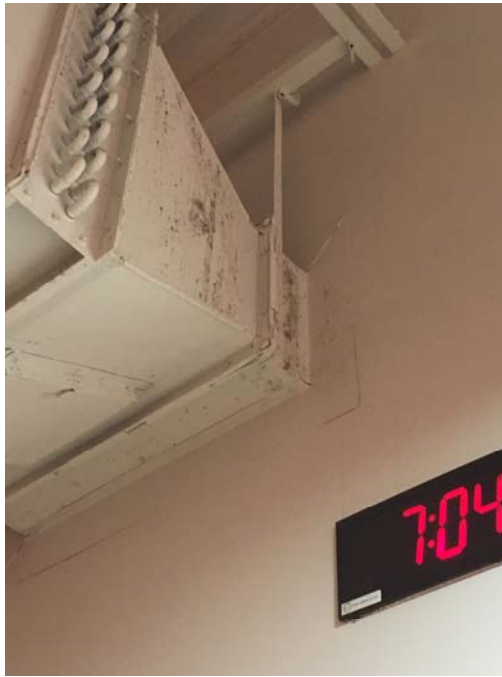
Photo 5 – IMC

Mold growth was observed on sections of the exposed duct work.

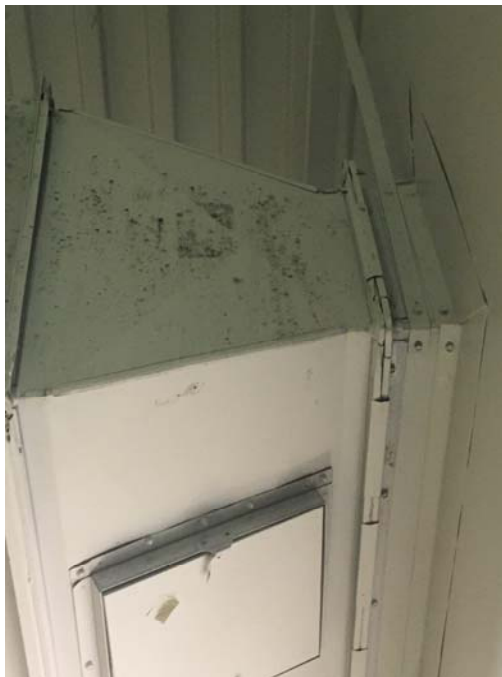
Photo 6 – IMC

Mold growth was observed on sections of the exposed duct work.

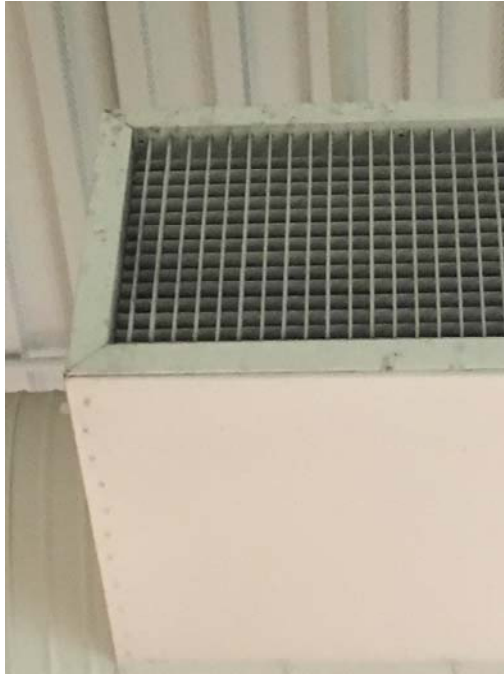
Photo 7– IMC

Mold growth was observed on sections of the exposed duct work.

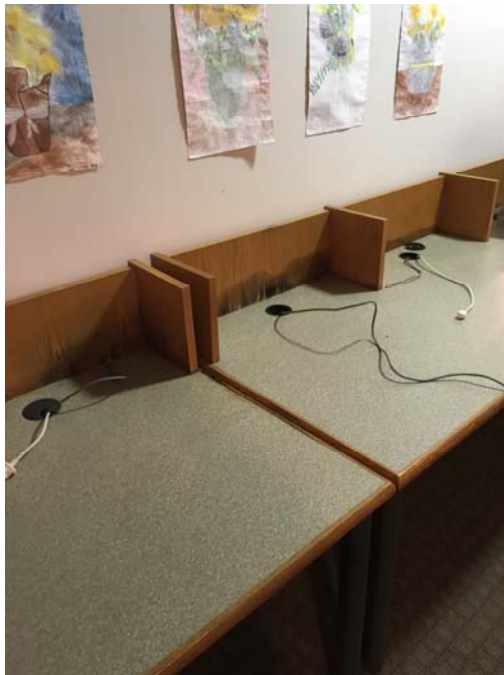
Photo 8 – IMC

| Action Item | Affected Material(s) | Total Quantity | Remediation* | Source of Moisture | Comments/Condition (i.e. dry/wet) |
|---|---|---|---|---|--|
| 3 | Mold growth was observed on the computer work stations located below the center supply branch. | 2 EA | DIS | | The impacted work stations should be discarded. |

Suspect mold growth was observed on the work stations below the center supply branch.

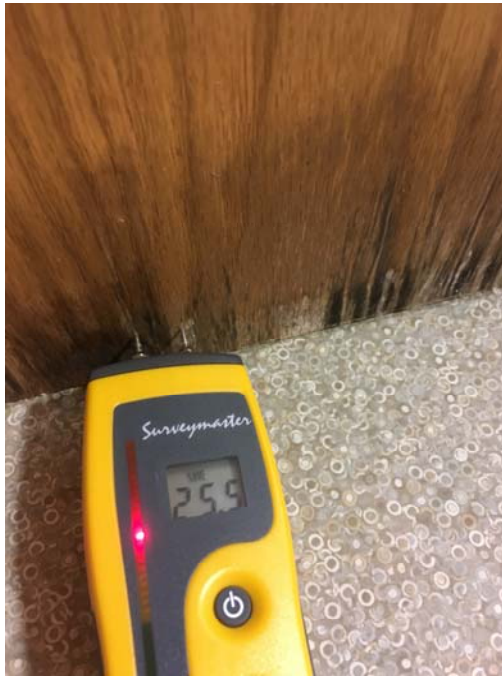
Photo 9 – IMC

Elevated moisture content was detected on the work stations below the center supply branch.
