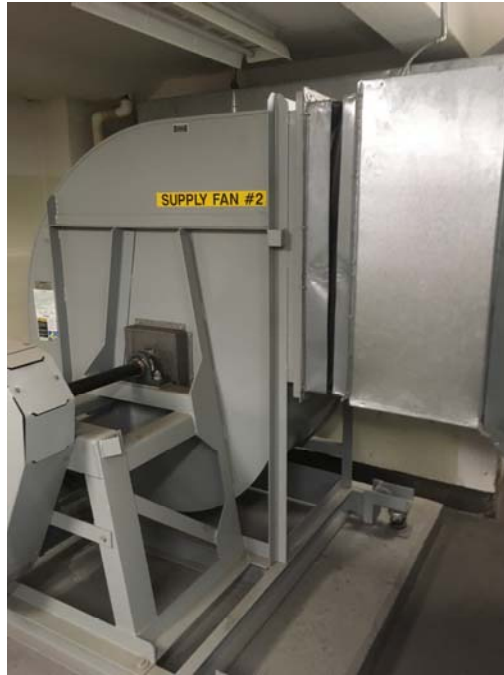
Photo 1 – Fan Room
A new house fan system was installed.

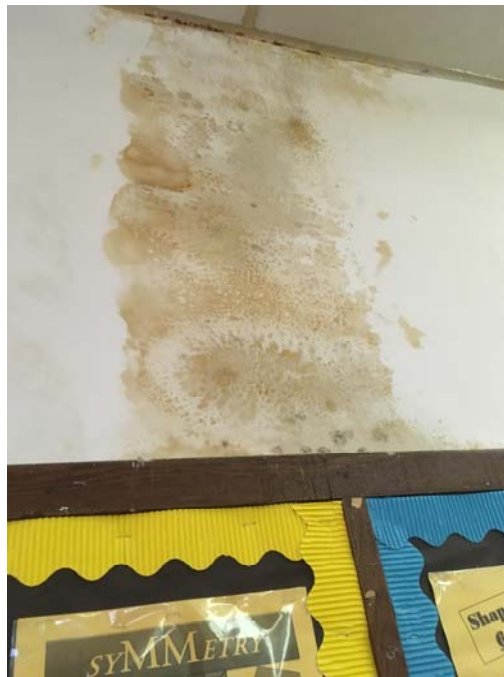
Photo 2 – Room 308
Mold growth was distributed over a moisture damaged section of plaster wall.

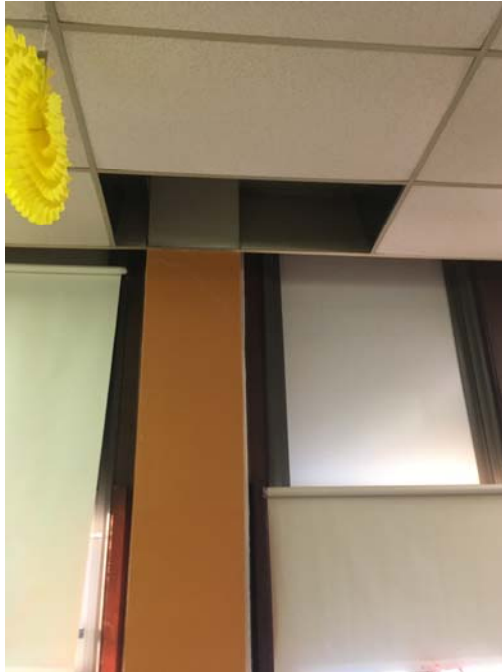
Photo 3 – Room 308
A missing ceiling tile was observed.

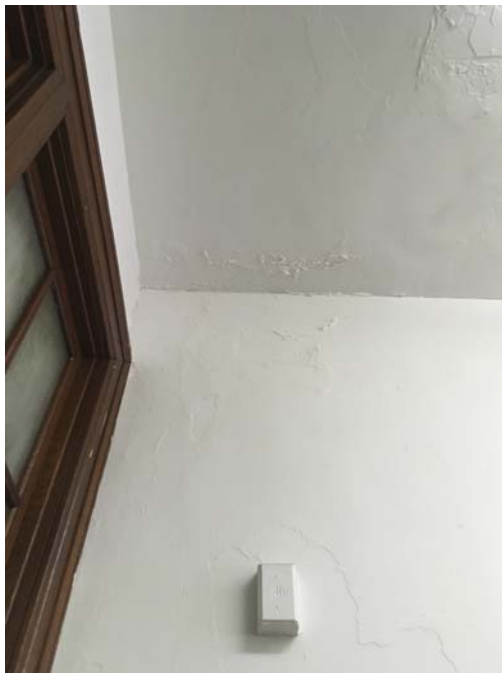
Photo 4 – 3rd Floor Boy's Room
Minor flaking paint and efflorescence was observed.

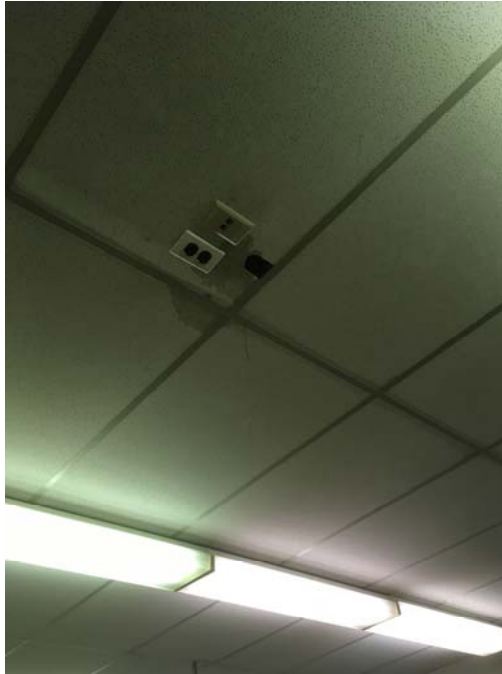
Photo 5 – Room 306
Water stained ceiling tiles were observed.

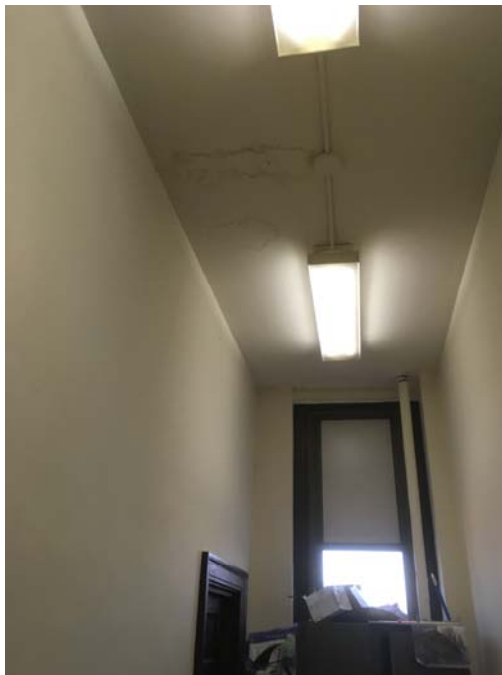
Photo 6 – Room 306 Closet
Staining was observed on the plaster ceiling.

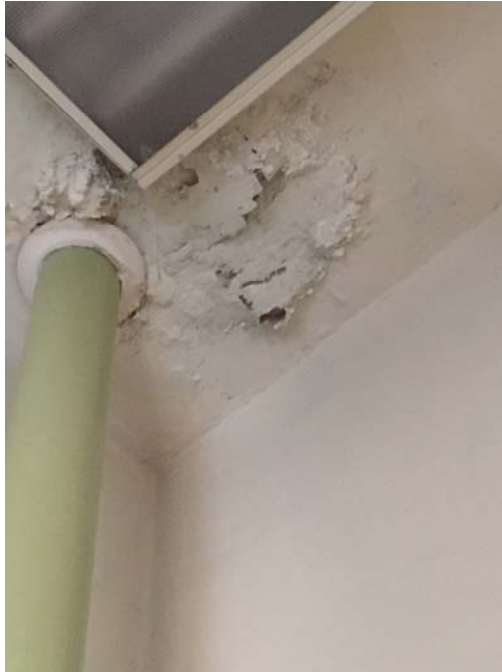
Photo 7 – Room 307 Closet
Flaking paint and efflorescence was observed around the roof drain.

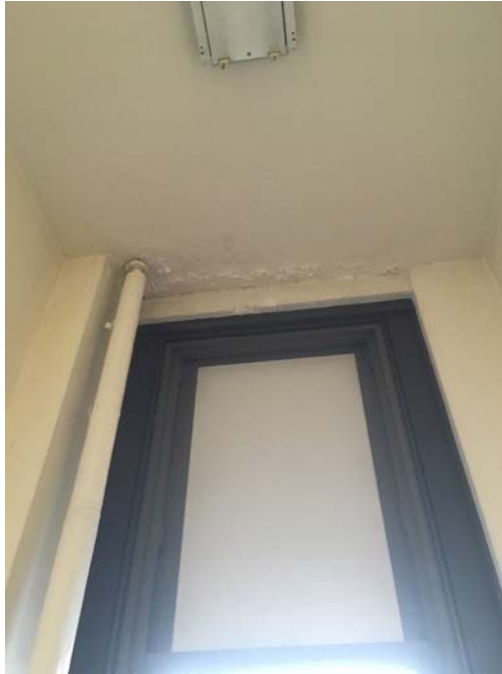
Photo 9 – Room 305 Closet
Minor flaking paint and efflorescence was observed above the window.

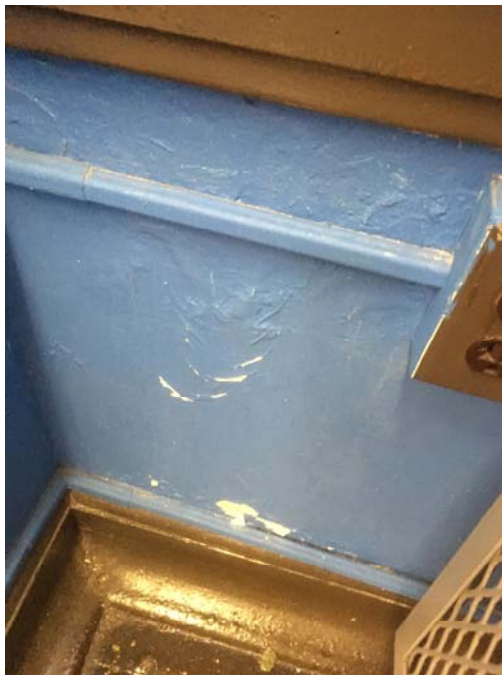
Photo 10 – Room 305
A minor section of damaged paint was observed below the window.

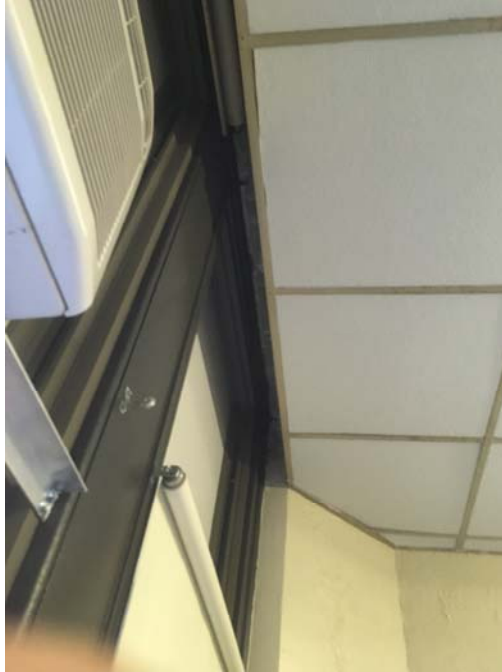
Photo 11– Room 304 A
Minor flaking paint and efflorescence was observed above the window.

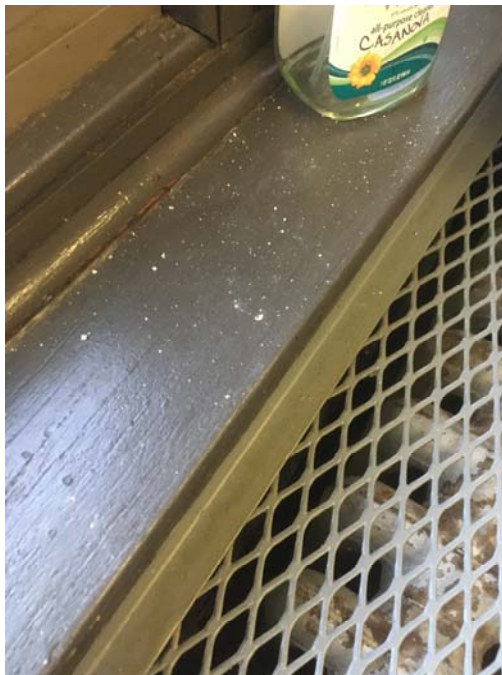
Photo 12 – Room 304 A
A minimum amount of plaster debris was observed on the window sill.

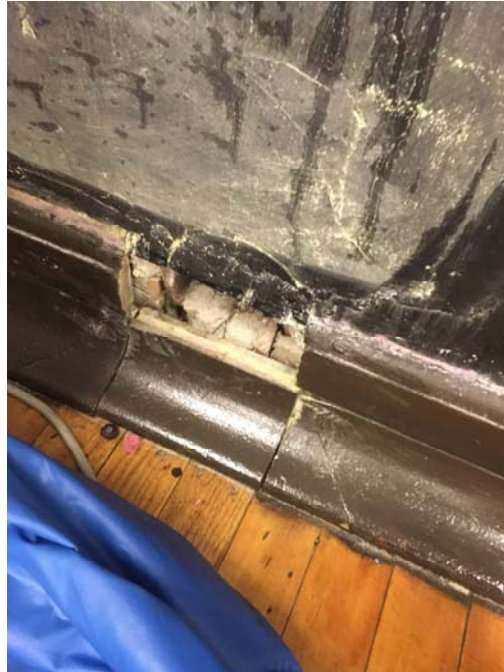
Photo 15 – Room 303
A small hole was observed on the baseboard on the back wall.

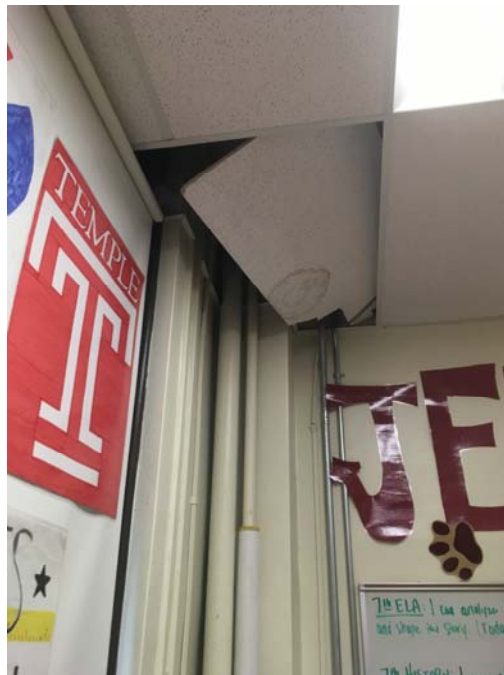
Photo 16 – Room 303
This ceiling tile was stained and about to fall from the suspended track.

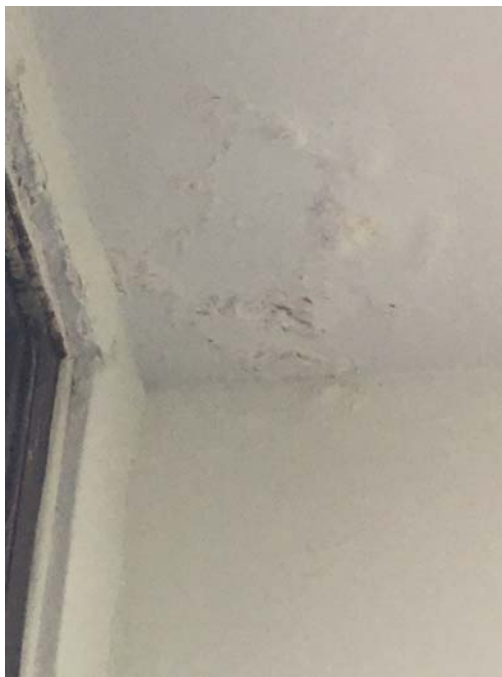
Photo 18 – 3rd Floor Girl's Room
Flaking paint and efflorescence was observed on the ceiling.

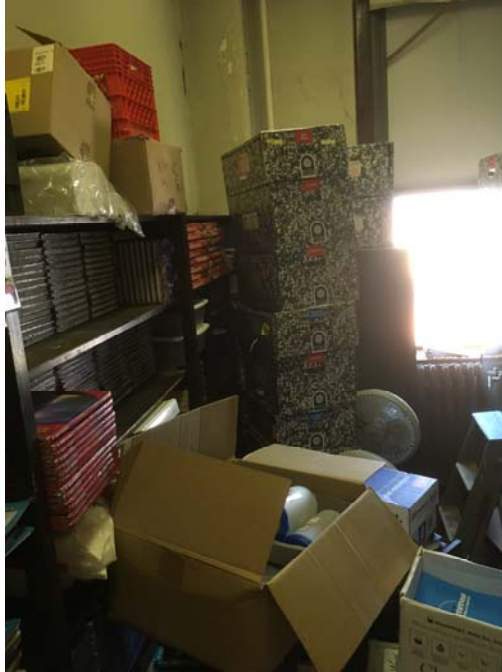
Photo 19 – Room 301 Closet
This closet appeared to be cluttered.

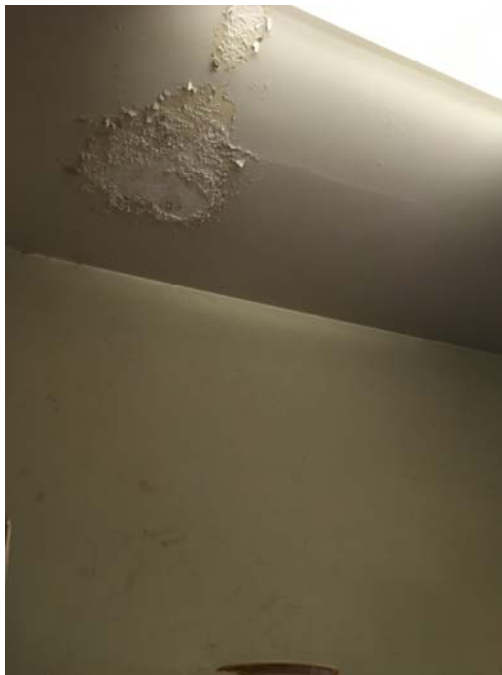
Photo 20 – Room 301 Closet
Minor flaking paint and efflorescence was observed on the ceiling.

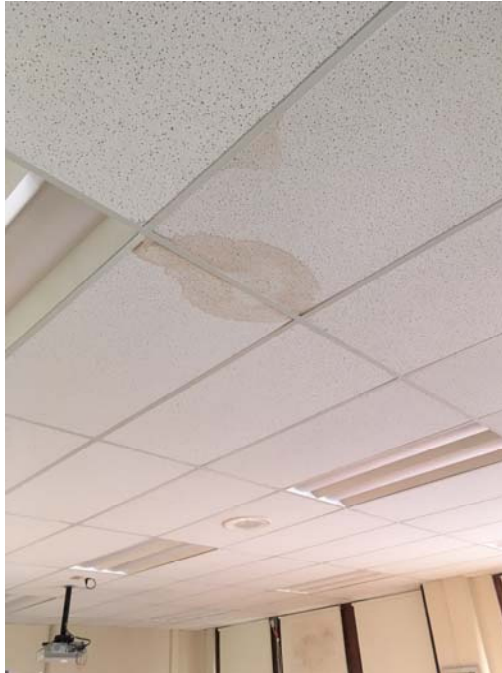
Photo 21 – IMC
Water stained ceiling tiles were observed.

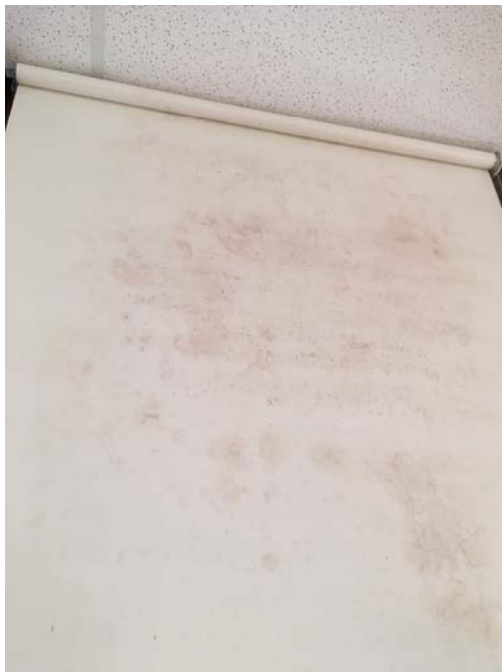
Photo 22 – IMC
Suspect mold growth was observed on the shade over window #2.

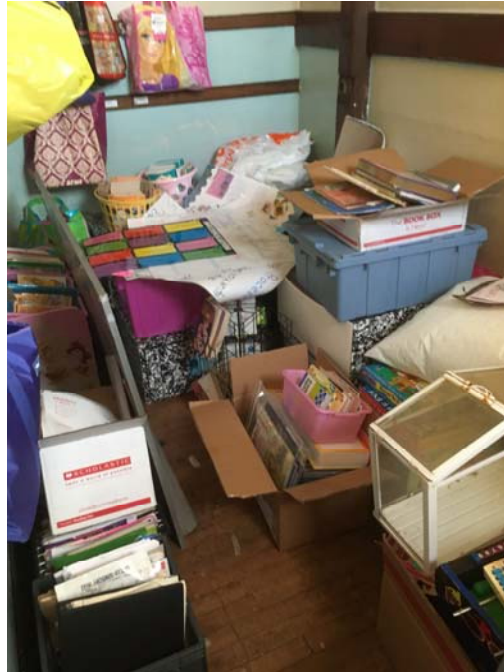
Photo 23 – Room 208 Closet
This closet appeared to be cluttered.

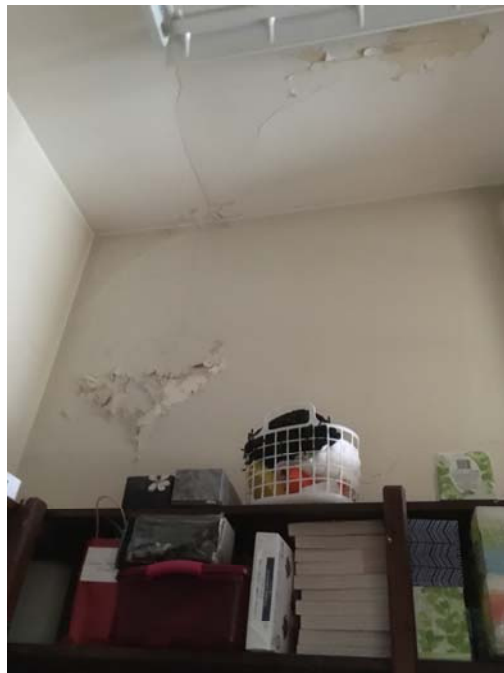
Photo 24 – Room 208 Closet
Flaking paint was observed on the wall.

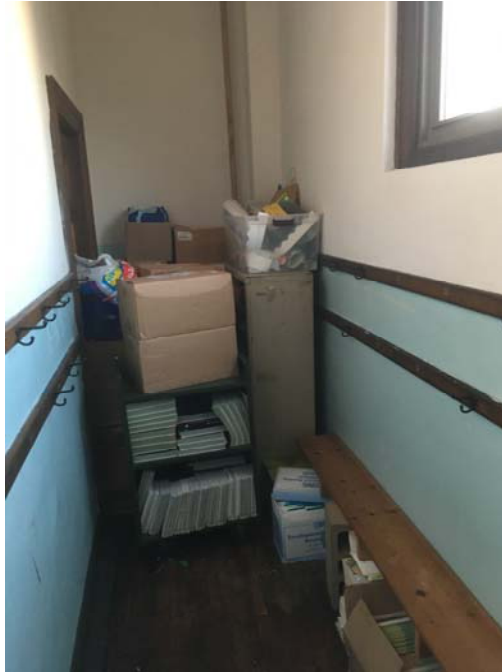
Photo 25 – Room 207
The contents of this closet were blocking access to the radiator.

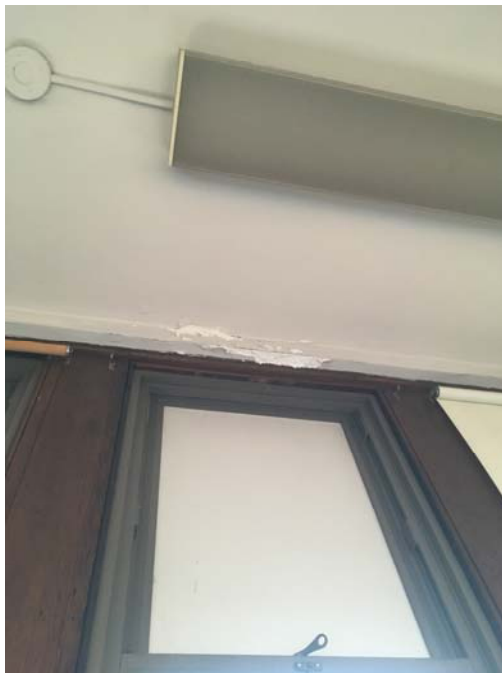
Photo 26 – Room 207 Closet
Minor flaking paint and efflorescence was observed above the window.

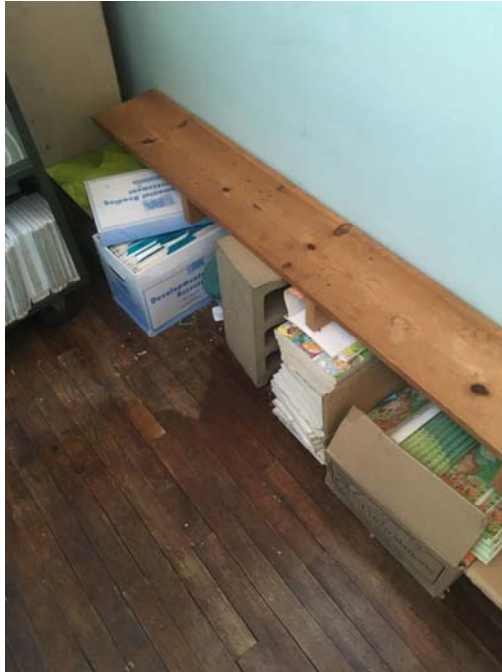
Photo 27 – Room 207 Closet

This makeshift bench was supported by cinder blocks and not secured to the wall.

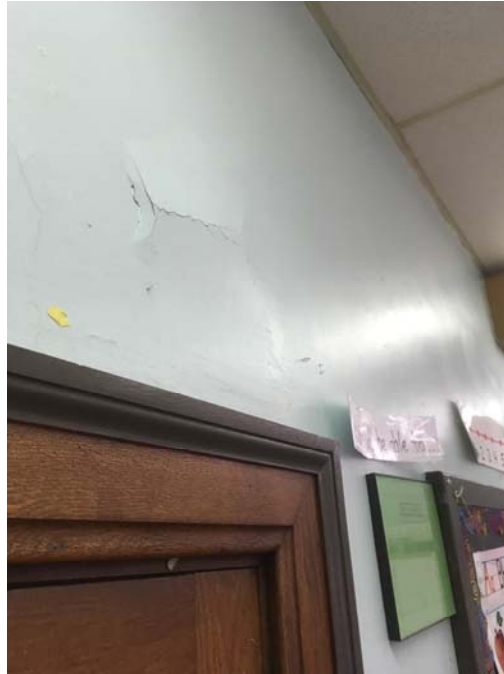
Photo 29 – Room 206
Delaminated sections of plaster wall were observed.

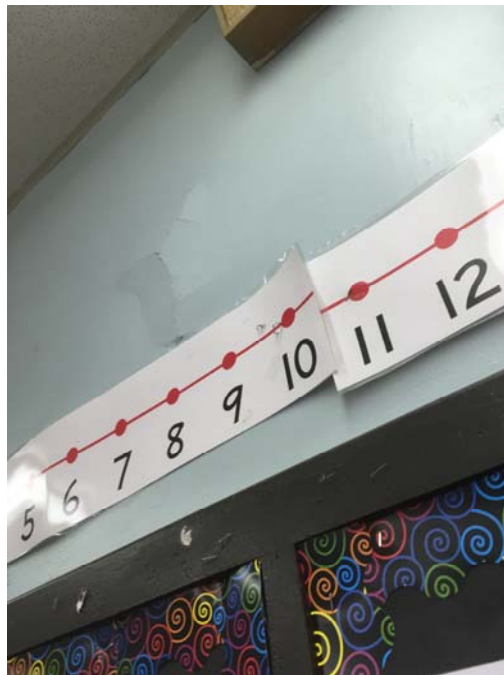
Photo 30 – Room 206
Delaminated sections of plaster wall were observed.

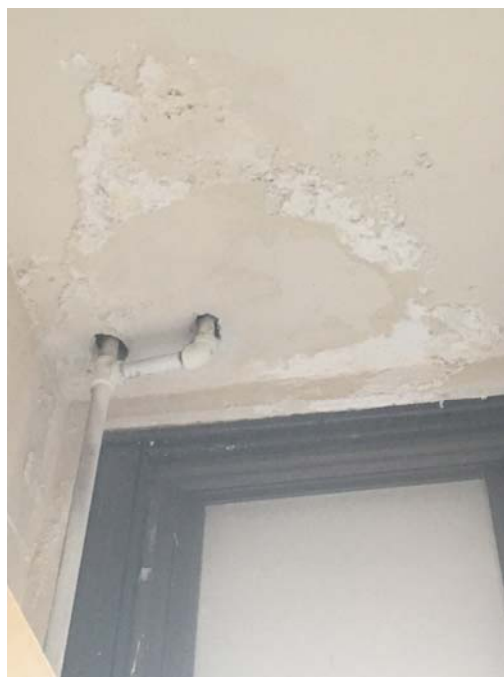
Photo 32 – Room 205 Closet
Flaking paint and efflorescence was observed in this closet.

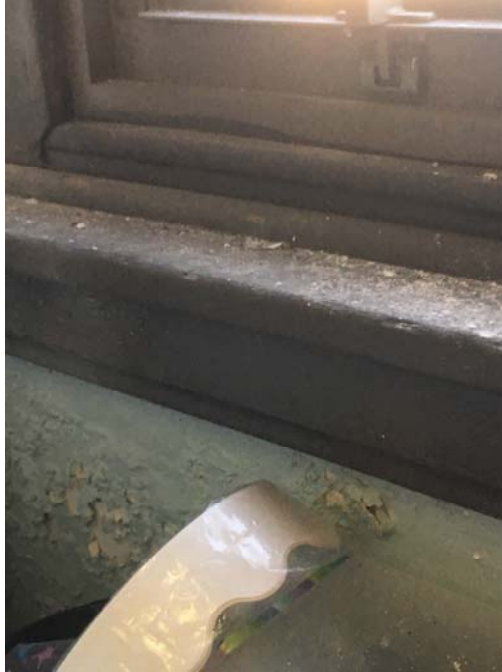
Photo 33 – Room 205 Closet
Paint and plaster debris was observed on the window sill and floor.

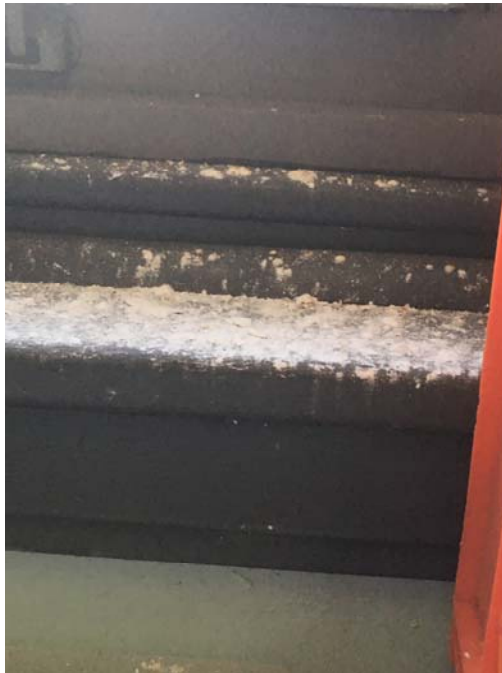
Photo 34 – Room 205 Closet
Paint and plaster debris was observed on the window sill and floor.

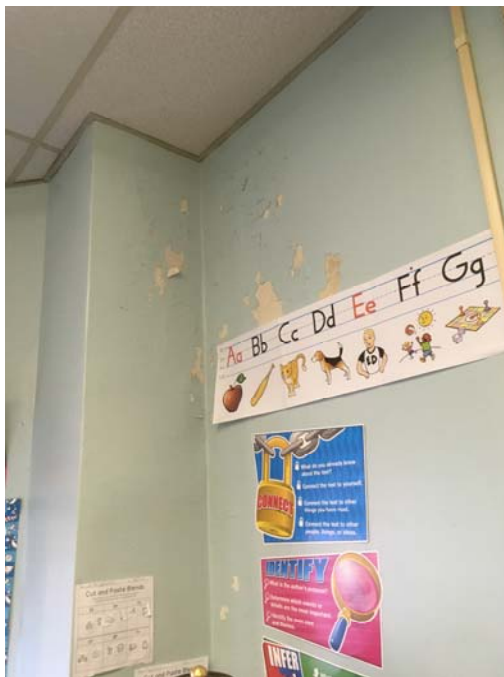
Photo 36 – Room 204 A
Flaking paint was observed on the wall.

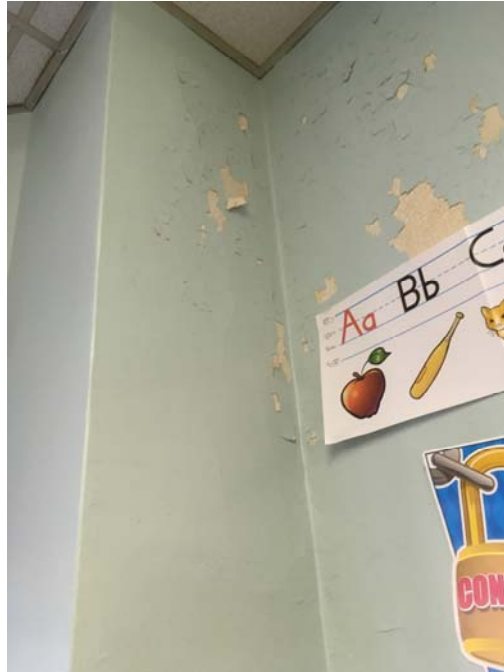
Photo 37 – Room 204 A
Flaking paint was observed on the wall.

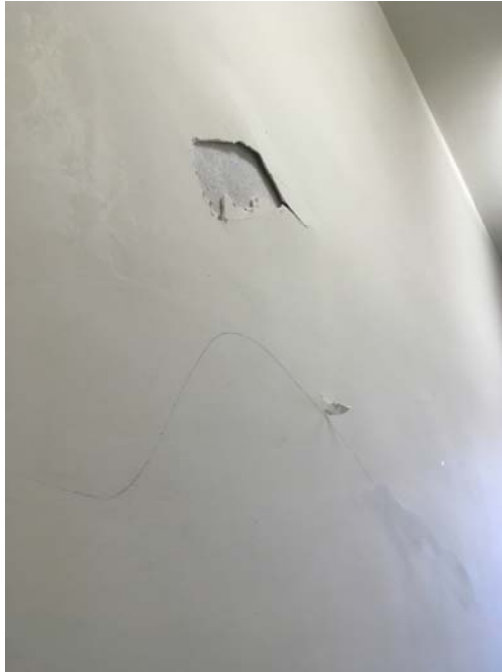
Photo 39 – Room 204 Closet
A delaminated section of plaster wall was observed in this closet.

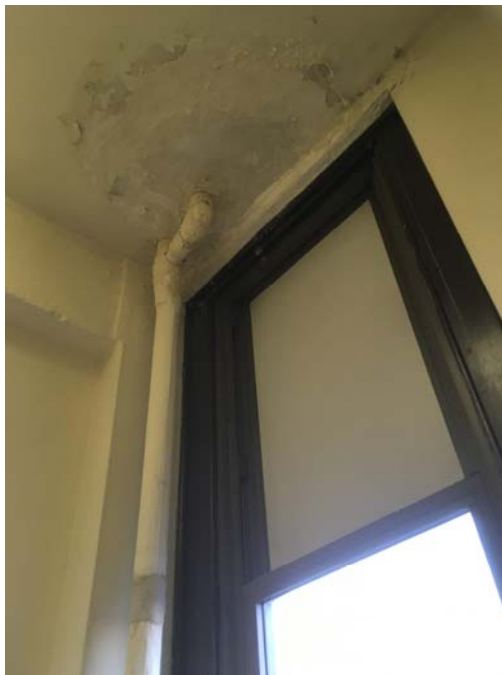
Photo 40 – Room 203 Closet
Flaking paint and efflorescence was observed in this closet.

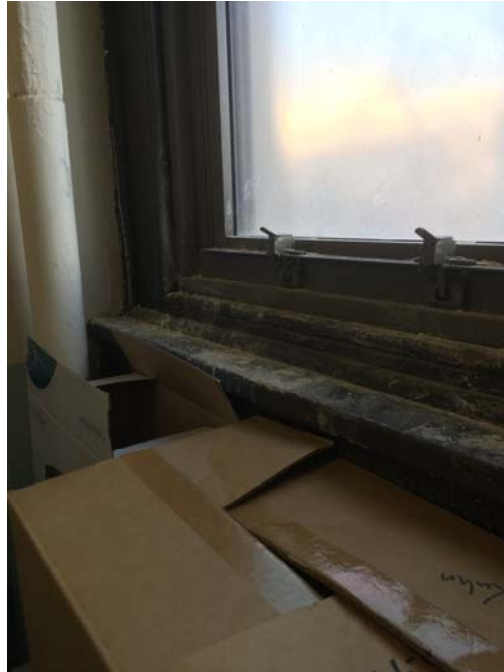
Photo 41 – Room 203 Closet
Paint and plaster debris was observed on the window sill and floor.

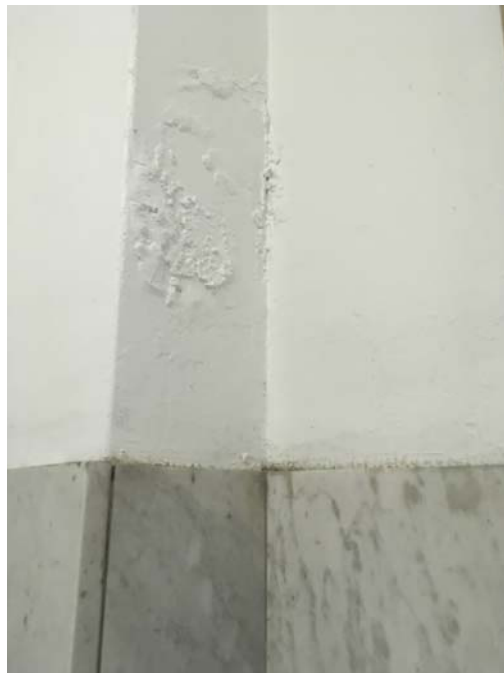
Photo 42 – 2nd Floor Men's Room
A minor amount of efflorescence was observed on the wall.

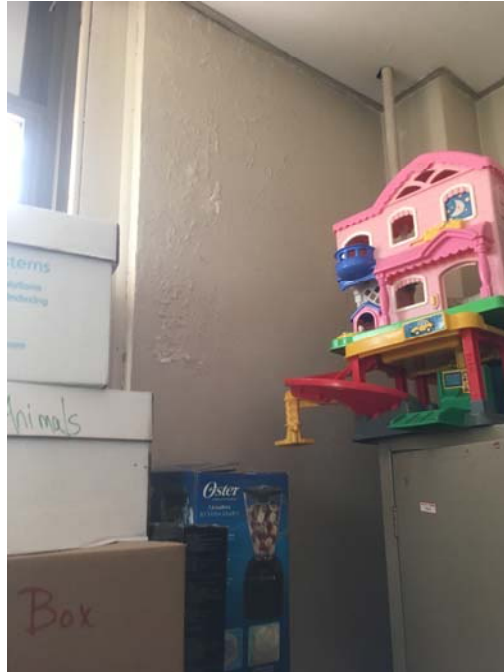
Photo 43 – Room 101 Closet
Flaking Paint was observed in this closet.

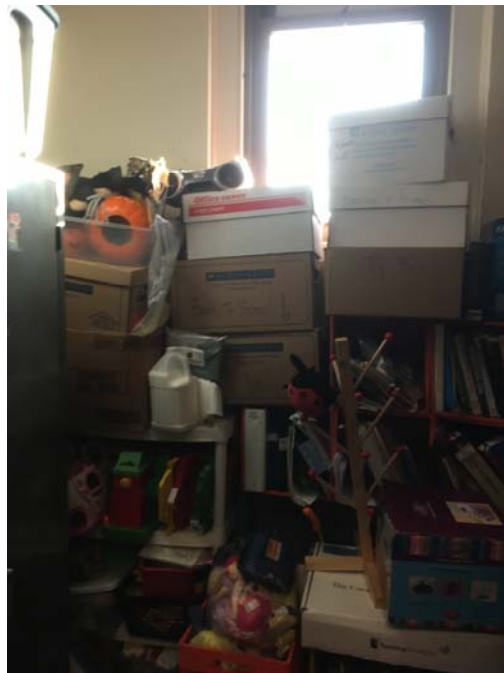
Photo 44 – Room 101 Closet
This closet appeared to be cluttered.

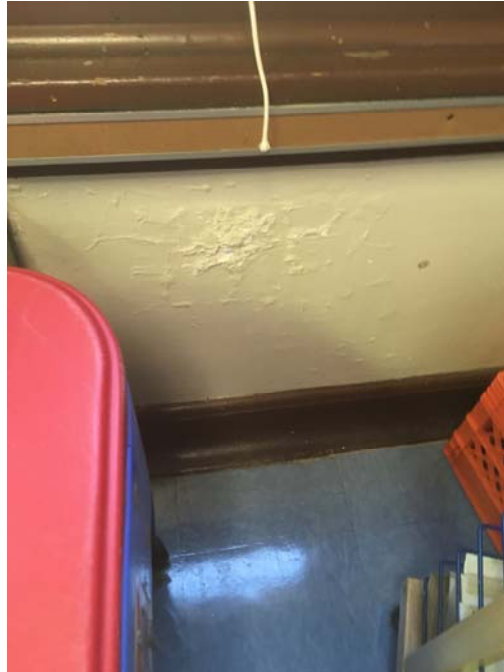
Photo 45 – Room 101

A minor amount of efflorescence was observed below the window.

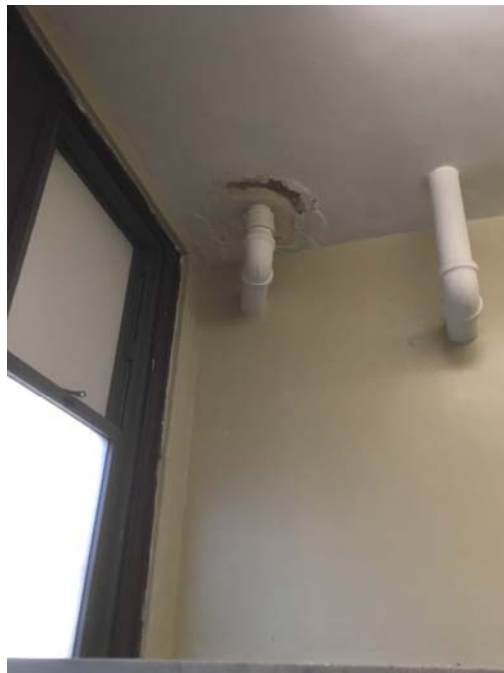
Photo 46 – 1st Floor Girl's Room

Paint and plaster damaged was observed around the waste line on the ceiling.

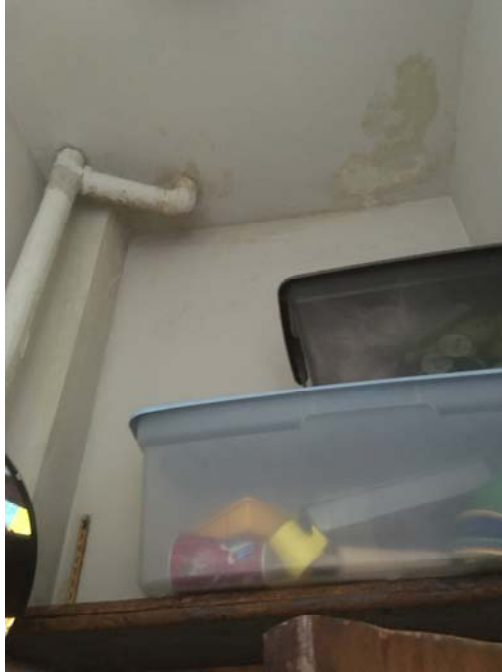
Photo 47 – Room 102 Closet
Water stained was observed on the closet ceiling.

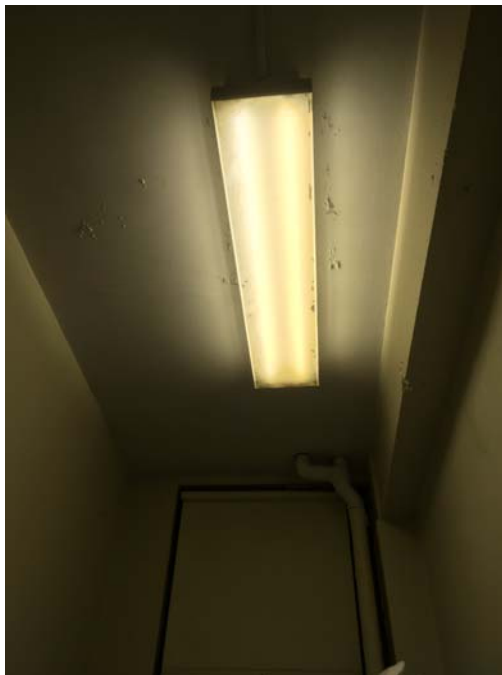
Photo 48 – Room 104 Closet
Minor sections of flaking paint were observed on the ceiling.

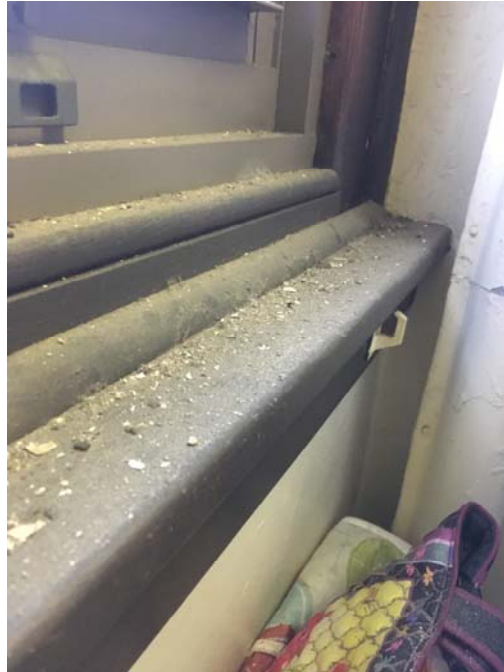
Photo 49 – Room 104 Closet
Paint and plaster debris was observe don the window sill.

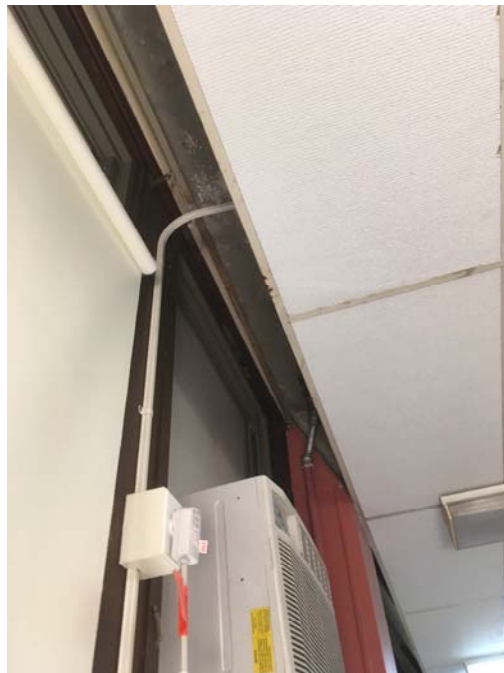
Photo 50 – Room 110
Missing ceiling tiles were observed above the windows.

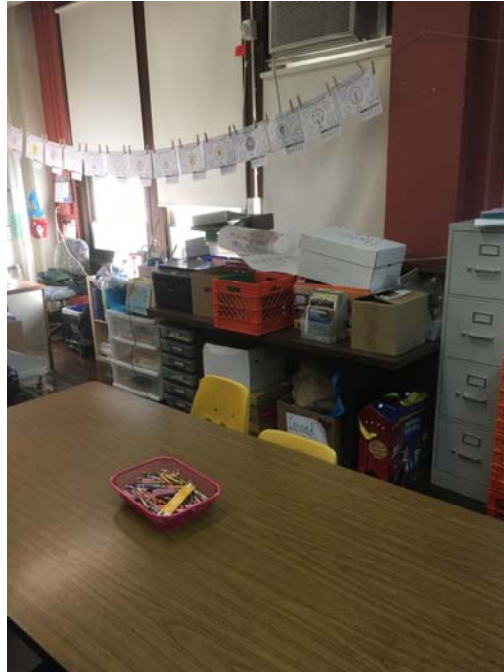
Photo 51 – Room 110
This room appeared to be cluttered.

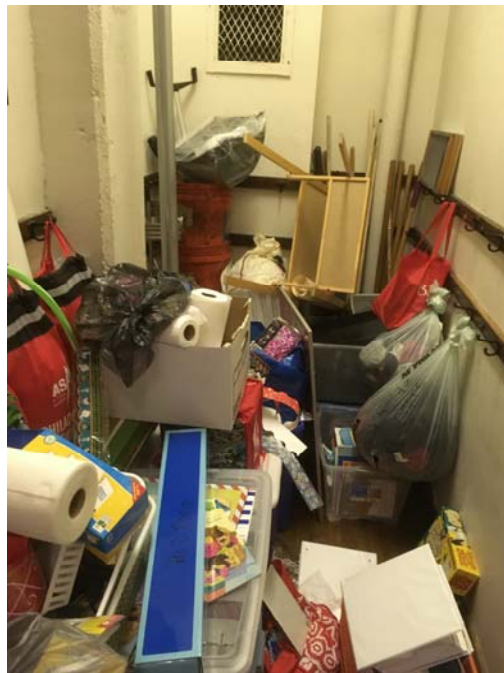
Photo 52 – Room 110 Closet
This closet appeared to be cluttered,

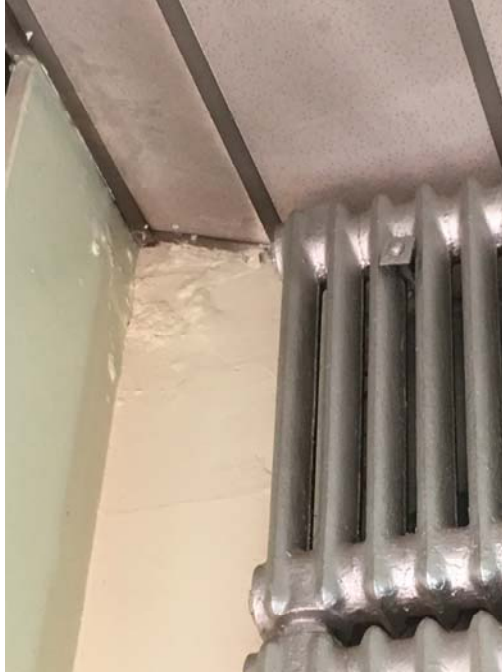
Photo 53 – Room 109 Kindergarten
A minor section of efflorescence was observed nest to the wall mounted radiator.

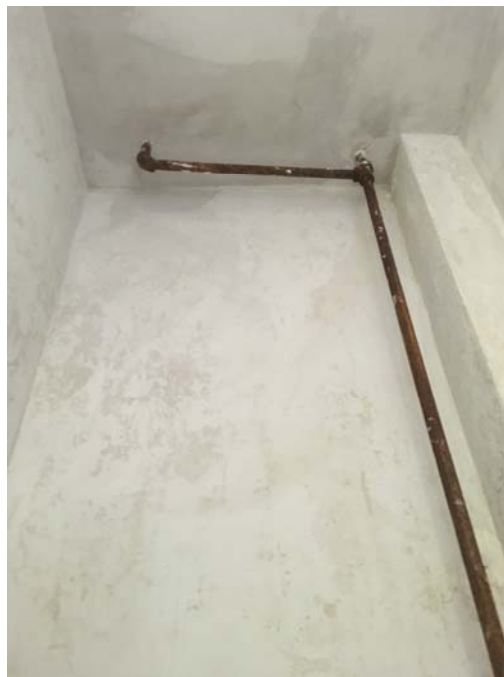
Photo 56 – Room 106 Closet

The plaster in this closet was repaired, however, sections of the paint appeared to be flaking again.

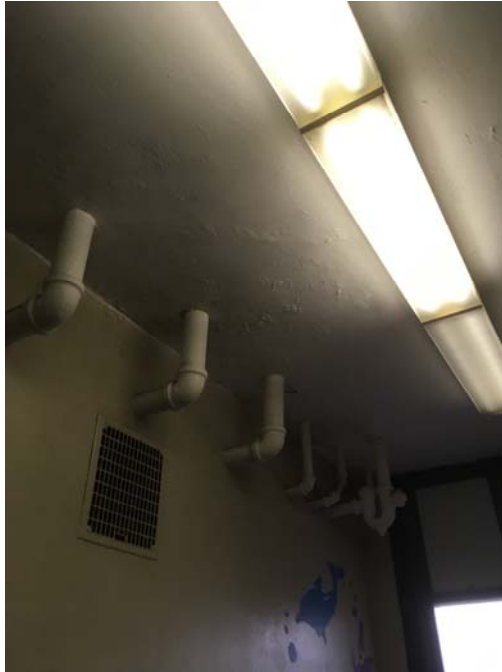
Photo 57 – 1st Floor Boy's Room
Flaking paint and efflorescence was observed on the ceiling.

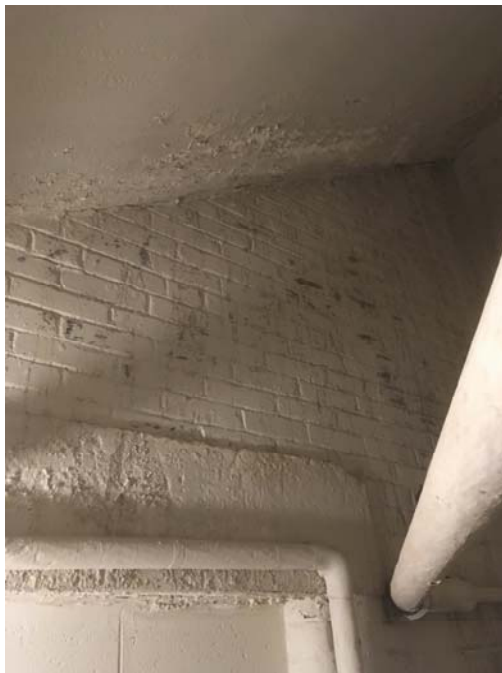
Photo 58 – Basement Boy's Side Custodial Closet
Flaking paint and efflorescence was observed on the walls and ceiling.

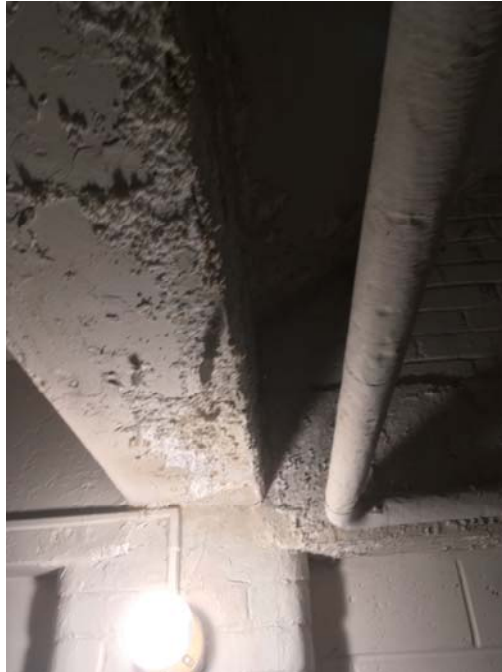
Photo 59 – Basement Boy's Side Custodial Closet
Flaking paint and efflorescence was observed on the walls and ceiling.

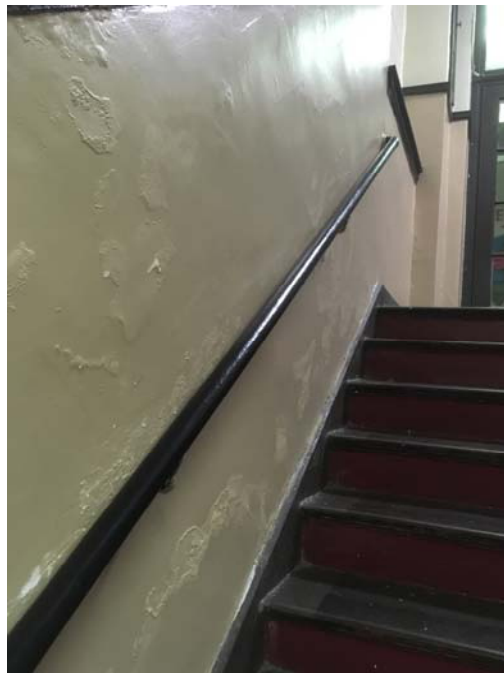
Photo 60 – Basement Boy's Stairwell to Gym
This plaster wall was recently repaired, and is beginning to deteriorate again from moisture intrusion.

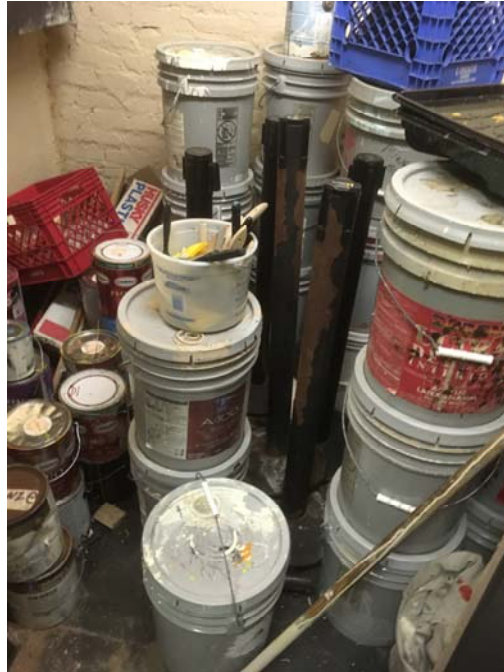
Photo 61 – Basement Boy's Side Stairwell Closet
Store paints were observed in this closet.

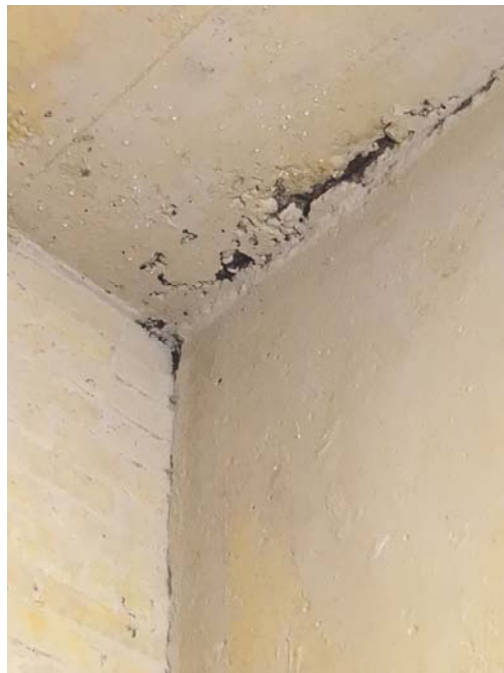
Photo 62 – Basement Boy's Side Stairwell Closet
This closet had a strong musty odors and water droplets were observed on the ceiling.

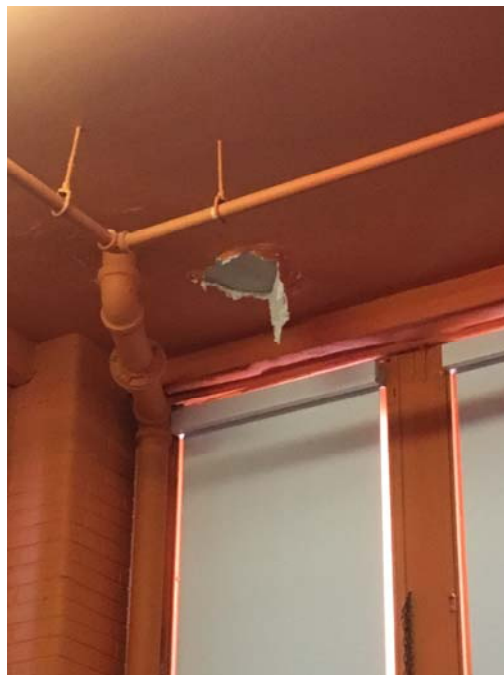
Photo 64 – Gymnasium/Cafeteria

A section of moisture damaged plaster was observed on the ceiling.

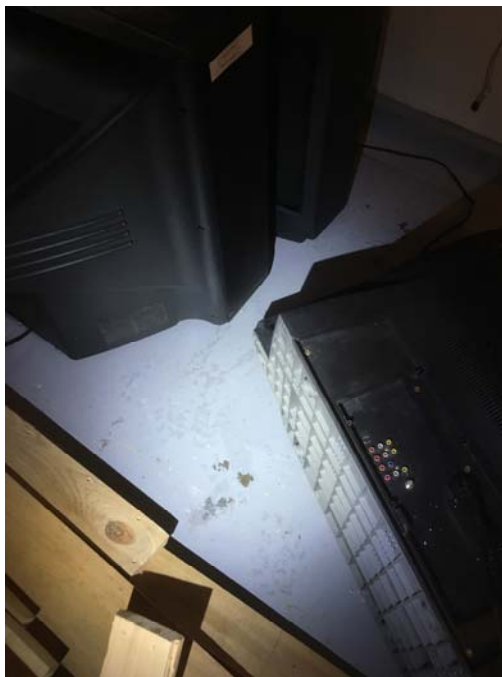
Photo 66 – Basement Girl's Side Stairwell Closet
Standing water was observed on the floor.

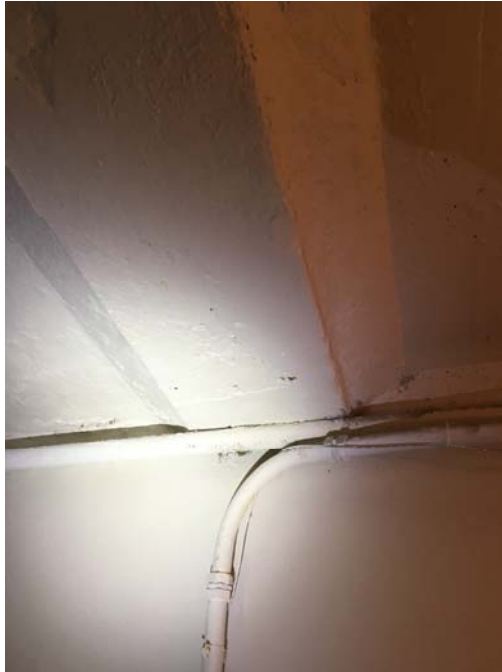
Photo 67 – Basement Girl's Side Stairwell Closet
Water leaked from the ceiling during the heavy rain that occurred the night before the inspection.

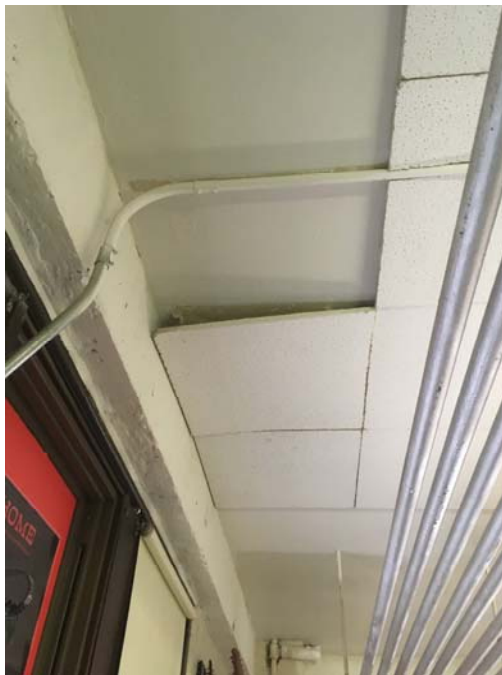
Photo 68 – Music Room
A couple of delaminated ceiling tiles were observed.

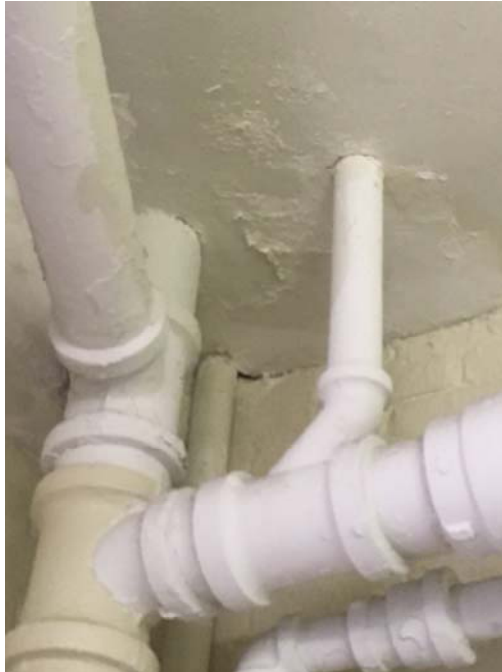
Photo 69 – Music Room

A minor section of flaking paint was observed on the corner of the room.

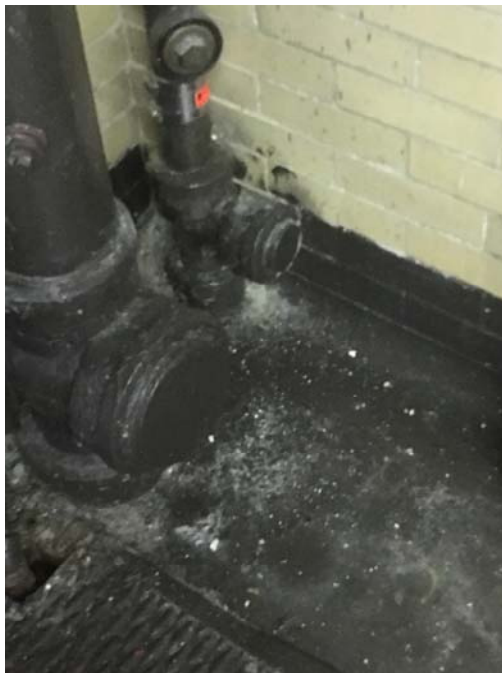
Photo 70 – Music Room

A minimum amount of plaster debris was observed on the floor in the corner of the room.
