School District of Philadelphia
Office of Environmental Management Services
440 North Broad St.
Philadelphia, PA 19030

Asbestos Design Data Collection (DDC)

Name of Building: Beeber High School
Address: 5925 Malvern Avenue ULCS # 4100

Work Area Location(s): (1) Room 101

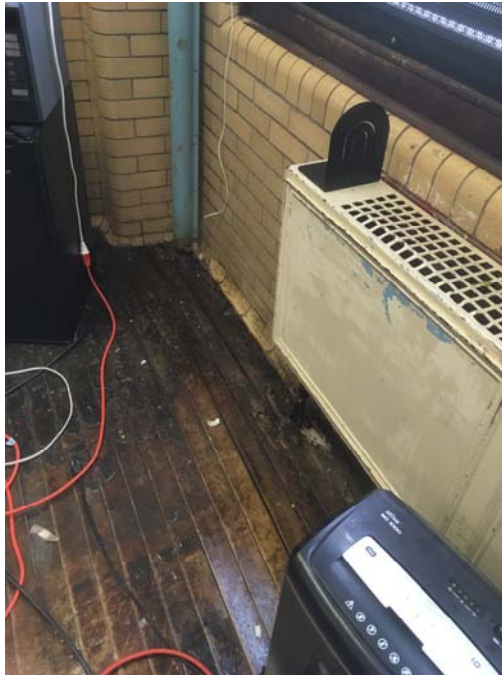
Photo 1 –Room 101

A steam leak in the crawlspace below impacted the hardwood flooring in the corner of the room.
