**Philadelphia Federation
of Teachers (PFT)
Health & Welfare Fund**

Inspection Date: 12.16.2016

**Solis Cohen Elementary
School
IEQ Site Visit**

Building Address: Tyson Avenue and Horrocks Street

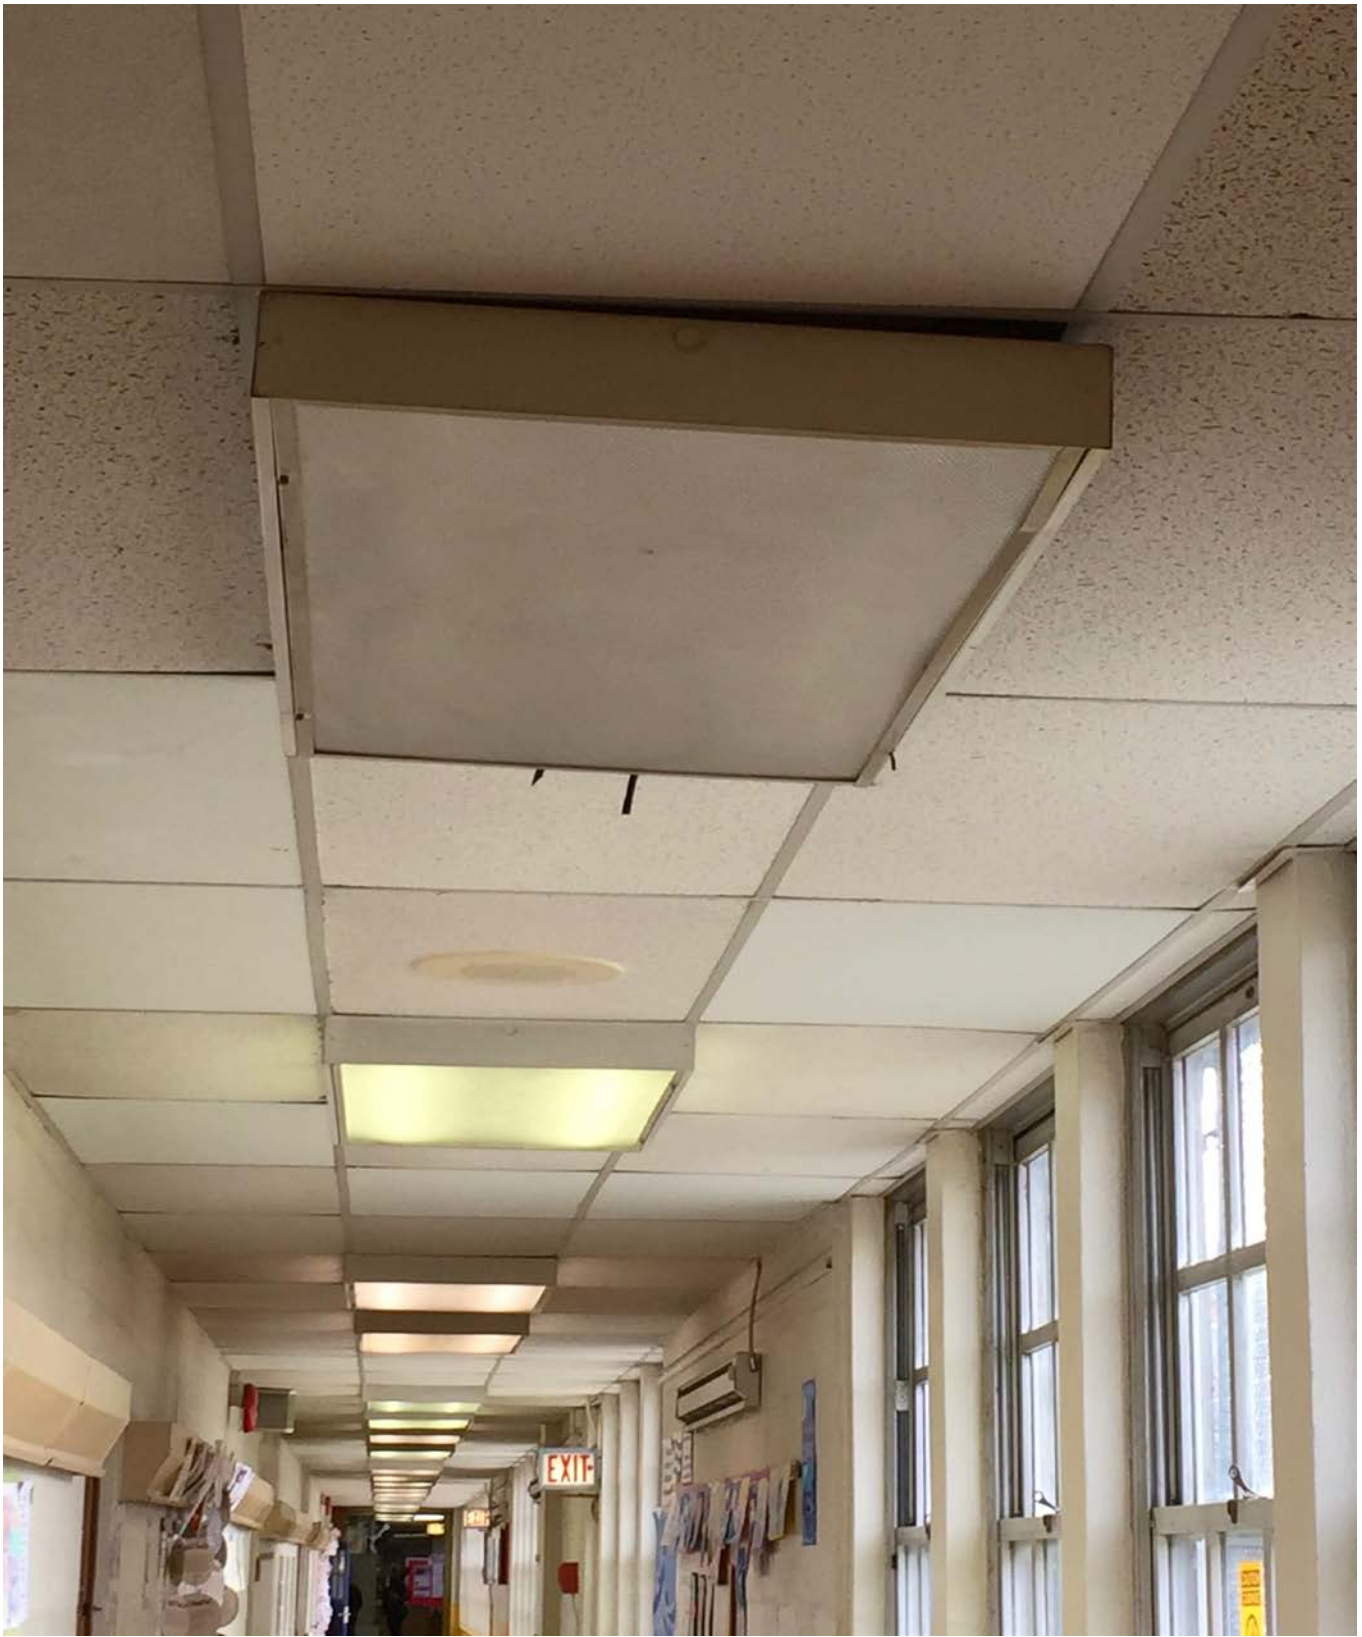
Photo 1 – Solis Cohen ES - 12.16.2016 – Main Office Hallway – Ceiling Mounted Light Fixture – Not Fully Secured

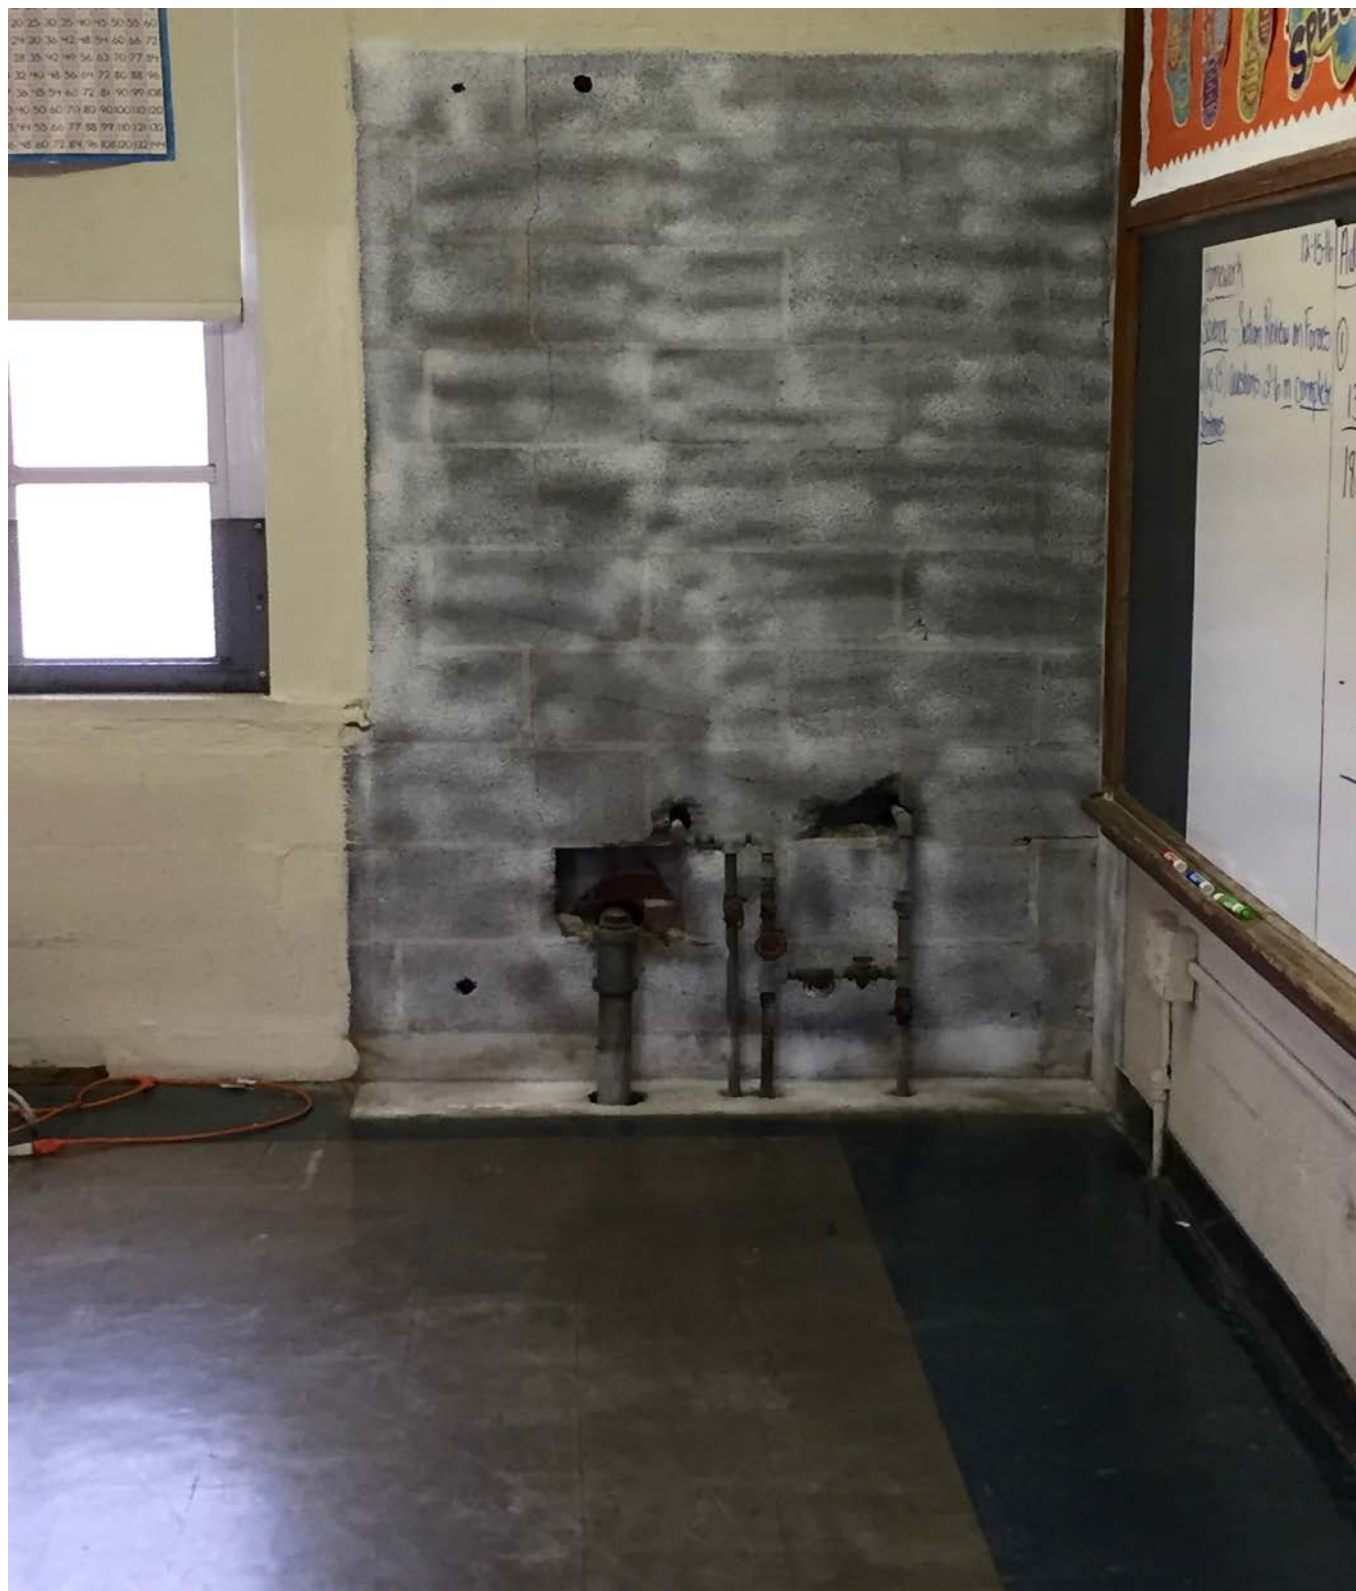
**Photo 2 - Solis Cohen ES - 12.16.2016 – Room 29 – Condition after mold remediation and removal of impacted
bookcase**

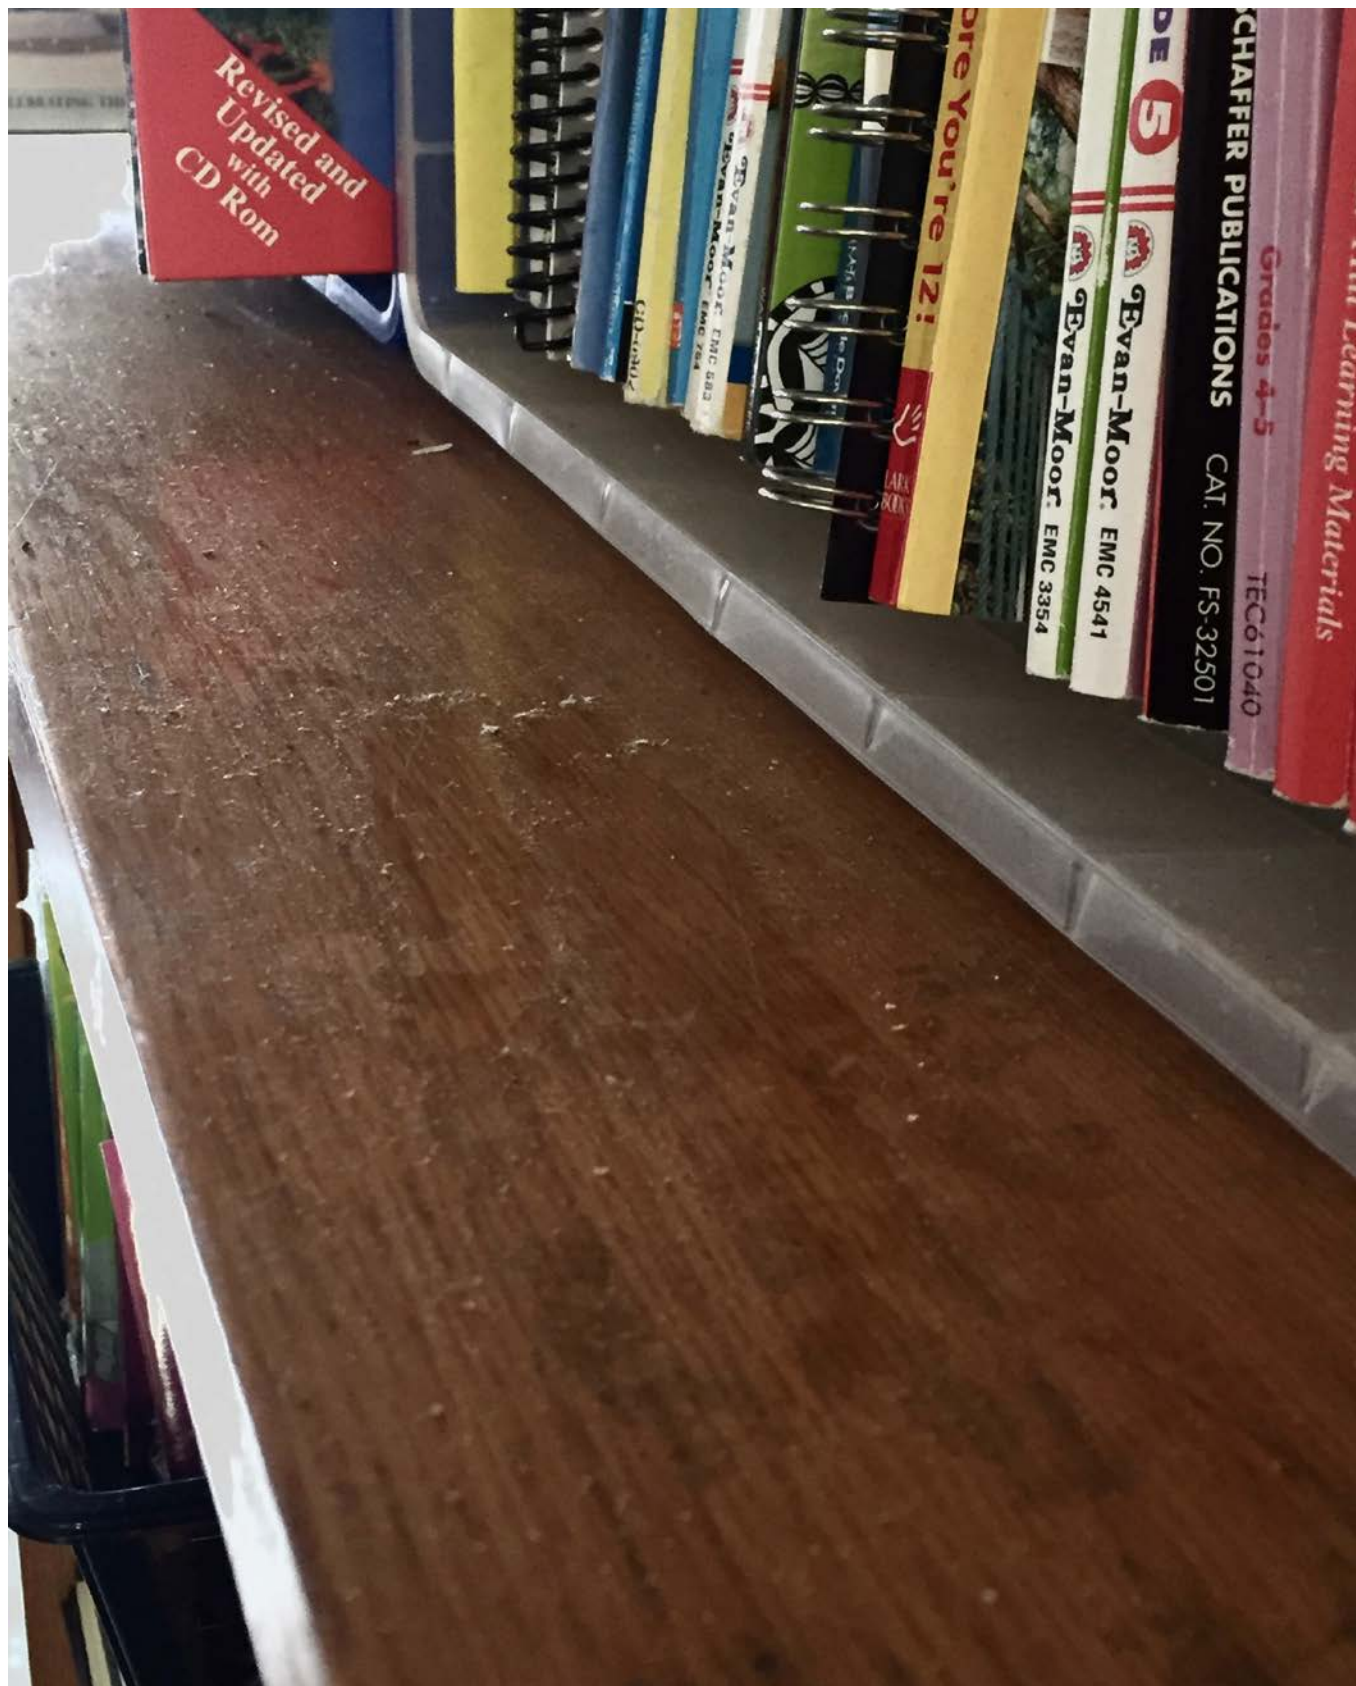
Room 30 A	<ul style="list-style-type: none"> • "Remediation" work [likely Mold related although uncertain because no information was provided or available] conducted without any notification provided – dust, dirt and debris was left on room surfaces & still present at the time of this inspections. Educational materials on wall had "overspray" & the teacher reported a "chemical odor" in room - Teacher is now being treated for respiratory symptoms 	<p>1) IEQ-related remediation work should only be conducted following notification to/coordination with OEMS and notification to the B.E., Principal and PFT representative about repair schedule details should be provided in order to facilitate effective site-specific planning, communication and remediation effectiveness, verification and accountability.</p> <p>2) A description of the remediation actions conducted should be provided.</p> <p>3) Additional cleaning of surfaces throughout this room should be immediately conducted.</p>

Photo 3 - Solis Cohen ES - 12.16.2016 – Room 30A – Dust/Dirt/Debris on surfaces – not properly cleaned following remediation
