**Philadelphia Federation  
of Teachers (PFT)  
Health & Welfare Fund**

**Inspection Date: 12.13.2016**

**Beeber Elementary School  
IEQ Site Visit**

**Building Address:** 5925 Malvern Avenue

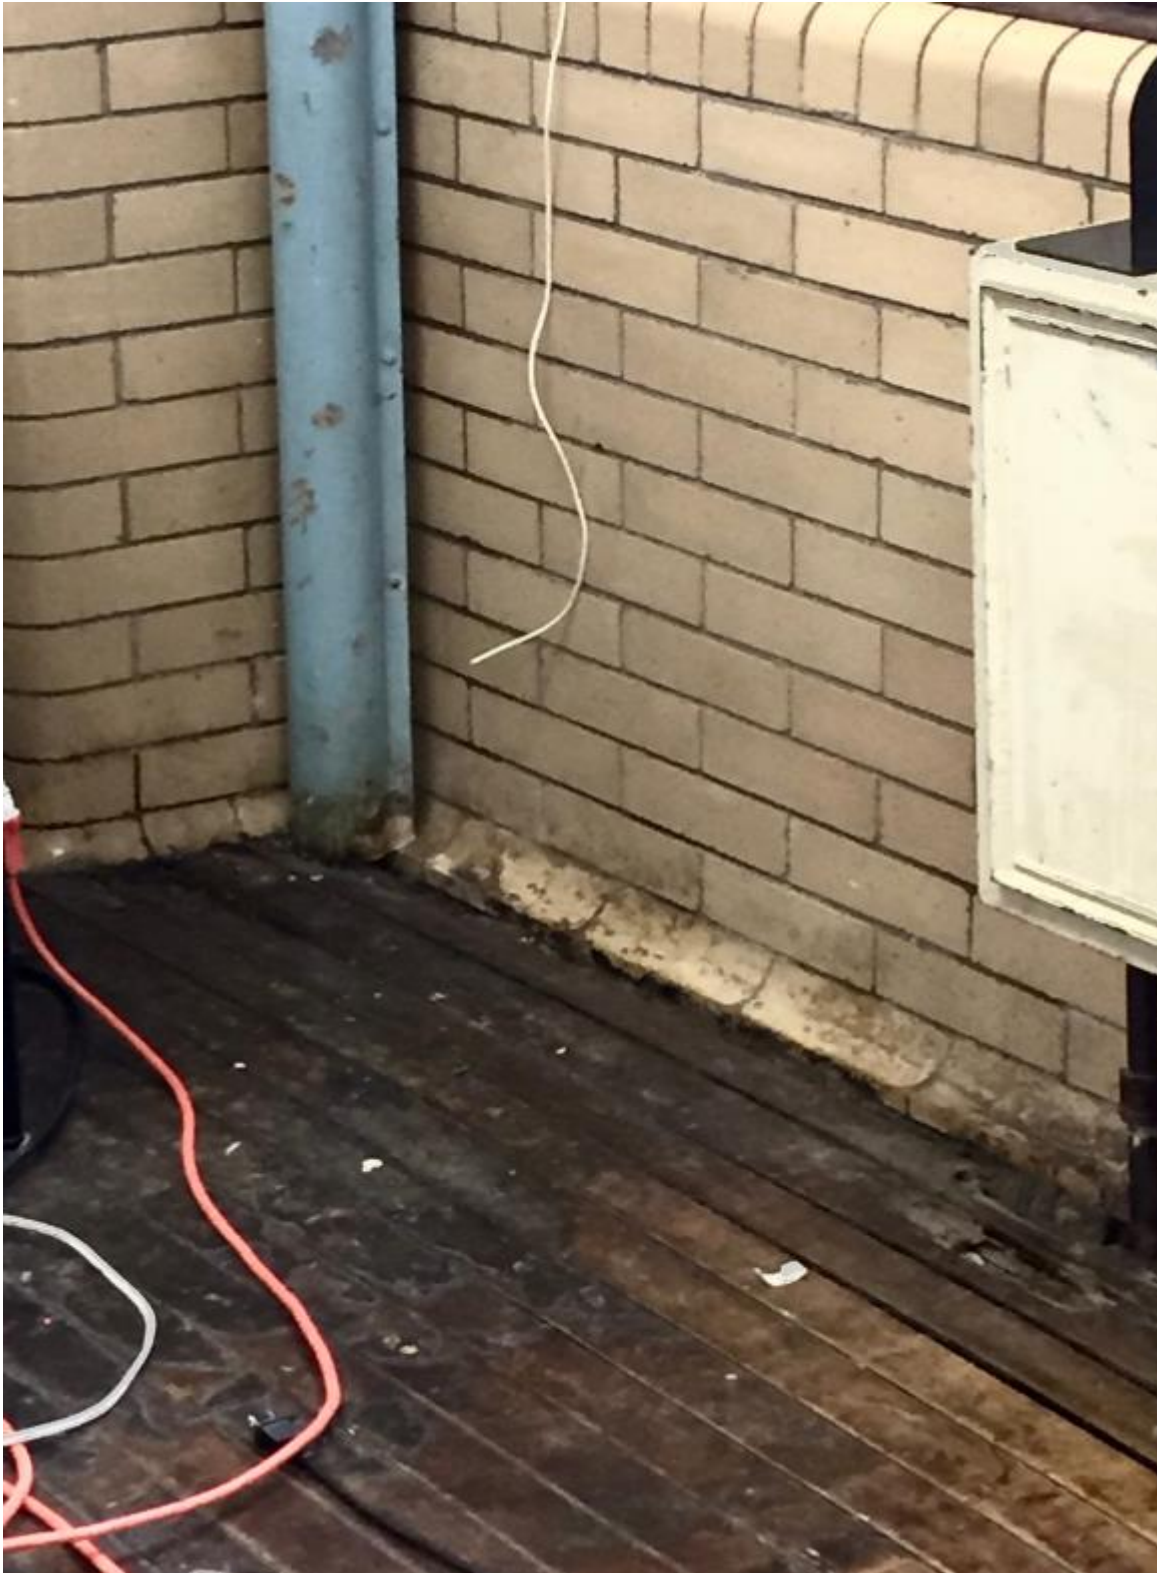
**Photo 1 - Beeber MS - 12.13.2016 – Room 101 – Steam Leak at Radiator – Floor Damage**

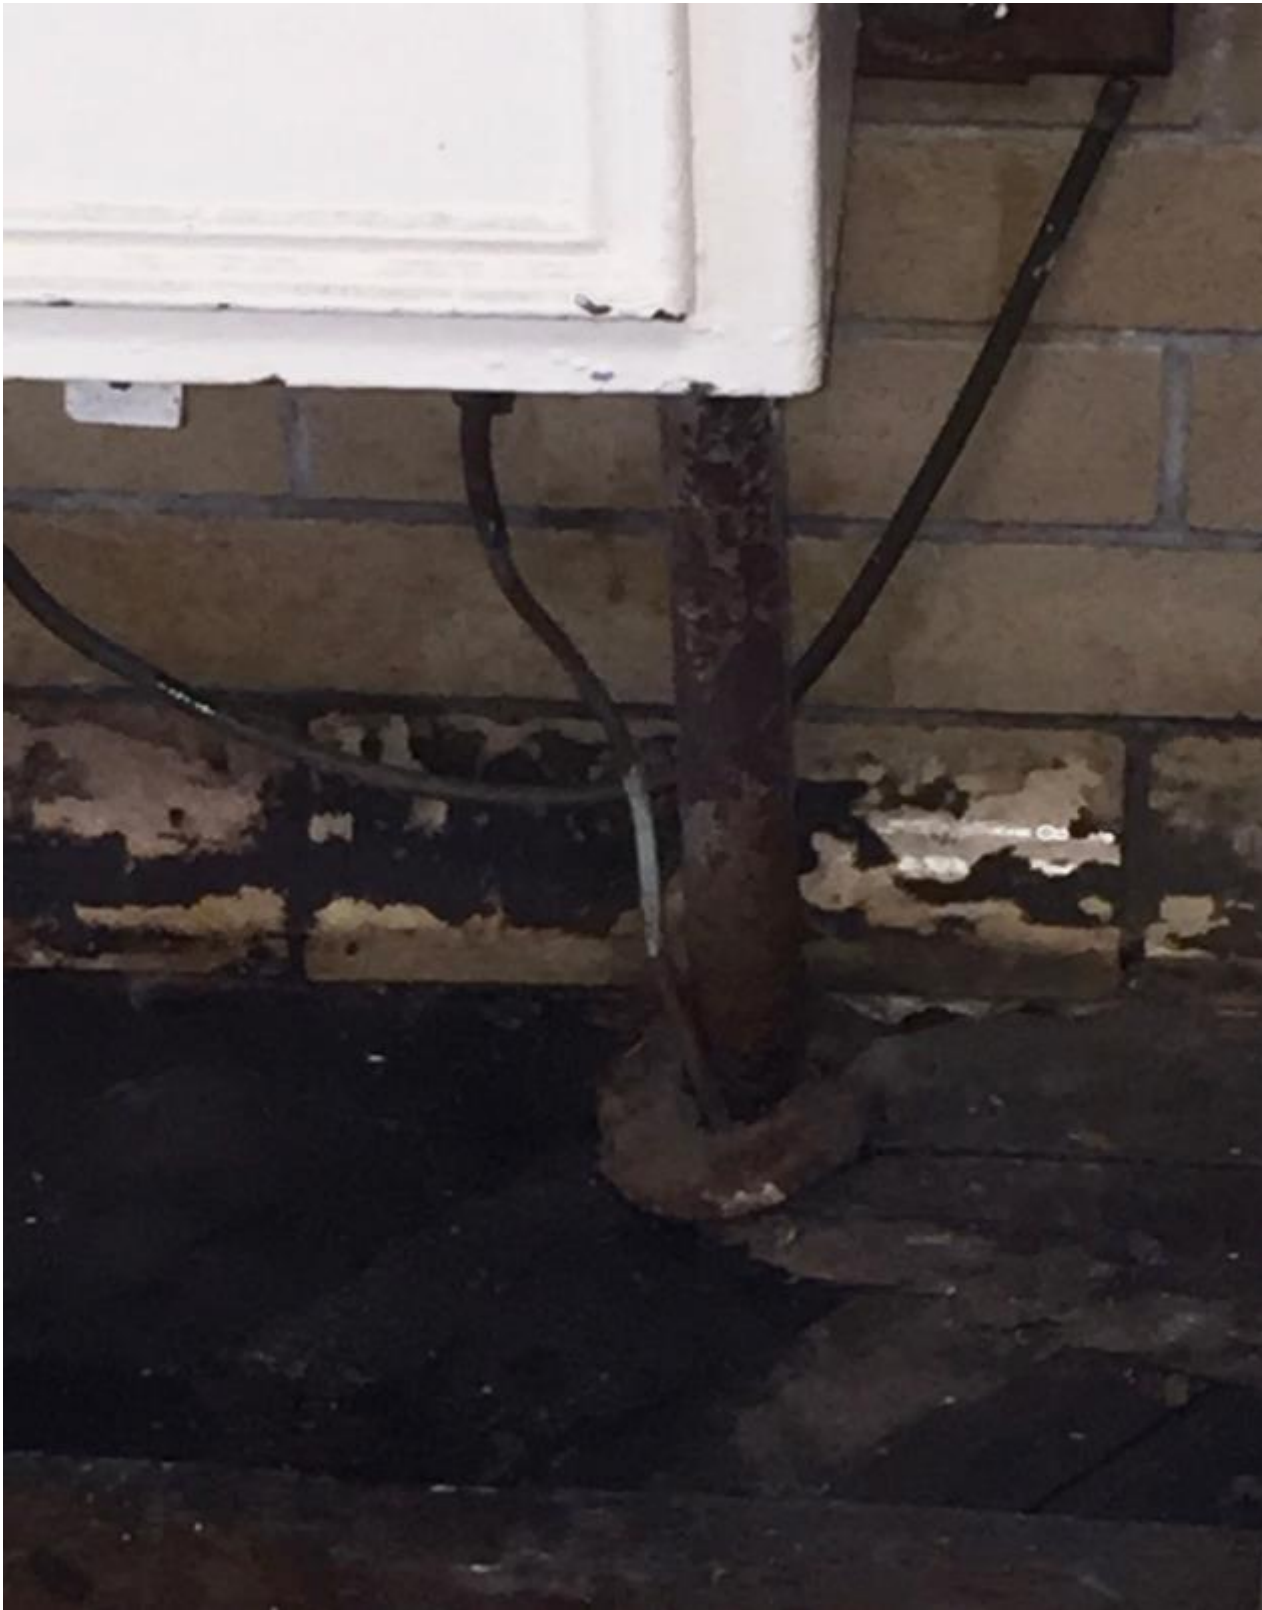
<b>Room 103</b>	<ul style="list-style-type: none"> <li>• Ongoing and currently active steam leak documented at radiator located between 103 A &amp; 103 B</li> <li>• Damage to hardware flooring observed with about 6 sq. ft. – 10 sq. ft. impacted</li> </ul>	<ol style="list-style-type: none"> <li>1) Assess and repair the steam leak.</li> <li>2) Remove/replace damaged floor materials after ensuring steam leak has been repaired</li> <li>3) FM&amp;O should coordinate with and notify B.E., Principal and PFT building and PFTH&amp;WF/U-H&amp;S representatives about repair schedule details in order to facilitate communication and remediation verification.</li> </ol>
<b>Room 108</b>	<ul style="list-style-type: none"> <li>• Ongoing and currently active steam leak documented at radiator – leak originating below floor level</li> <li>• Damage to wooden baseboard documented – possible mold growth observed</li> </ul>	<ol style="list-style-type: none"> <li>1) Assess and repair the steam leak.</li> <li>2) Remove/replace damaged baseboard after ensuring steam leak has been repaired</li> <li>3) FM&amp;O should coordinate with and notify B.E., Principal and PFT representative about repair schedule details in order to facilitate communication and remediation verification.</li> </ol>

**Photo 2 - Beeber MS - 12.13.2016 – Room 103 – Steam Leak at Radiator – Floor Damage**

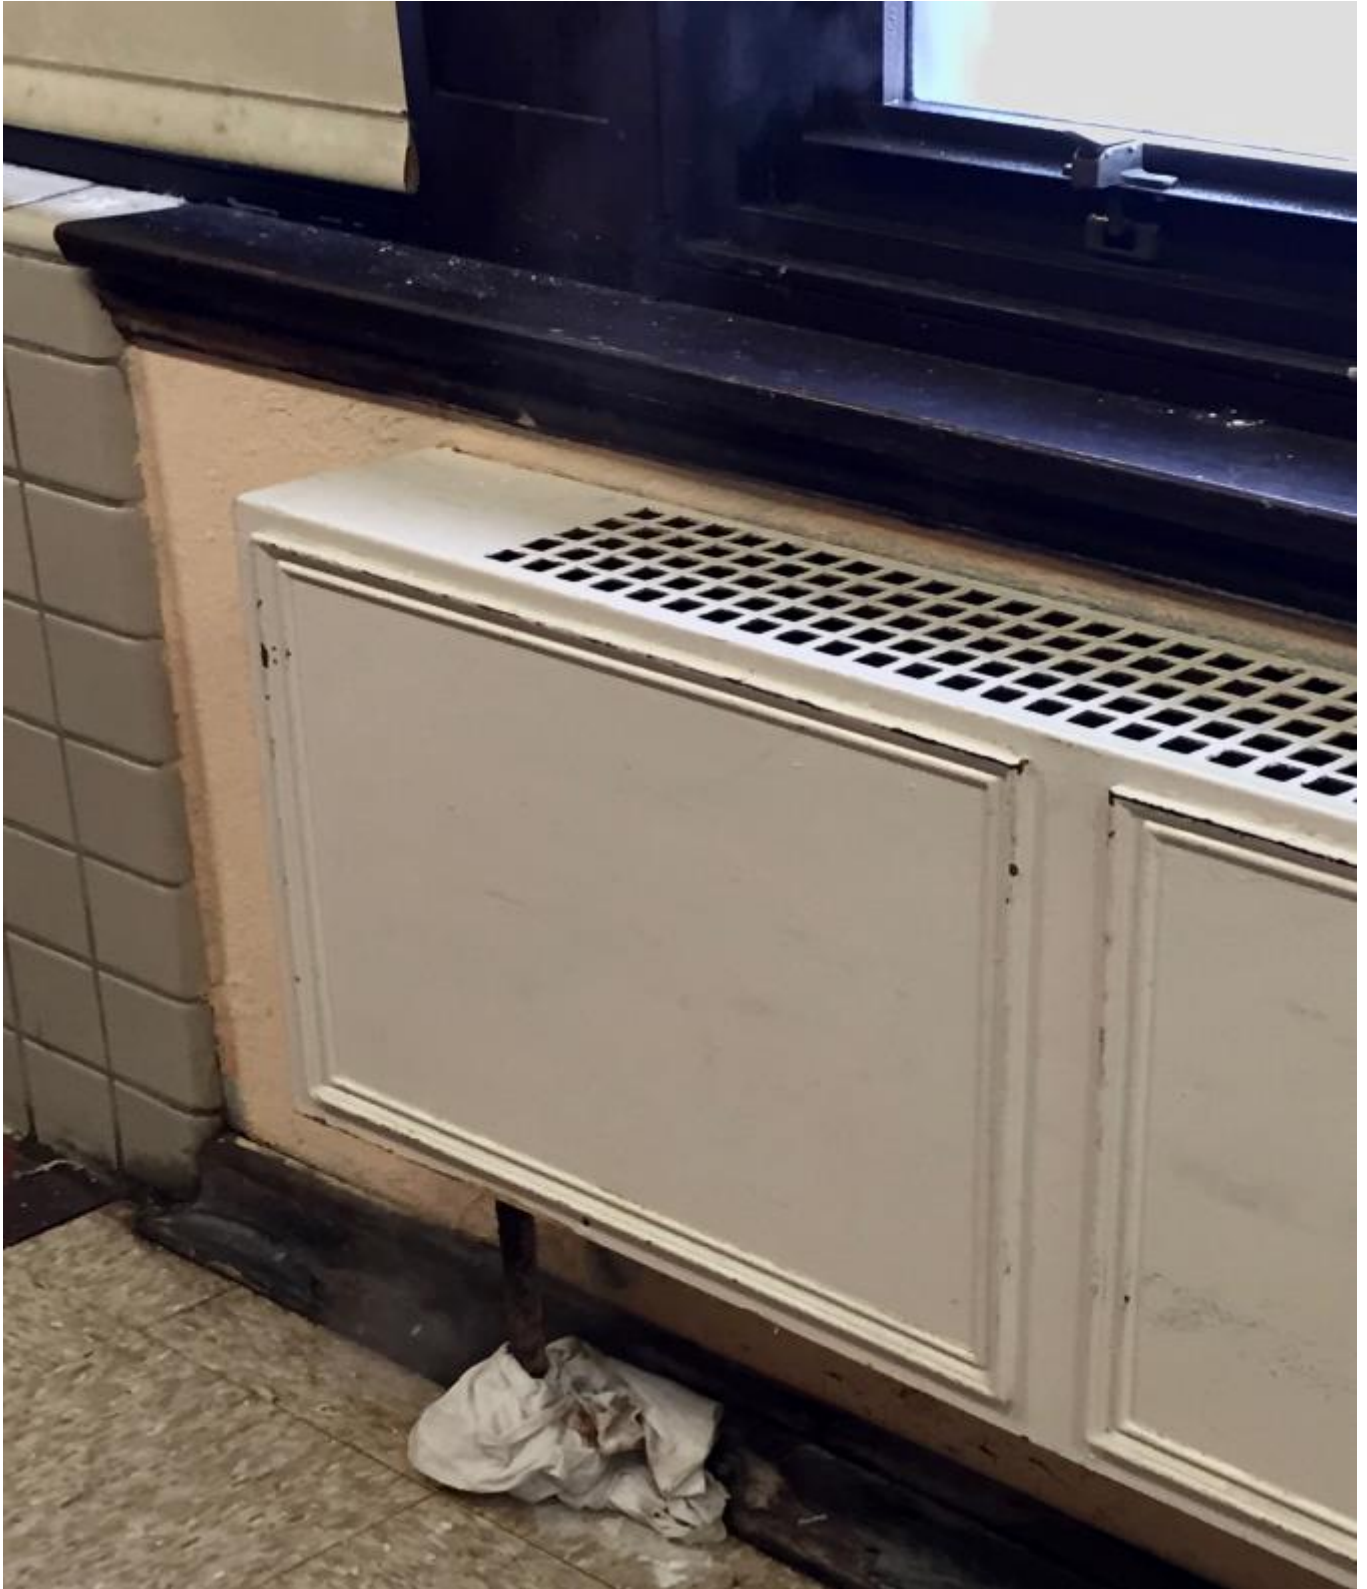
**Photo 3 - Beeber MS - 12.13.2016 – Room 108 – Steam leak at radiator underneath floor – baseboard impacted**

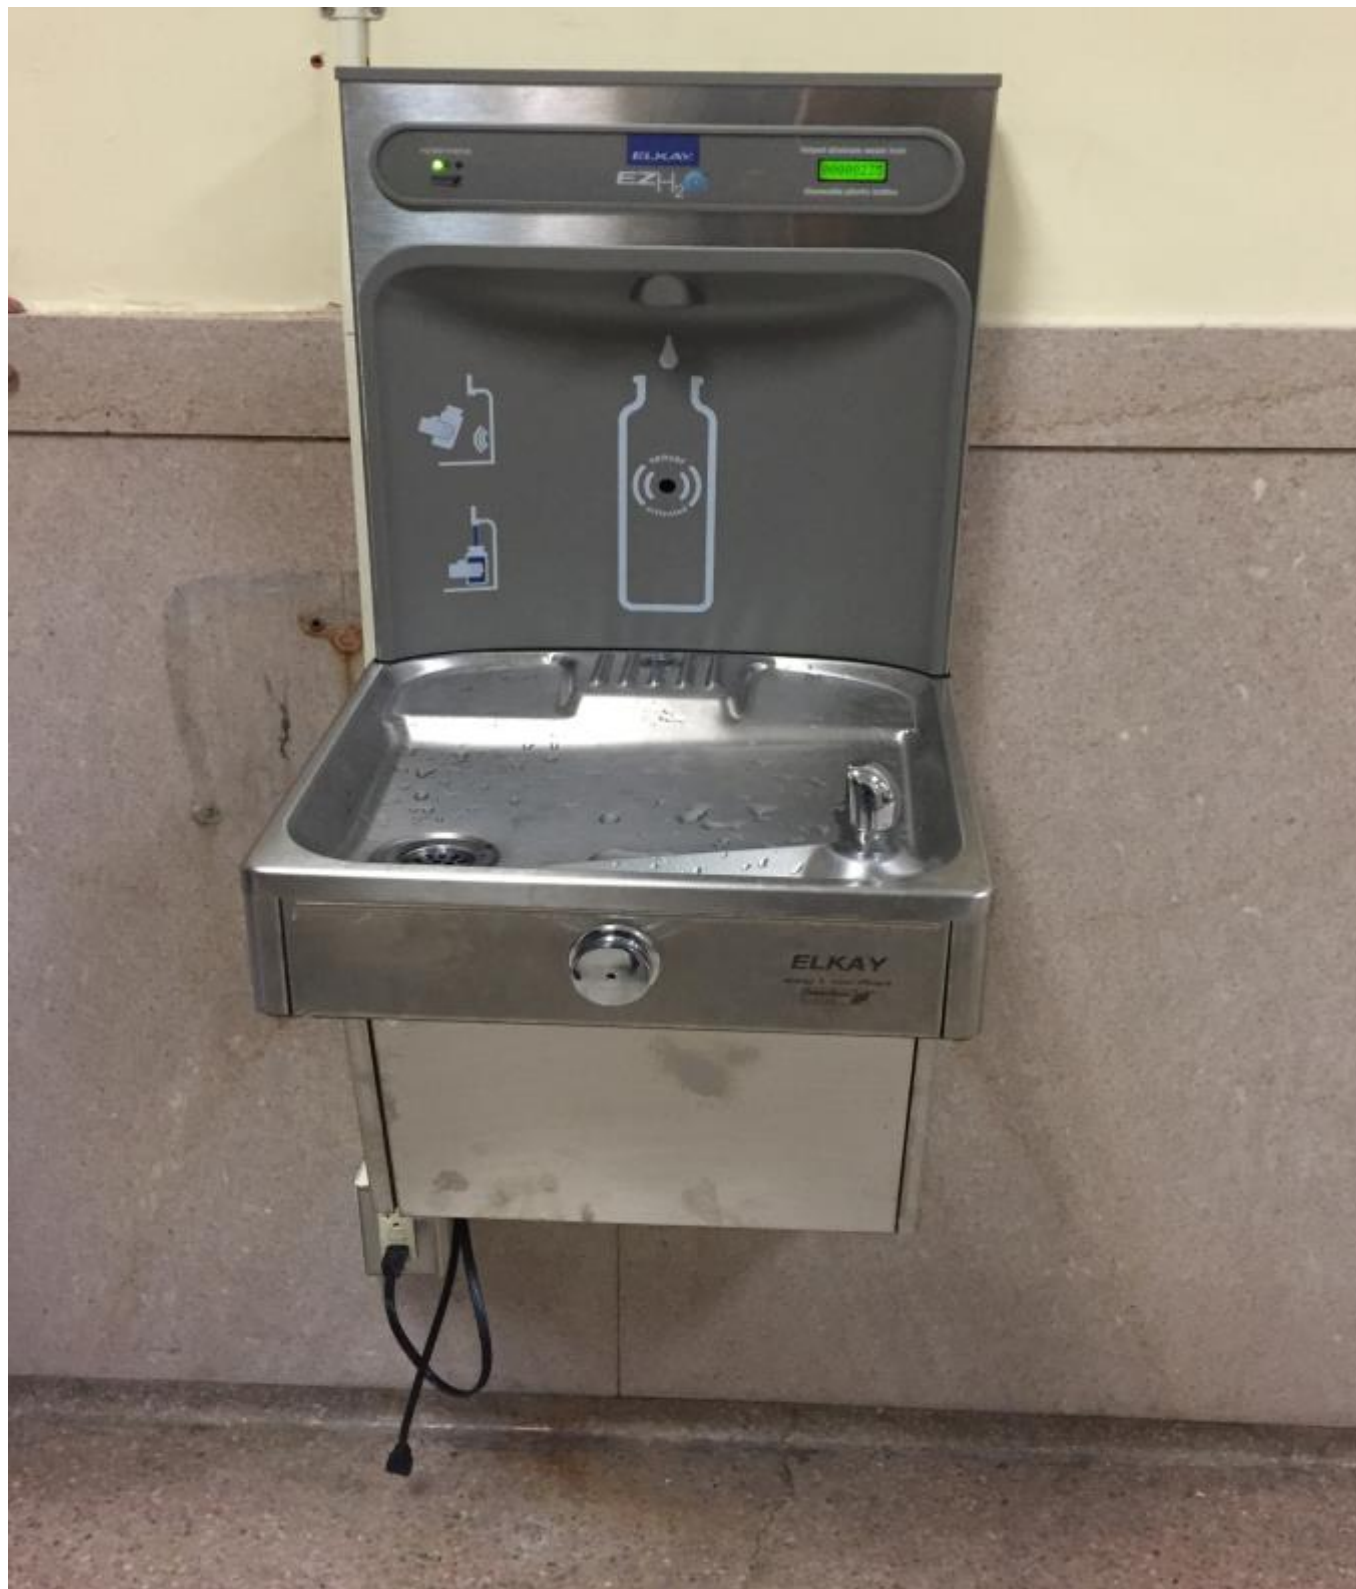
<b>Hallway – 1<sup>st</sup> Floor</b>	<ul style="list-style-type: none"> <li>• Newly installed [about 3 weeks ago] Hydration Station not functioning properly – Problem was reportedly with the new compressor [one of the power cords for the hydration station was unplugged]</li> <li>• Lack of available information related to filter storage [on site] and availability, and/or filter handling/replacement and change</li> </ul>	<ol style="list-style-type: none"> <li>1) Assess and repair compressor/hydration station.</li> <li>2) Ensure B.E. is provided with necessary information and support to facilitate routine preventive and reactive maintenance work and filter changes for the hydration station.</li> </ol>
<b>Building Wide Issues</b>	<ul style="list-style-type: none"> <li>• Steam leak &amp; related heating system have been documented as occurring for an extended period of time</li> <li>• Problems with the Automatic Temperature Control [ATC] system, steam traps and other heating system components have been documented and reported during previous inspections</li> </ul>	<ol style="list-style-type: none"> <li>1) Immediately conduct a comprehensive evaluation of the heating &amp; ATC systems and all components and review all outstanding work orders and make repairs as necessary to ensure occupant areas are properly heated.</li> <li>2) FM&amp;O should coordinate with and notify B.E., Principal and PFT and PFTH&amp;WF/U-H&amp;S representative about repair schedule details in order to facilitate communication and remediation verification.</li> </ol>

Photo 4 - Beeber MS - 12.13.2016 – 1<sup>st</sup> Floor Hallway – Hydration Station – Bad Compressor & Unplugged
