**Philadelphia Federation
of Teachers (PFT)
Health & Welfare Fund**

Inspection Date: 12.13.2016

**Bethune Elementary School
IEQ Site Visit**

Building Address: 3301 Old York Road

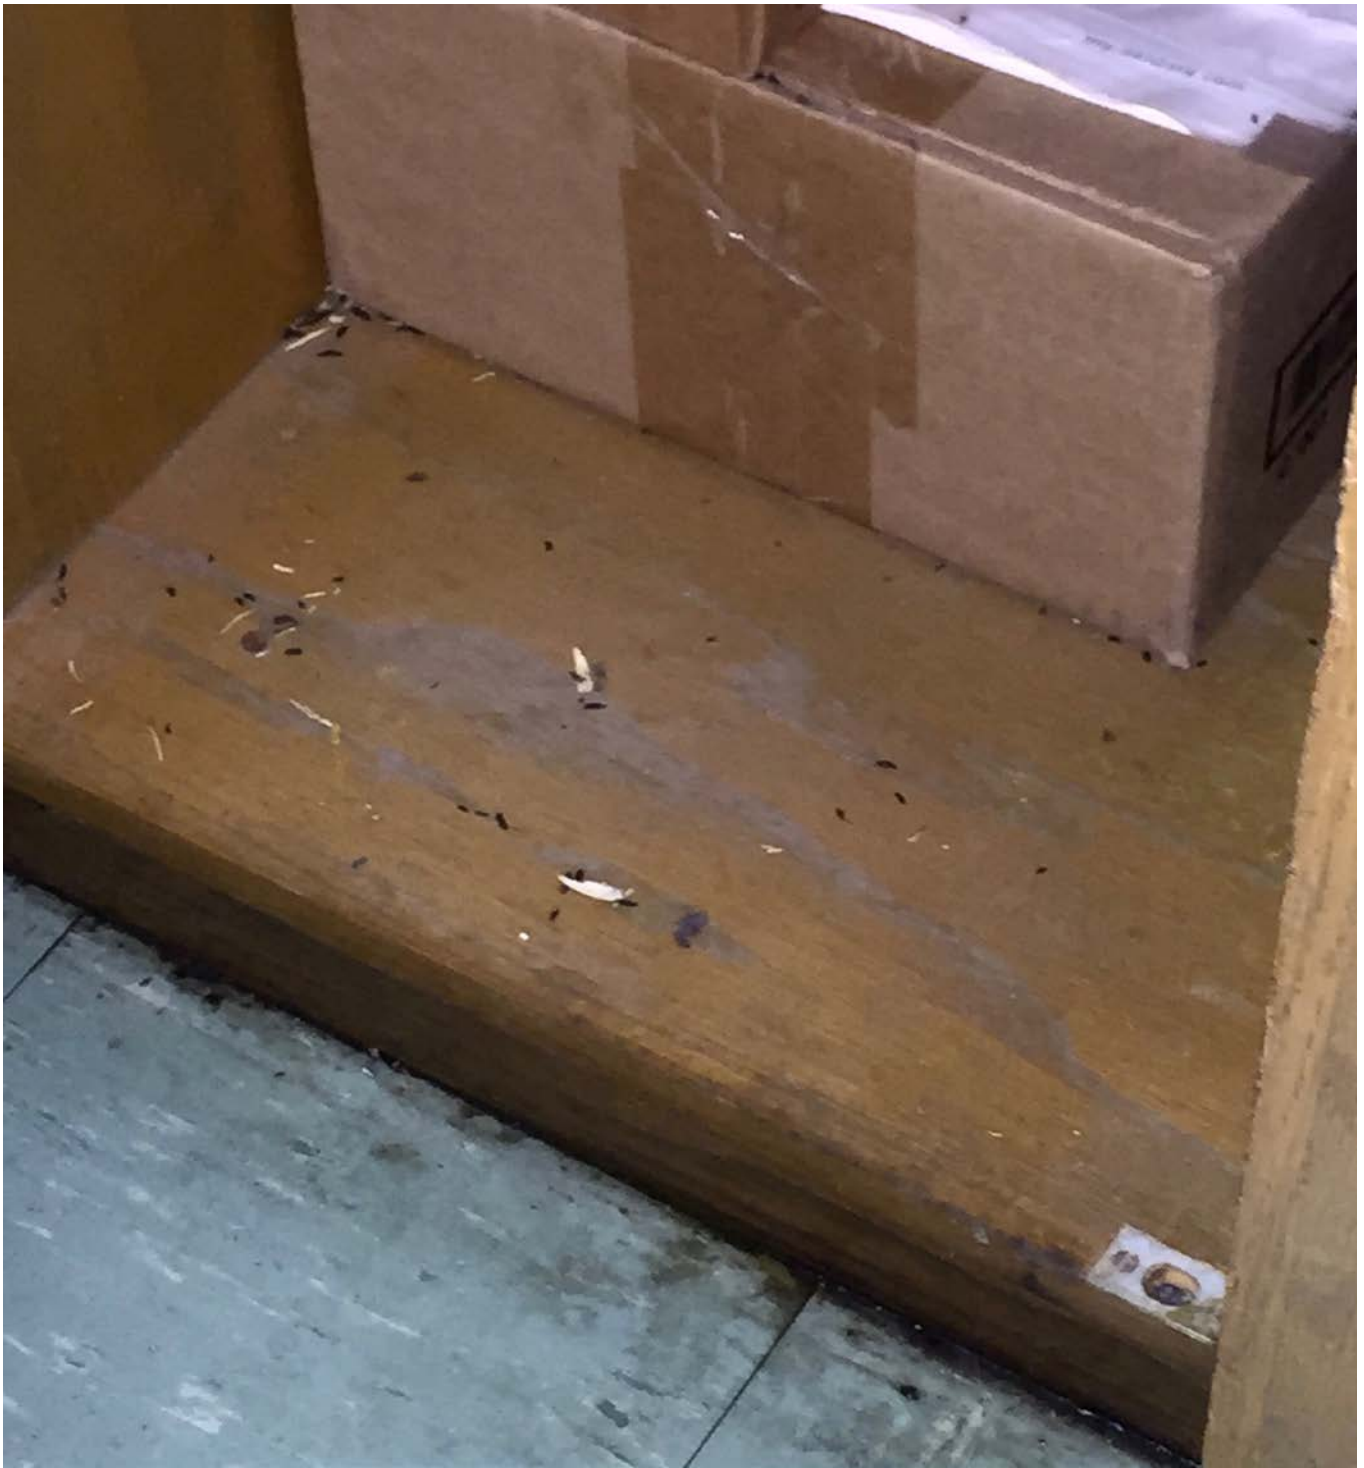
Pest-Rodent Issues	<ul style="list-style-type: none"> • Mouse droppings [major asthma triggers] were observed and documented in classrooms inspected and staff reported rodent/insect sightings and droppings. • Bethune was identified by the SDP-OEMS as a school with a “high-prevalence” of student asthma inhaler use and was inspected during the summer of 2016 specifically for the presence of “asthma triggers.” During the June, 2016 inspections mouse droppings were found in many normally occupied locations and recommendations were made at that time, for cleaning and disinfection of impacted surfaces. • Staff reported that “Universal Feeding” of all students began this year in classrooms - instead of in the cafeteria – this situation has resulted in an exacerbation of the pest problems observed. 	<ol style="list-style-type: none"> 1) Mouse droppings and other pest/rodent materials should be effectively cleaned on a daily basis to help eliminate asthma triggers and protect student and staff health. 2) An upgraded and more effective IPM program should be jointly [PFTH&WF/U-H&S & SDP-OEMS] developed and implemented to reflect recognized Best Practices approaches. 3) Post-remediation evaluations [PREs] should be conducted following cleaning, trapping and other IPM actions taken to help ensure effective outcomes. 4) Additional cleaning/custodial staff is required in order to effectively control and clean-up pest/rodent/insect droppings and other materials.

Bethune ES - 12.13.2016 – Room 200 – Computer Room – Cabinet and Floor with Mouse Droppings

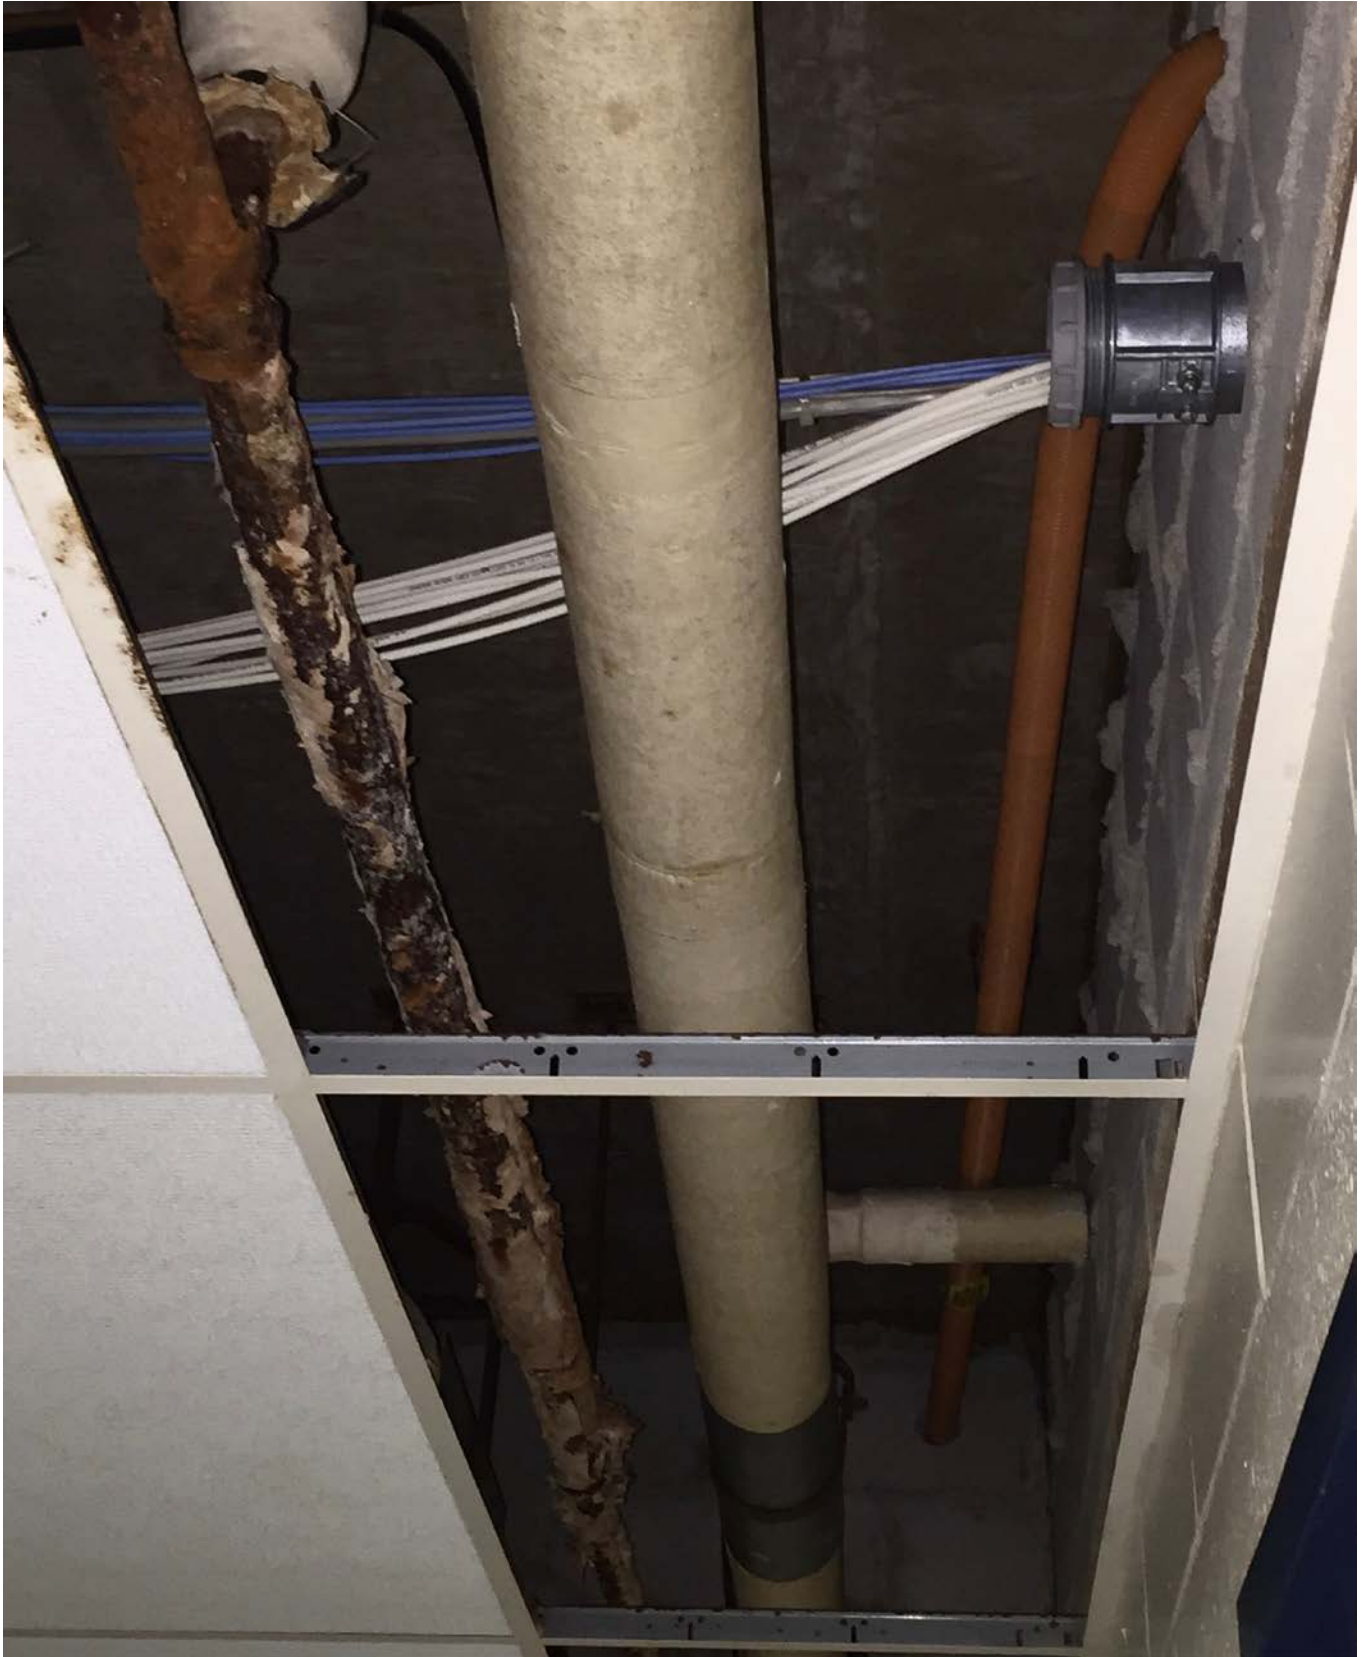
Bethune ES - 12.13.2016 – 1st Floor Hallway – Outside Community Room

1st Floor Hallway Outside Community Room	<ul style="list-style-type: none"> • Ceiling tiles were observed to be missing in this area and a leaking, exposed and corroded/rusted overhead pipe is present and visible. There is asbestos insulation on some sections of the piping. • This problem has been previously identified and it was reported that it is scheduled for repair, likely over the Christmas/winter break. 	<p>1) Evaluate the structural integrity of the deteriorated piping to determine if it is able to be repaired or must be replaced;</p> <p>2) FM&O should coordinate with and notify B.E., Principal and PFTH&WF/U-H&S and school representatives about the repair details and schedule to facilitate and ensure effective communication and remediation verification.</p> <p>3) Asbestos removal activities as necessary should be conducted to include notification to the PFTH&WF/U-H&S and asbestos remediation inspection & testing should be jointly scheduled and conducted.</p>
