City of Long Beach
2013 Update of Select Facilities
Facilities Condition Assessment Report

September 17, 2013

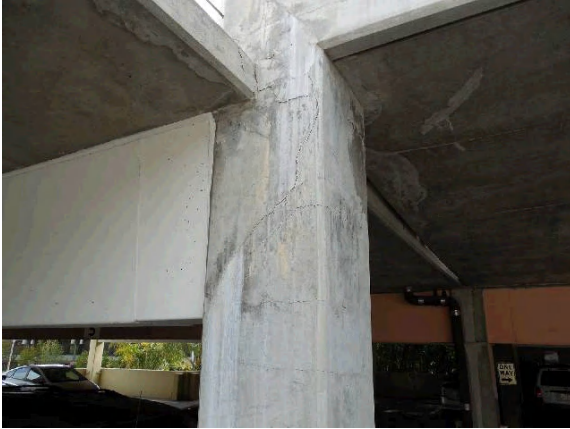
Analysis: The system is in good condition. The system was installed in 1984. It has a 100-year service life. However, in the assessment, it was found to be currently deficient and is non-renewable.

Location: Building Systems
Material: Cast In Place Concrete
Distress: Failing
Category: Building Integrity
Priority: 2 - Potentially Critical
Correction: Seismic upgrade - concrete
Qty: 160,900-S.F.
Estimate: \$433,028.16
Assessor Name: Tom Moe
Date Created: 09/11/2013

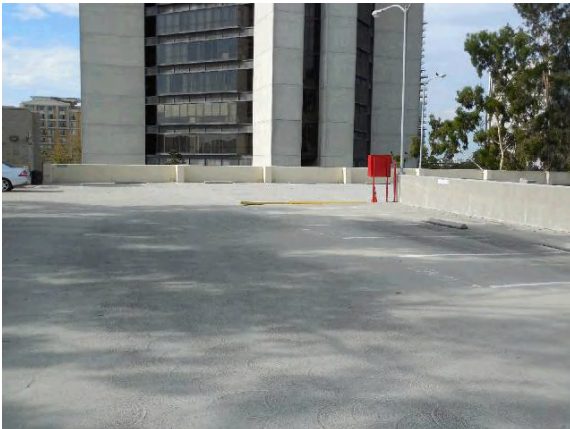
Analysis: The system is in good condition. The system was installed in 1984. It has a 100-year service life. However, in the assessment, it was found to be currently deficient and is non-renewable.

Location: Building Systems
Material: Concrete Floor, Finished
Distress: Failing
Category: Building Integrity
Priority: 3 - Necessary / Not Critical
Correction: Slope and provide drainage at top parking deck
Qty: 4,000-S.F.
Estimate: \$20,657.45
Assessor Name: Tom Moe
Date Created: 09/12/2013

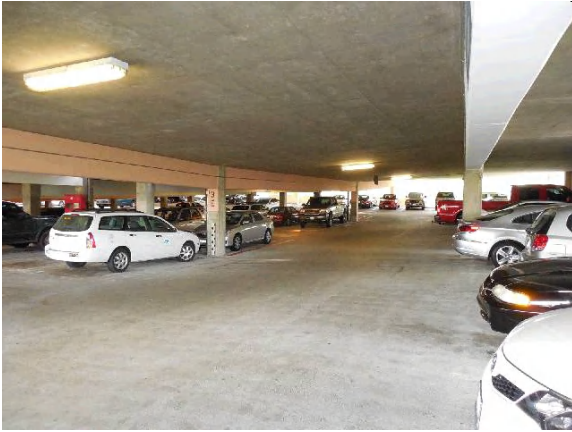
Analysis: The system is in good condition. The system was installed in 1984. It has a 100-year service life. However, in the assessment, it was found to be currently deficient and is non-renewable.

Location: Building Systems

Material: Cast in Place Slabs, One Way

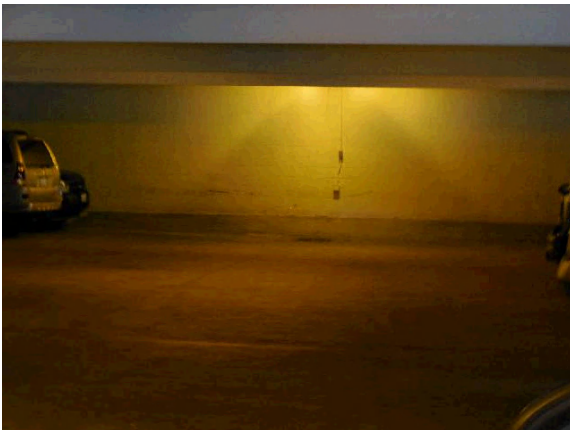
Analysis: The system is in poor condition. The system was installed in 1984. It has a 5-year service life which expired in 1989.

Location: Building Systems

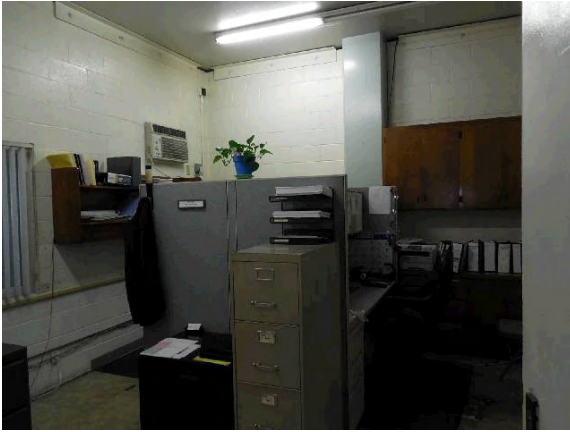
Analysis: The system is in poor condition. The system was installed in 1984. It has a 5-year service life which expired in 1989.

Location: Building Systems
Material: Paint & Covering
Distress: Beyond Useful Life
Category: Deferred Maintenance
Priority: 4 - Recommended
Correction: Repaint Interior Walls/Ceilings
Qty: 1,200-S.F.
Estimate: \$3,243.51
Assessor Name: Tom Moe
Date Created: 09/12/2013

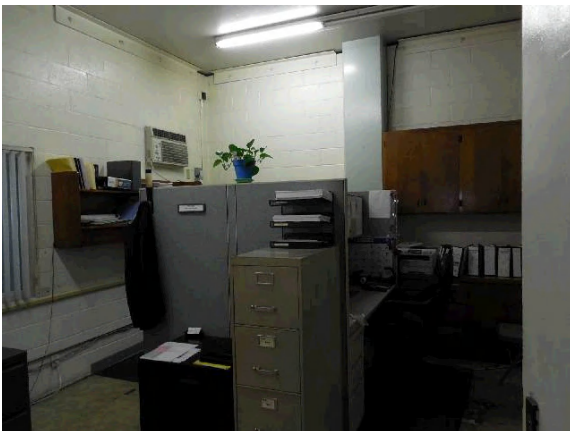
Analysis: The system is in poor condition. The system was installed in 1984. It has a 20-year service life which expired in 2004.

Location: Building Systems
Material: System
Distress: Beyond Useful Life
Category: Capital Renewal
Priority: 4 - Recommended
Correction: Renew System
Qty: 1-Ea.
Estimate: \$9,409.32
Assessor Name: Tom Moe
Date Created: 09/11/2013

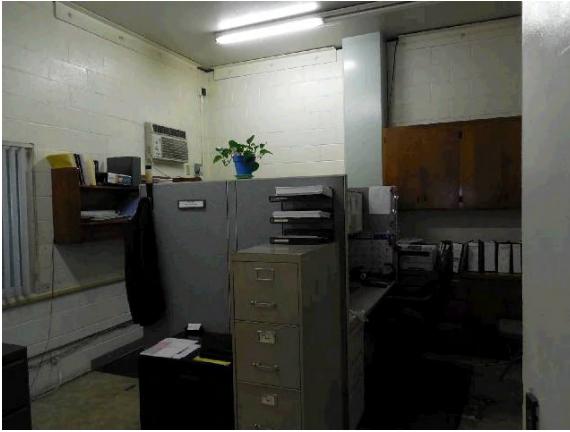
Analysis: The system is in poor condition. The system was installed in 1984. It has a 5-year service life which expired in 1989.

Location: Building Systems
Material: System
Distress: Beyond Useful Life
Category: Capital Renewal
Priority: 4 - Recommended
Correction: Renew System
Qty: 1-Ea.
Estimate: \$6,272.88
Assessor Name: Tom Moe
Date Created: 09/11/2013

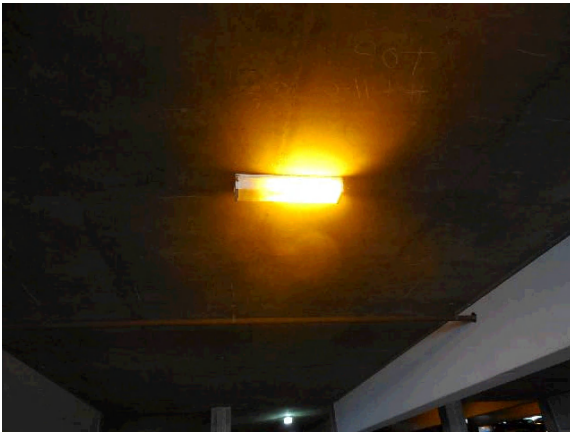
Analysis: The system is in poor condition. The system was installed in 1984. It has a 5-year service life which expired in 1989.

Location: Building Systems
Material: Paint & Covering
Distress: Inadequate
Category: Building Integrity
Priority: 4 - Recommended
Correction: Paint parking garage ceilings to increase lighting
Qty: 164,100-S.F.
Estimate: \$367,635.69
Assessor Name: Tom Moe
Date Created: 09/11/2013

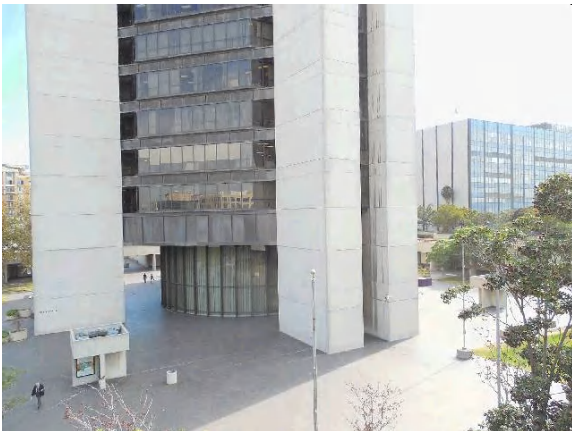
Analysis: The system is in poor condition. The system was installed in 1976. It has a 30-year service life which expired in 2006.

Location: Building Systems

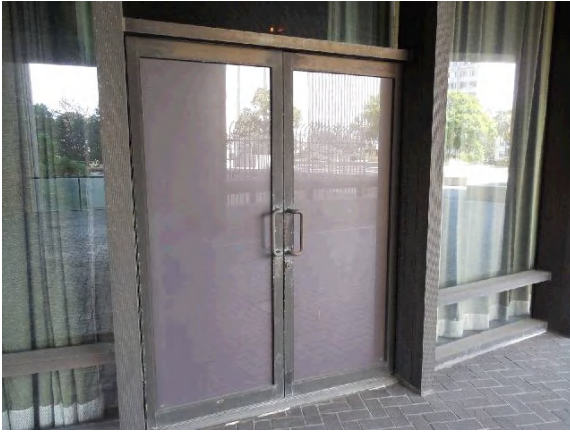
Analysis: The system is in poor condition. The system was installed in 1976. It has a 30-year service life which expired in 2006.

Location: Building Systems
Material: System
Distress: Beyond Useful Life
Category: Capital Renewal
Priority: 4 - Recommended
Correction: Renew System
Qty: 1-Ea.
Estimate: \$164,421.57
Assessor Name: Tom Moe
Date Created: 09/10/2013

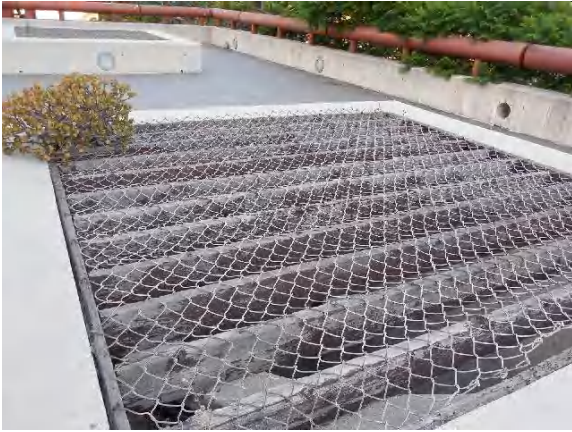
Analysis: The system is in poor condition. The system was installed at an unknown date. It has a 25-year service life.

Location: Building Systems

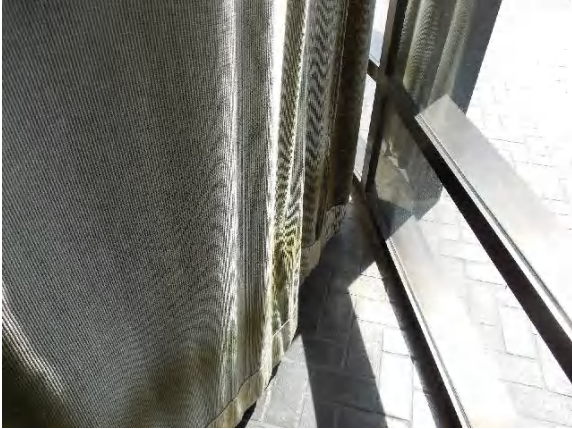
Analysis: The system is in poor condition. The system was installed in 1976. It has a 20-year service life which expired in 1996.

Location: Building Systems
Material: System
Distress: Beyond Useful Life
Category: Capital Renewal
Priority: 4 - Recommended
Correction: Renew System
Qty: 1-Ea.
Estimate: \$374,996.55
Assessor Name: Tom Moe
Date Created: 09/12/2013

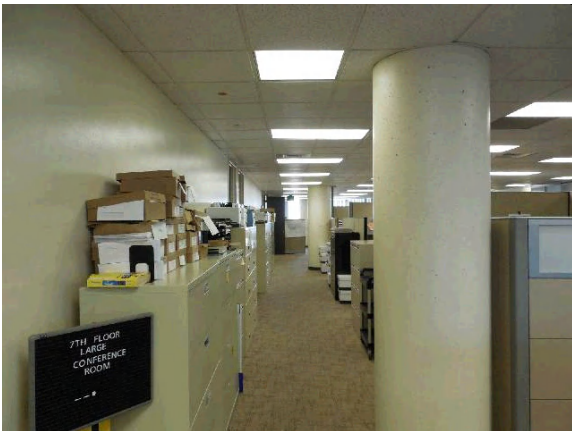
Location: Building Systems
Material: System
Distress: Beyond Useful Life
Category: Capital Renewal
Priority: 4 - Recommended
Correction: Renew System
Qty: 1-Ea.
Estimate: \$383,238.23
Assessor Name: Tom Moe
Date Created: 09/10/2013

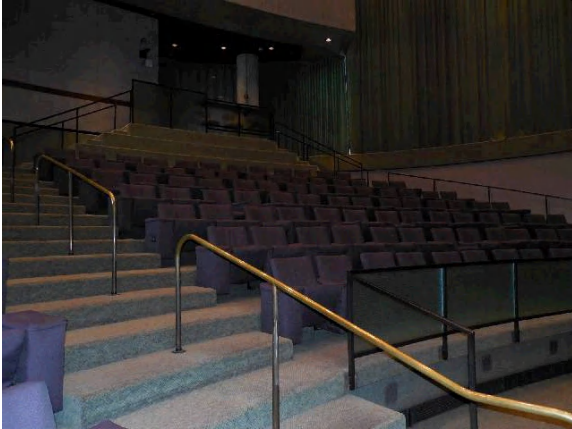
Location: Building Systems
Material: System
Distress: Beyond Useful Life
Category: Capital Renewal
Priority: 4 - Recommended
Correction: Renew System
Qty: 1-Ea.

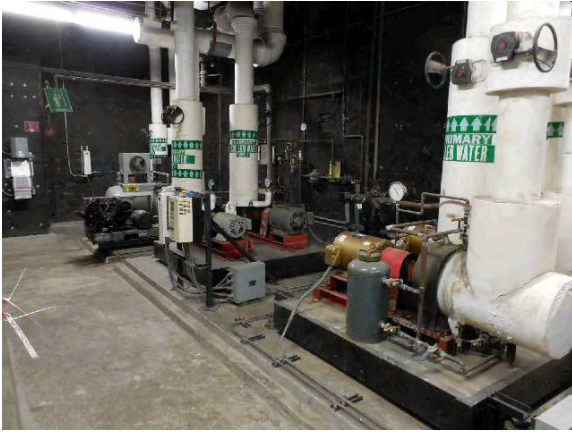
Location: Building Systems
Material: System
Distress: Beyond Useful Life
Category: Capital Renewal
Priority: 4 - Recommended
Correction: Renew System
Qty: 1-Ea.
Estimate: \$2,506,707.72
Assessor Name: Tom Moe
Date Created: 09/10/2013

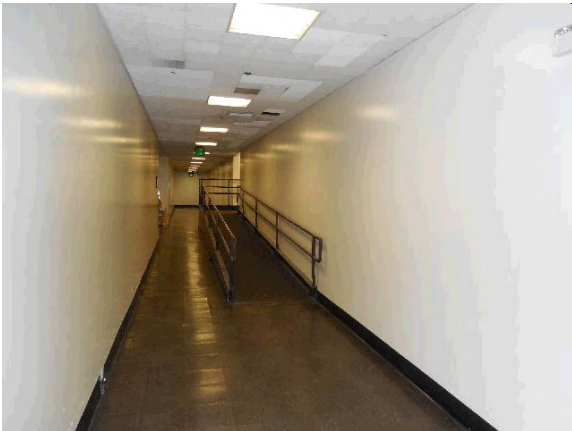
Location: Building Systems
Material: System
Distress: Beyond Useful Life
Category: Capital Renewal
Priority: 4 - Recommended
Correction: Renew System
Qty: 1-Ea.
Estimate: \$1,413,448.54
Assessor Name: John Oualline
Date Created: 09/12/2013

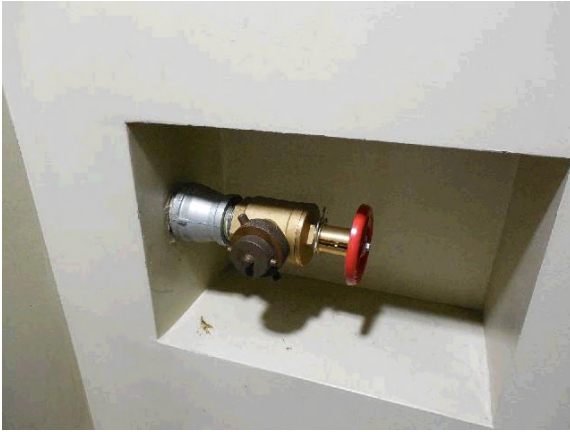
Location: Building Systems
Material: System
Distress: Beyond Useful Life
Category: Capital Renewal
Priority: 4 - Recommended
Correction: Renew System
Qty: 1-Ea.
Estimate: \$74,175.14
Assessor Name: John Oualline
Date Created: 09/12/2013

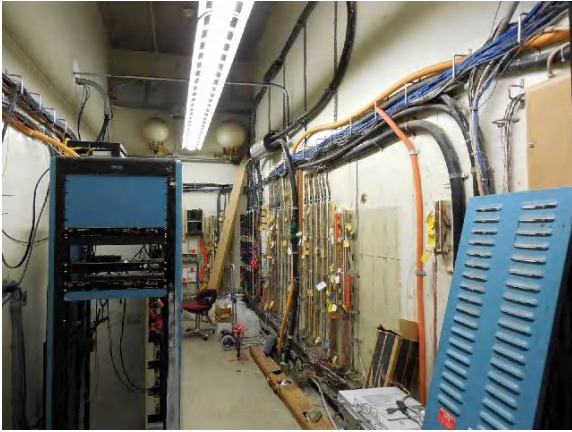
Location: Building Systems
Material: System
Distress: Beyond Useful Life
Category: Capital Renewal
Priority: 4 - Recommended
Correction: Renew System
Qty: 1-Ea.
Estimate: \$1,203,285.64
Assessor Name: Tom Moe
Date Created: 09/10/2013

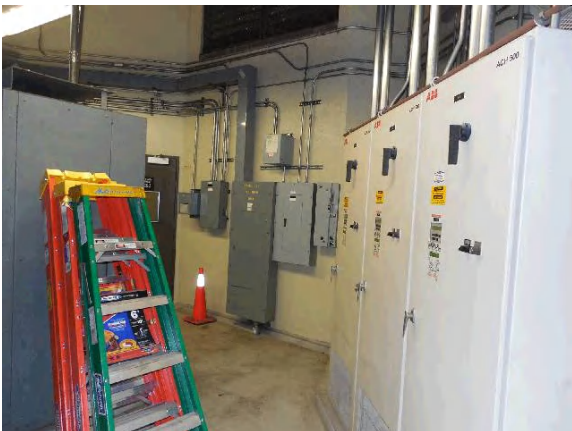
Location: Building Systems
Material: System
Distress: Beyond Useful Life
Category: Capital Renewal
Priority: 4 - Recommended
Correction: Renew System
Qty: 1-Ea.
Estimate: \$127,746.08
Assessor Name: John Oualline
Date Created: 09/12/2013

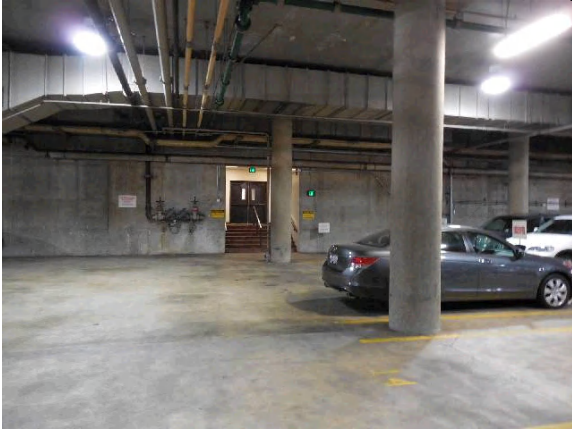
Location: Building Systems
Material: System
Distress: Beyond Useful Life
Category: Capital Renewal
Priority: 4 - Recommended
Correction: Renew System
Qty: 1-Ea.
Estimate: \$1,081.20
Assessor Name: John Oualline
Date Created: 09/12/2013

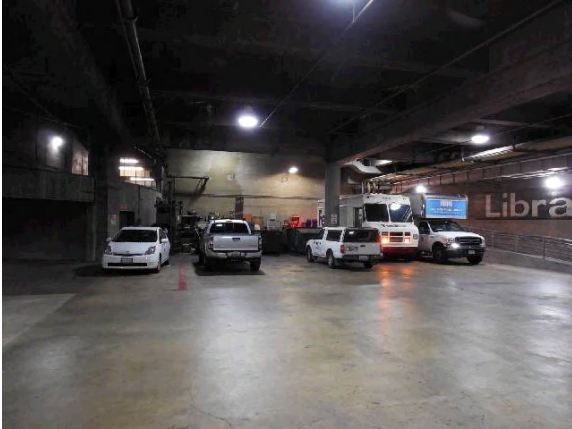
Location: Building Systems
Material: System
Distress: Beyond Useful Life
Category: Capital Renewal
Priority: 4 - Recommended
Correction: Renew System
Qty: 1-Ea.
Estimate: \$18,380.39
Assessor Name: John Oualline
Date Created: 09/12/2013

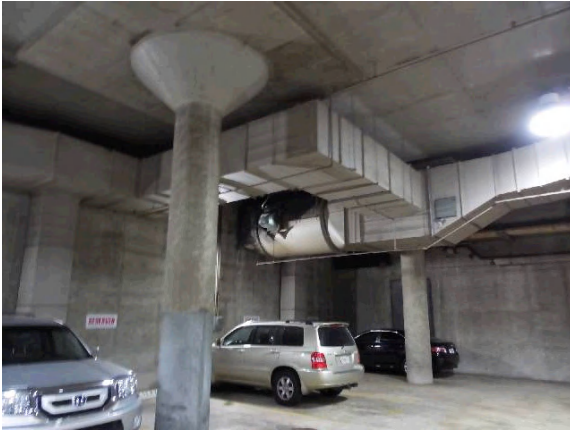
Location: Building Systems
Material: System
Distress: Beyond Useful Life
Category: Capital Renewal
Priority: 4 - Recommended
Correction: Renew System
Qty: 1-Ea.
Estimate: \$109,561.53
Assessor Name: John Oualline
Date Created: 09/12/2013

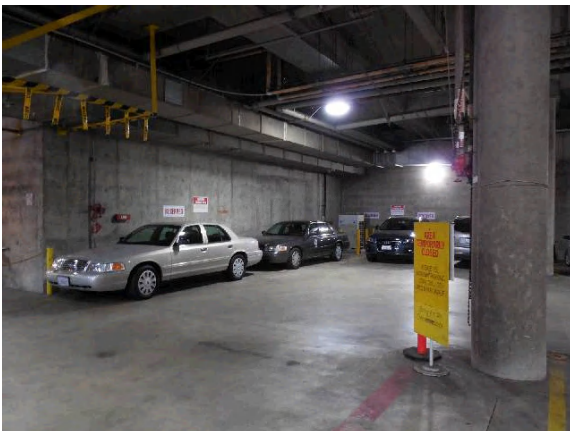
Location: Building Systems
Material: System
Distress: Beyond Useful Life
Category: Capital Renewal
Priority: 4 - Recommended
Correction: Renew System
Qty: 1-Ea.
Estimate: \$198,580.27
Assessor Name: John Oualline
Date Created: 09/12/2013

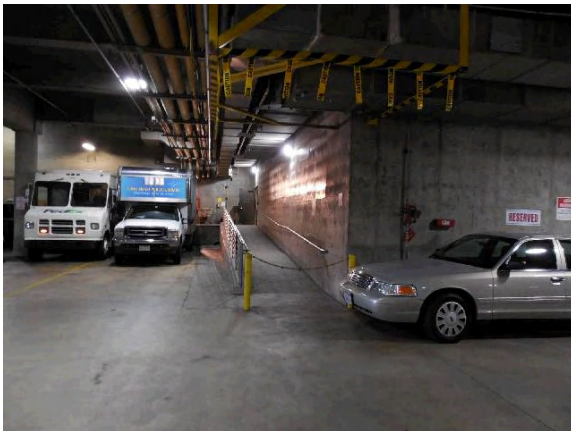
Location: Building Systems
Material: System
Distress: Beyond Useful Life
Category: Capital Renewal
Priority: 4 - Recommended
Correction: Renew System
Qty: 1-Ea.
Estimate: \$10,811.99
Assessor Name: John Oualline
Date Created: 09/12/2013

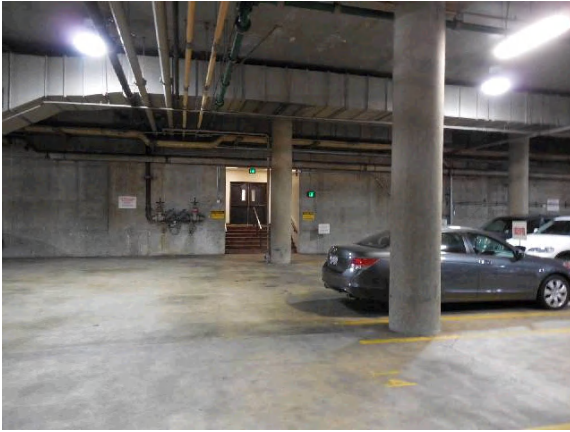
Location: Building Systems
Material: System
Distress: Beyond Useful Life
Category: Capital Renewal
Priority: 4 - Recommended
Correction: Renew System
Qty: 1-Ea.
Estimate: \$91,541.54
Assessor Name: John Oualline
Date Created: 09/12/2013

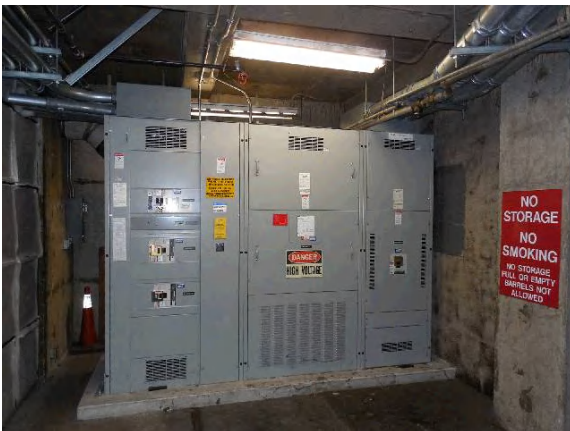
Location: Building Systems
Material: System
Distress: Beyond Useful Life
Category: Capital Renewal
Priority: 4 - Recommended
Correction: Renew System
Qty: 1-Ea.
Estimate: \$73,791.85
Assessor Name: John Oualline
Date Created: 09/12/2013

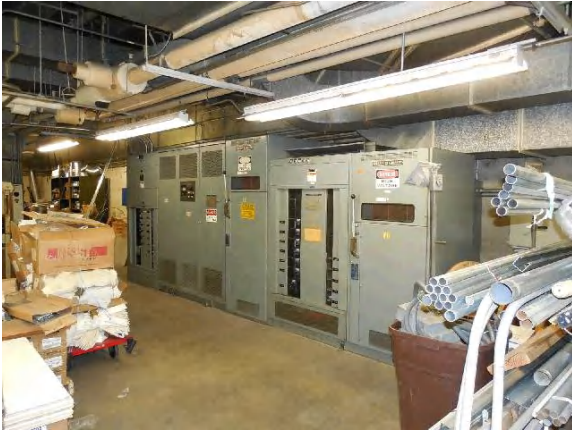
Location: Building Systems
Material: System
Distress: Beyond Useful Life
Category: Capital Renewal
Priority: 4 - Recommended
Correction: Renew System
Qty: 1-Ea.
Estimate: \$358,806.81
Assessor Name: Tom Moe
Date Created: 09/10/2013

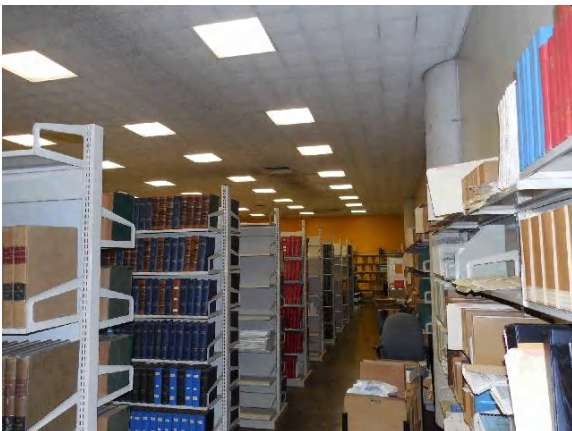
Location: Building Systems
Material: System
Distress: Beyond Useful Life
Category: Capital Renewal
Priority: 4 - Recommended
Correction: Renew System
Qty: 1-Ea.
Estimate: \$4,988,337.75
Assessor Name: Tom Moe
Date Created: 09/10/2013

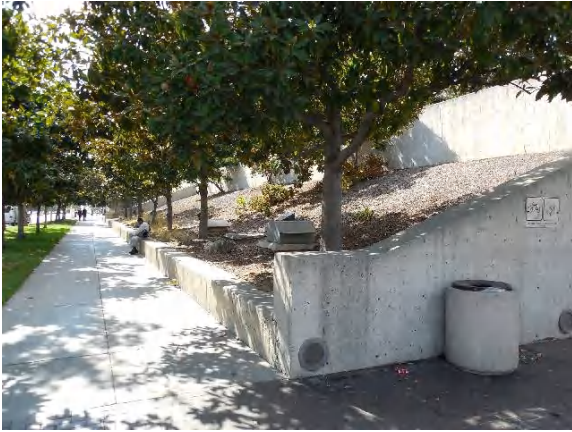
Location: Building Systems
Material: System
Distress: Beyond Useful Life
Category: Capital Renewal
Priority: 4 - Recommended
Correction: Renew System
Qty: 1-Ea.
Estimate: \$1,207,054.39
Assessor Name: Tom Moe
Date Created: 09/13/2013

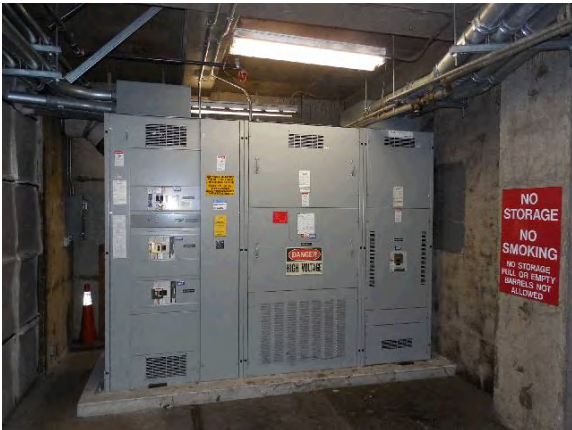
Location: Building Systems
Material: System
Distress: Beyond Useful Life
Category: Capital Renewal
Priority: 4 - Recommended
Correction: Renew System
Qty: 1-Ea.
Estimate: \$1,207,054.39
Assessor Name: Tom Moe
Date Created: 09/13/2013

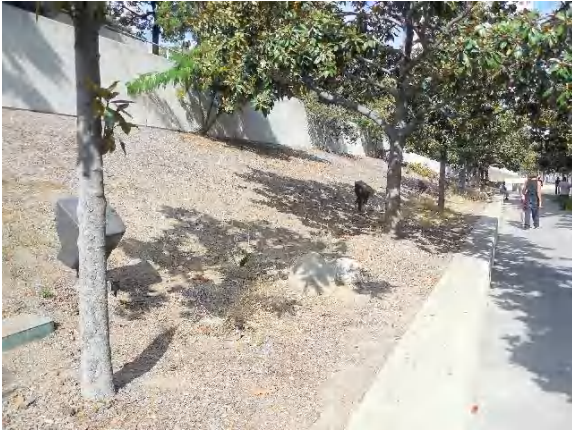
Location: Building Systems
Material: System
Distress: Beyond Useful Life
Category: Capital Renewal
Priority: 4 - Recommended
Correction: Renew System
Qty: 1-Ea.
Estimate: \$608,598.85
Assessor Name: Tom Moe
Date Created: 09/13/2013

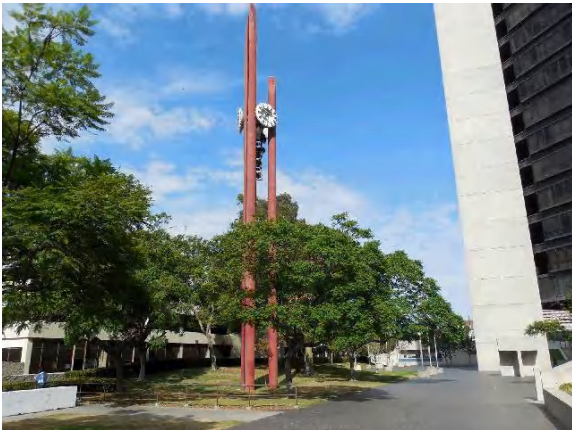
Location: Building Systems
Material: System
Distress: Beyond Useful Life
Category: Capital Renewal
Priority: 4 - Recommended
Correction: Renew System
Qty: 1-Ea.
Estimate: \$608,598.85
Assessor Name: Tom Moe
Date Created: 09/13/2013
