Nathan Clifford School Building

Conditions Assessment Report

The City of Portland
April 12, 2013

**Winton Scott Architects
Becker Structural Engineers, Inc.
Wright Ryan Construction**

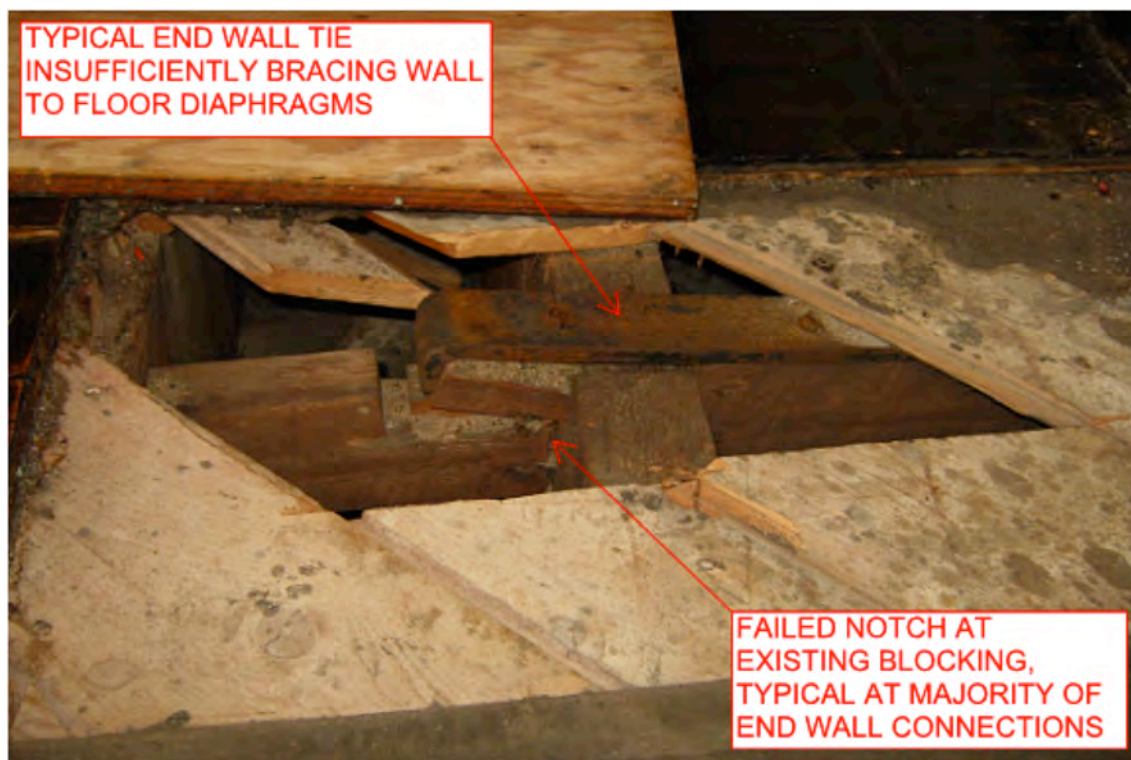
▲ Typical End Wall Tie

A prior report (by others) identifies areas at the east and west ends where outward movement of the exterior walls was suspected. Flooring was removed to view masonry wall ties and wood block monitors were installed. These areas are still accessible. The majority of the monitor blocks appear to be tight to the exterior wall. The prior report concluded that there was no evidence of a structural instability, and attributed the minor movement to expansion and contraction associated with moisture. However, our observation of the existing wall ties at the end walls reveals a condition which represents a structural failure of the original tie system where the walls are no longer adequately tied to the floor diaphragms and a repair is required.

Better wall anchorage needs to be implemented at each floor level of each end wall. For the purposes of estimating a basic probable cost, we have assumed the following:

1. Remove flooring and board sheathing for a width of 8' from inside of end walls, from exterior north/south walls to the interior masonry walls, at all floor levels and roof (to be coordinated with reroofing work) – approximately 3600 SF. This assumes intent is to preserve ceiling plaster; otherwise work could be done from below.

2. Install new ties at equal spacing set approximately 6' away from wall and anchoring to new blocking. We have assumed 96 ties total. Final design (by others) may determine if more or less anchors are required.

3. Galvanized threaded rod would extend from masonry wall to inset tie. Final design (by others) will determine if rods are bolted through the masonry with exterior bearing plates, or if they can be epoxied. Final detailing may also explore if the existing ties may be incorporated into the new work.

4. Replace floor and roof sheathing with (2) layers of ¾" plywood, glued and screwed.

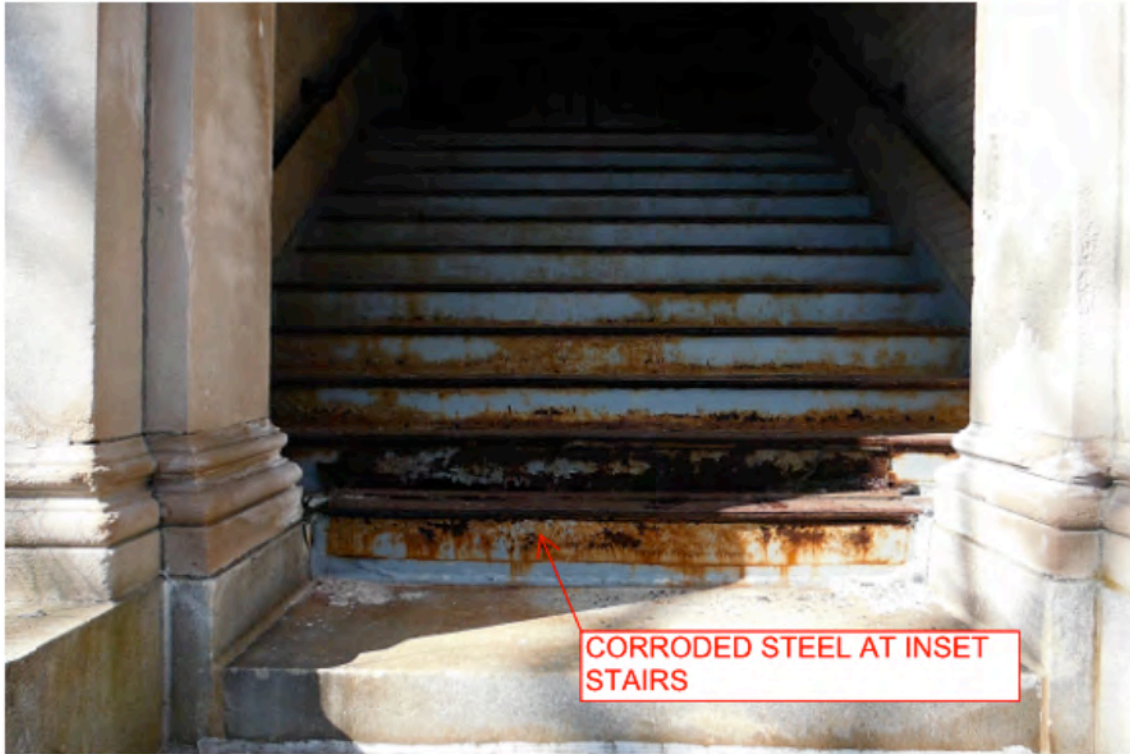
▲ South Stair (Inset Portion)

CORRODED STEEL AT INSET STAIRS

At each of the four entrance stairs, the stairs transition from granite to steel. Corrosion is present at all four stairs, with the worst being at the east and west sides. We recommend these stairs be repaired / replaced in kind with new galvanized and coated steel elements. The east and west stairs may require complete replacement, while the north and south stairs may only require a tread replacement (to be determined by final design). The granite portion beyond the building face appeared to be in sound condition with the exception of the south stair, where we recommend the granite be removed, approximately 16 LF of 8" concrete frost wall be installed, and the granite steps reset. Site stairs removed from the building were not considered for this report.

Repair / replacement of steel stairs at inset portion of entries as noted above: ...\$62,000.00

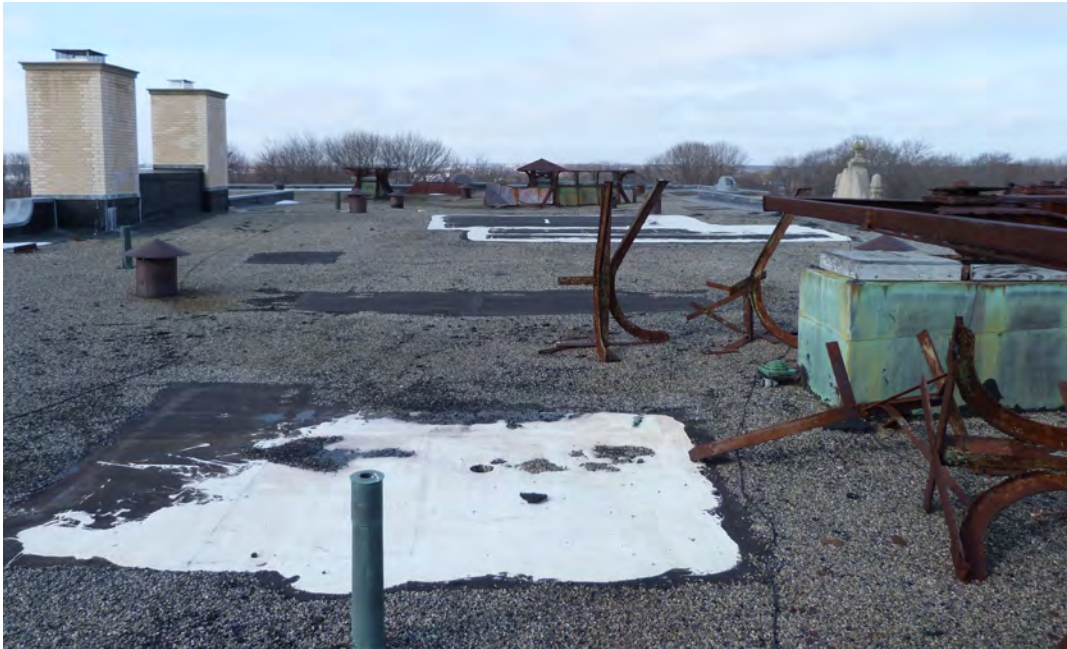
General roofscape showing deteriorated vent hoods, patches in built up roofing, & various vents and stacks that penetrate the roof

The existing built up roofing is beyond its useful life and should be removed and replaced with new EPDM membrane roofing. At the time of roof replacement, existing abandoned equipment and vents should be removed complete to eliminate unnecessary penetrations and flashings.

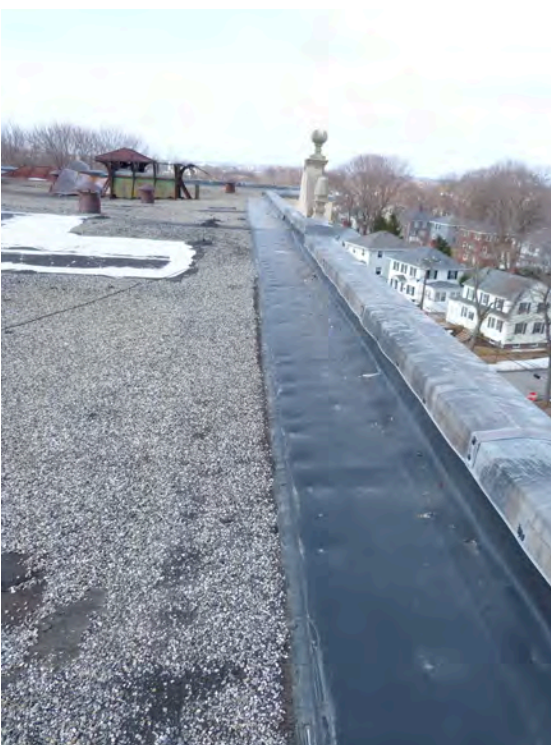
The roof area is approximately 11,465 square feet and consists of ballasted built up tar roofing throughout. A +/- 2' band of newer EPDM membrane roofing has been installed along the entire perimeter as a repair to the junction between the roof surface and the parapet wall which presumably experienced water infiltration issues over the years. The built up roofing has multiple patches at locations of removed equipment or other areas where leaks developed (evidence of past and active leaks is present at several locations on the third floor) and while partial attics have some blown in insulation, the roof is not insulated at the deck. Metal cap flashings at the parapet walls appear to be in good condition throughout.

Area of patched in strip of EPDM roofing along building perimeter.

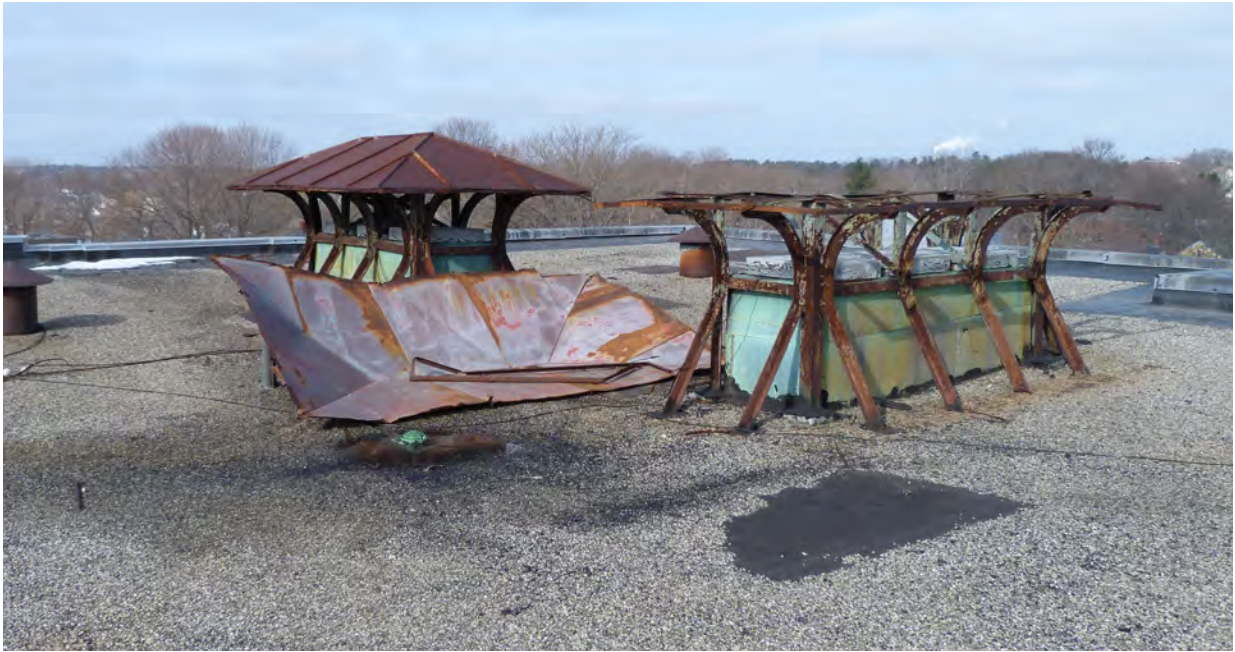
The original building design incorporated passive ventilation chimneys that were gathered into (6) groups of 3 shafts at the roof. Each of these was covered by a metal hood supported on decorative steel supports. Of the six hoods, one has been removed completely and roofed over. The other five hoods are in various stages of disrepair with many or all structural supports missing and hood roofs laid loosely on the roof. Structural supports tie into the roof structure and are set in pitch pockets that are dried out and cracked. There are also various other roof penetrations such as exhaust vents and plumbing vents that are flashed into the roof with copper flashings. The roof pitches approximately 1/2" per foot toward two functional roof drains. No significant standing water was observed on the roof surface.

Ventilation hoods and close up detail of deteriorated pitch pocket where steel supports penetrate roof to fasten to underlying structure.

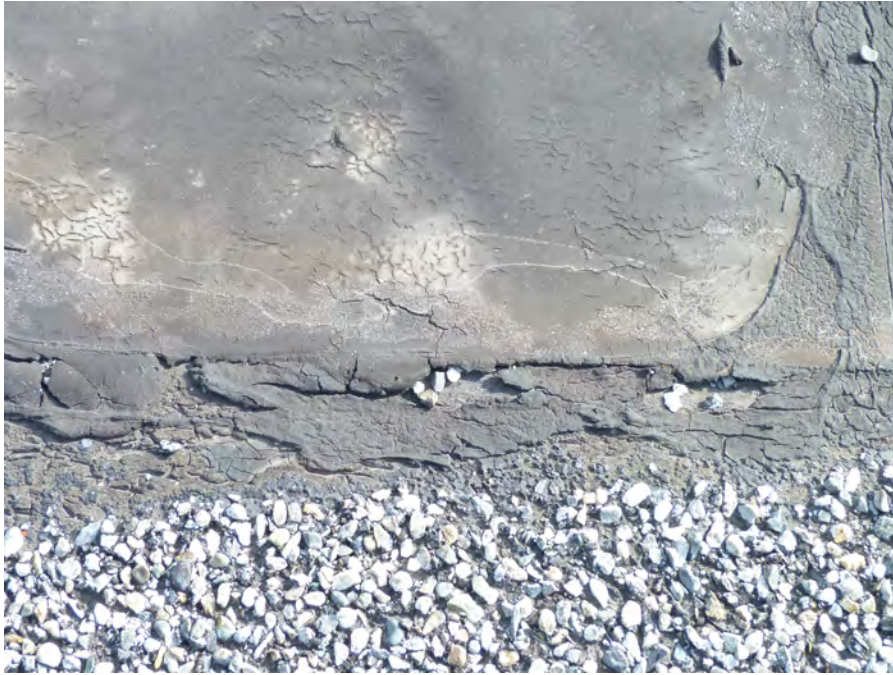
▲ Example of previously patched built up roofing with cracking along the joints.

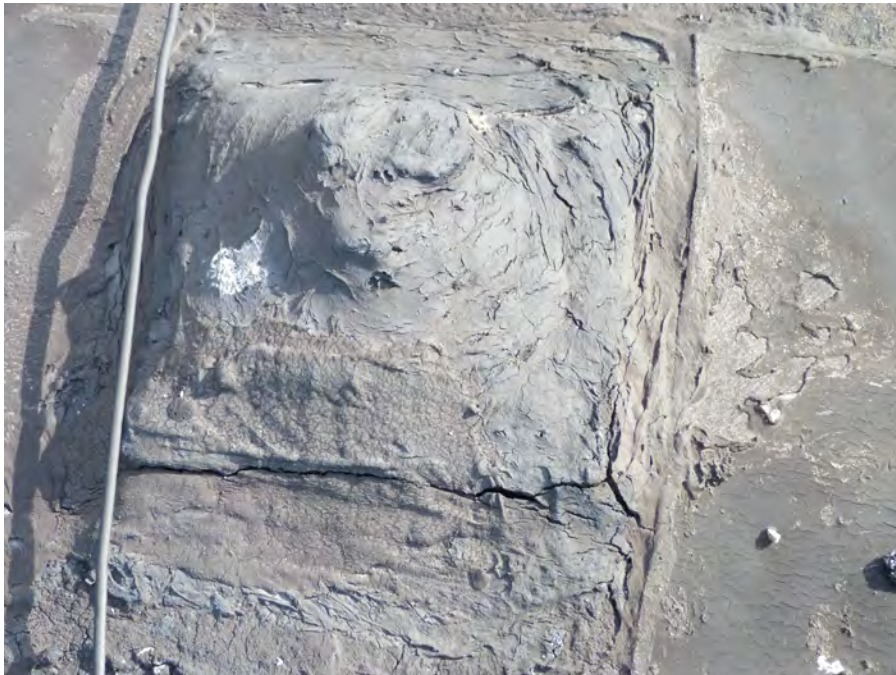
▼ Area of former steel post penetration that has been patched. Cracking visible along edges

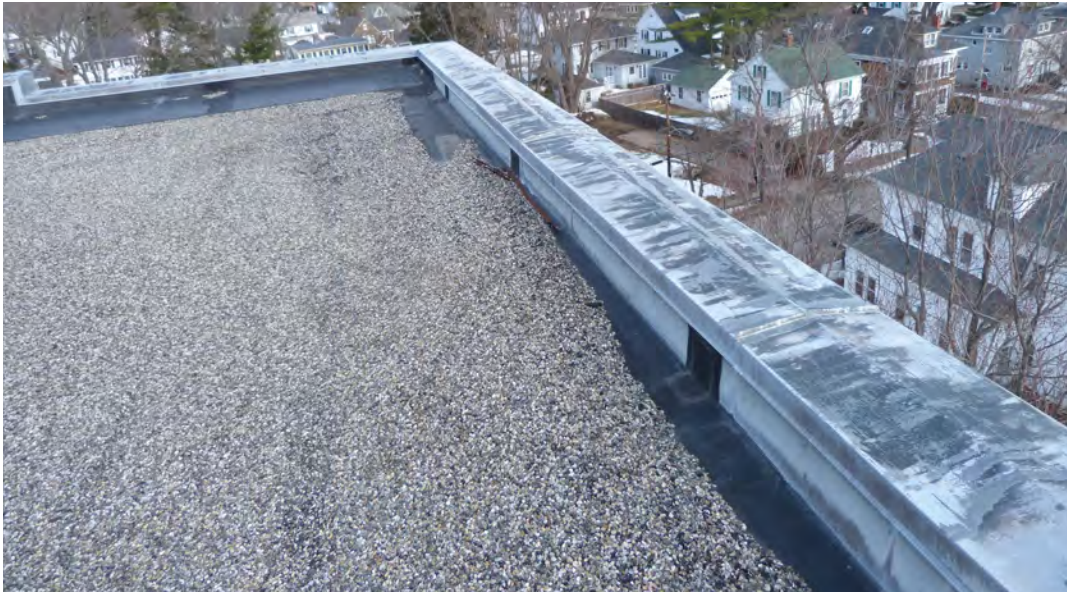
▲ Metal parapet wall cap flashing is in good condition at all locations.

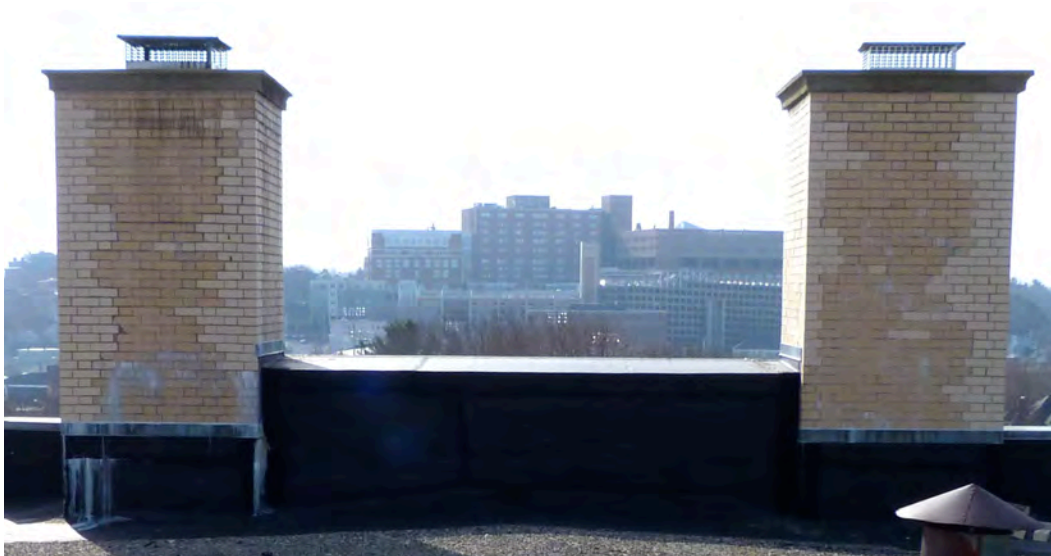
At a centered location on the building's south facade there are two masonry chimneys engaging the wall. They show signs of having been repaired which is confirmed by written documentation provided by Portland Public Schools showing repairs were made in the summer of 2008. Despite the repair work, the chimneys have experienced additional cracking and mortar deterioration and are again in need of further repair.

▼ Chimneys centered on south facade. Previous repairs have deteriorated with loose mortar and some cracking evident.

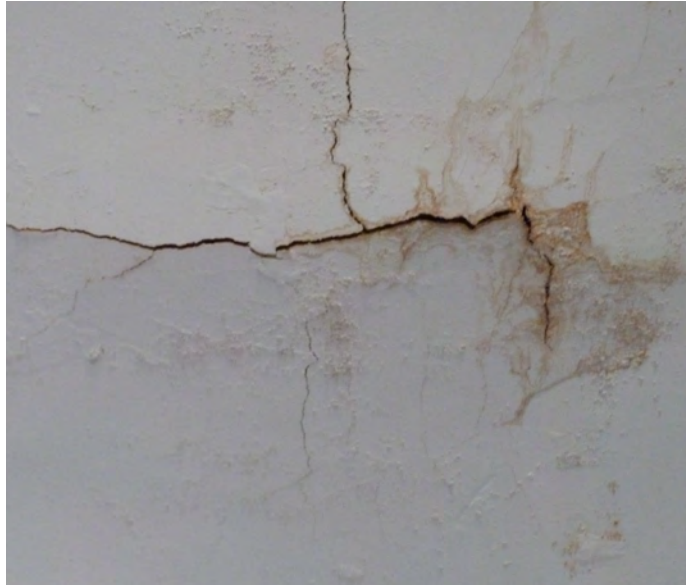
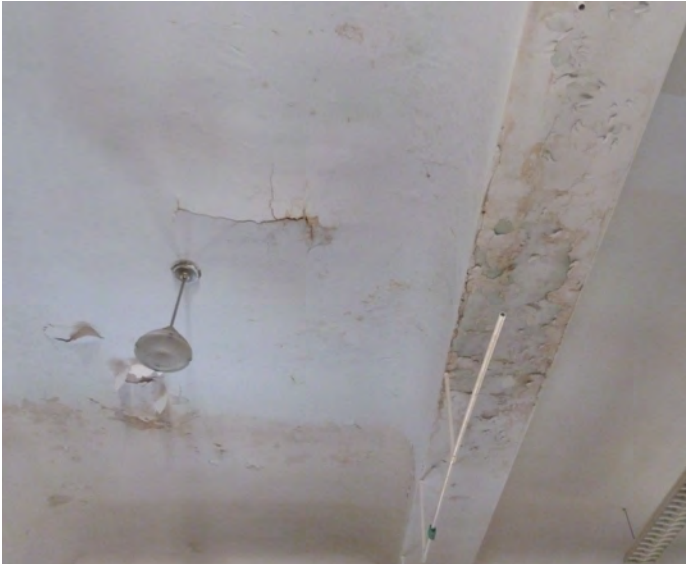
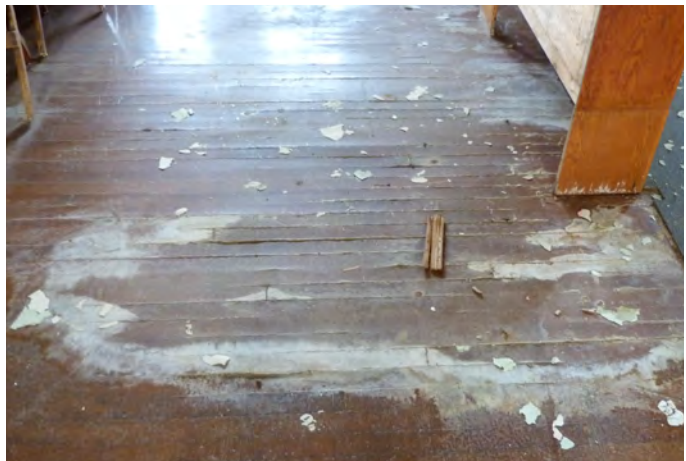
Water damage from roof leaks at third floor ceilings and floors.

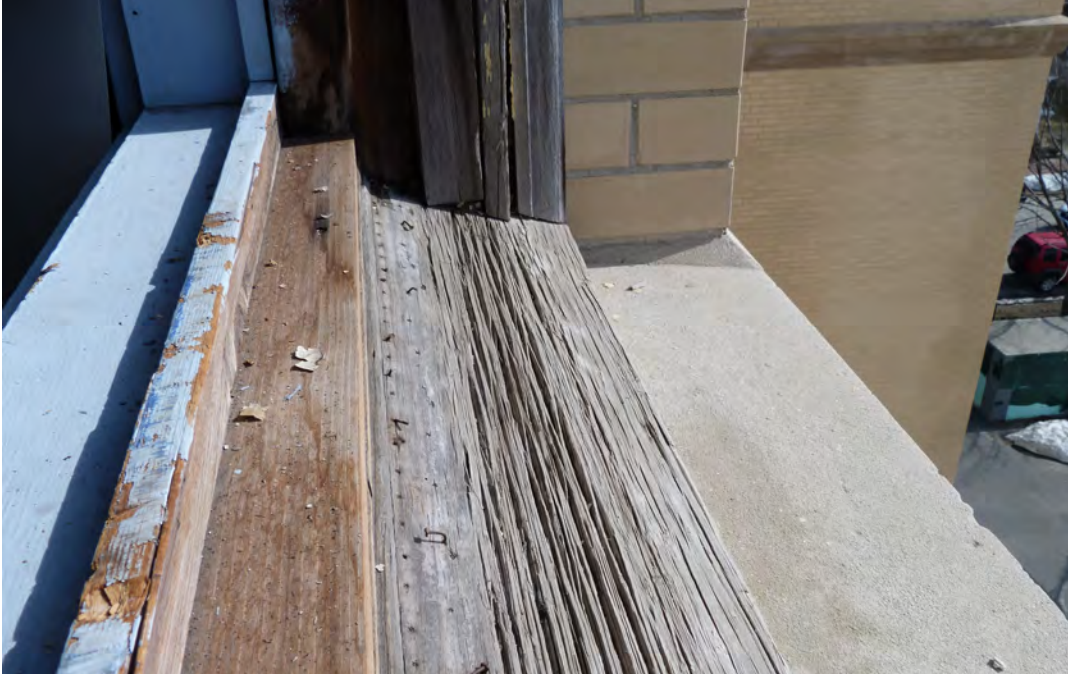
The existing windows all fall into the same general category for the most part with the majority having sashes that are in fair to good condition for their age and exterior frames that are in fair condition. A large portion of the wood sills are heavily weathered with multiple open fissures in the grain. Many of the existing sash were glazed with a polycarbonate material that has become clouded with age to the point where most can no longer be seen through. Glazing putty is dry, brittle and falling out in most locations. Sash chords are broken on many units as well.

Typical wood sill at original double hung windows showing severe weathering

The wood windows, while in need of significant restoration, are all intact enough to be repaired and brought back to serviceable condition. Sashes will require removal, stripping, joint repairs, replacement of weatherstripping, and reglazing of all glass. Wood frames can be repaired and stripped in place with missing and completely rotted moldings being replaced in kind. The wood sills require treatment with wood epoxy consolidant and filler to restore their structural integrity and create a solid smooth surface for paint to adhere to. The windows are only single glazed so interior or exterior storm windows should be considered to improve thermal efficiency.

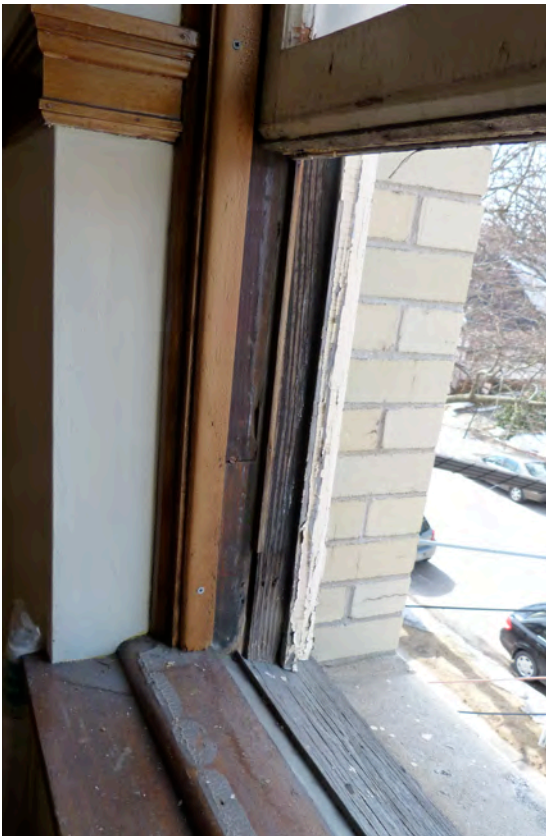
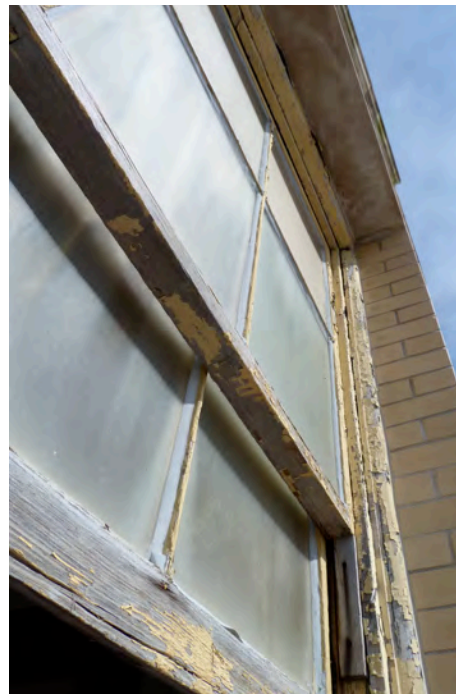
Typical wood window showing sashes and frame to be in repairable condition.

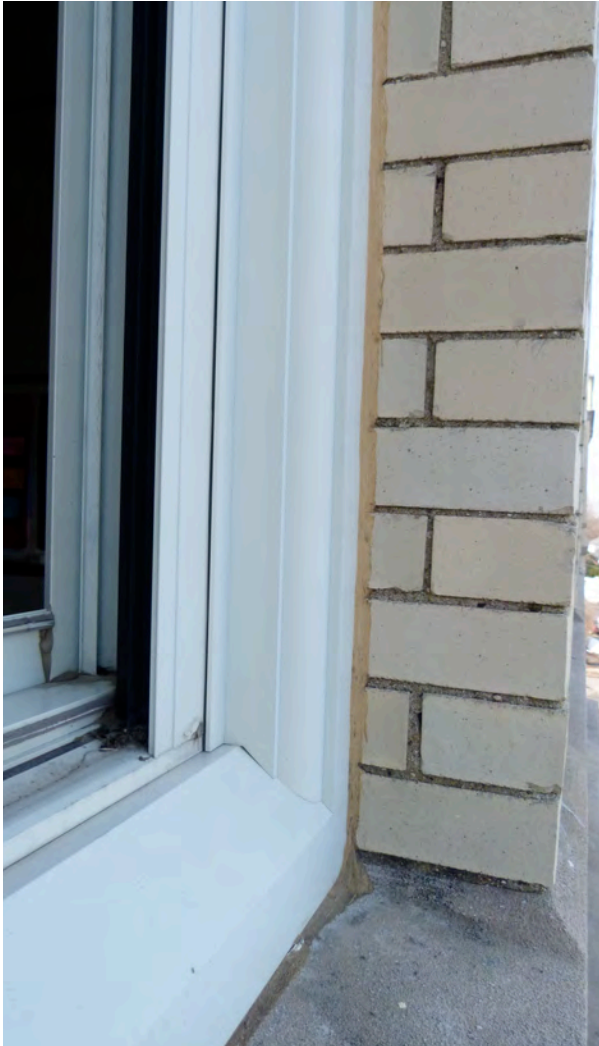
The newer aluminum replacement windows are in good to excellent condition, however the sealant used to seal the windows to the brick is starting to show its age and should be replaced in the near future.

Typical replacement aluminum window
showing exterior sealant joint

The newer aluminum replacement windows on the building are in good shape and do not represent a risk to the long term integrity of the building. Re-sealing the joint between the window frame and masonry should be completed within 5 years to assure the weather tightness of the assembly.

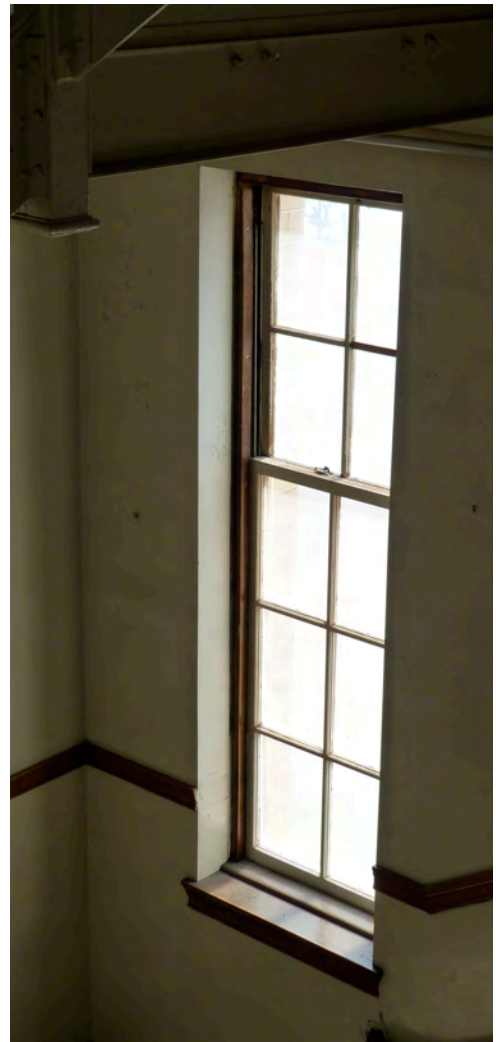
Typical interior of wood window
