<b>Philadelphia Federation of Teachers Health &amp; Welfare Fund &amp; Union</b>	<b>Evaluation Requested By:</b> PFT H&W Fund & Union <span style="float: right;"><b>Page 1 of</b></span>	
	<b>Date Inspected:</b> 12/2/2013 <b>Initial Inspection?</b> <input type="checkbox"/> <b>Follow-Up Inspection?</b> <input checked="" type="checkbox"/>	<b>Inspected by:</b> Jerry Roseman M.Sc. I.H. <b>Others Present? N</b> <b>Name[s]:</b>
<b>IEQ Evaluation &amp; Inspection Summary Report – OEC E.S. &amp; Annex</b>	<b>Date Report Issued:</b> 12-2-13  <b>Report Provided To:</b> Arthur Steinberg, PFTH&W Fund	<b>Photos Attached:</b> <input checked="" type="checkbox"/> <b>Sketches Attached:</b> <input type="checkbox"/>
<b>Building Name:</b> Overbrook Education Center [OEC] & Annex <b>Building Address:</b> 6722 Lansdowne Ave. <b>Phone #:</b> 215-581-5890 <b>Main Contact[s]:</b> S. Pritchard [PFT Rep]; Angela Thompson [Principal]; Mr. Hester [B.E.]

## PHOTO LOG - Selected & Representative Photos

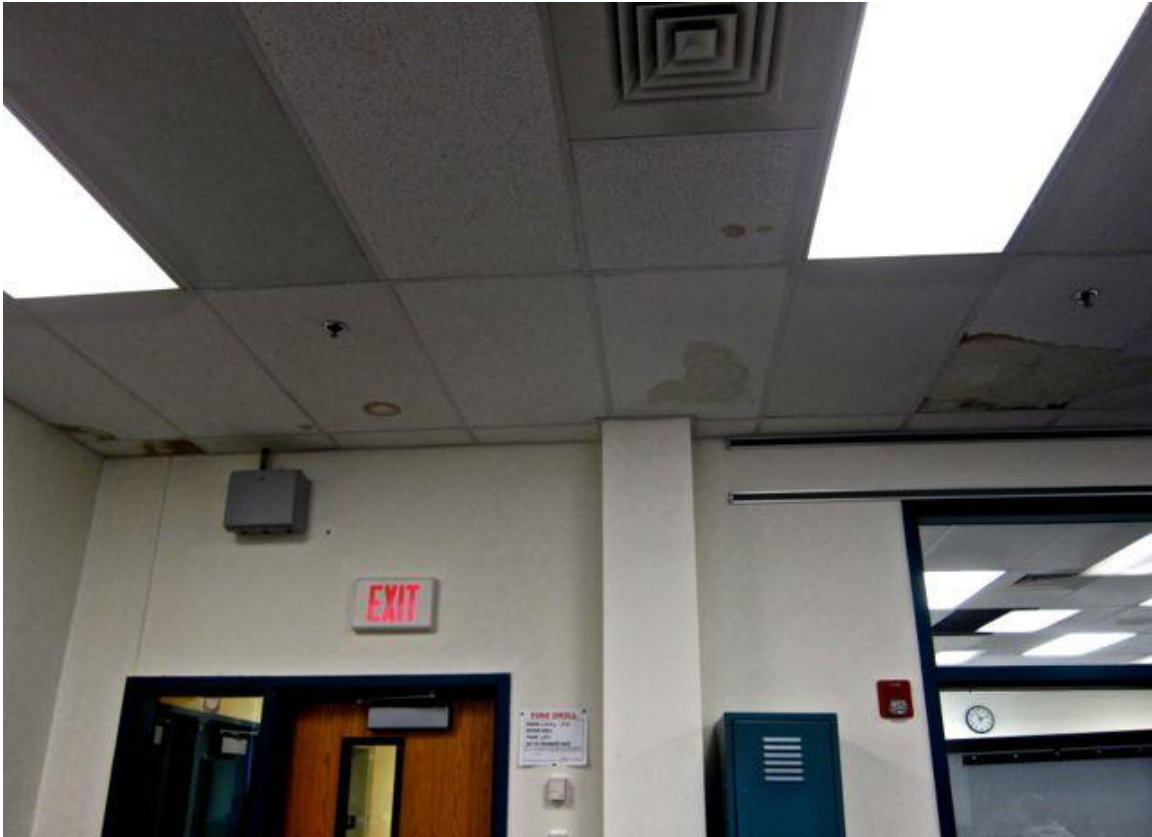
OEC Main Building - 12/2/13 - Library - 3<sup>rd</sup> floor

Main Building  Library	* Approximately 20-24 stained ceiling tiles observed – 1 with visible mold. * Active “leaking” from HVAC/Condensate during cooling season was reported by occupants	1. Replace damaged tiles and conduct a root cause evaluation to determine the source of the water intrusion/moisture; 2. Effect repairs of the root cause[s] as necessary
Main Building 3 <sup>rd</sup> floor – Girls & Boys bathrooms	Stained ceiling tiles observed – B.E. was unsure if damage was recent or long term	1. Replace damaged tiles and conduct a root cause evaluation to determine the source of the water intrusion/moisture; 2. Effect repairs of the root cause[s] as necessary
Main Building 3 <sup>rd</sup> floor – Hallway areas	Stained ceiling tiles observed – B.E. was unsure if damage was recent or long term	1. Replace damaged tiles and conduct a root cause evaluation to determine the source of the water intrusion/moisture; 2. Effect repairs of the root cause[s] as necessary

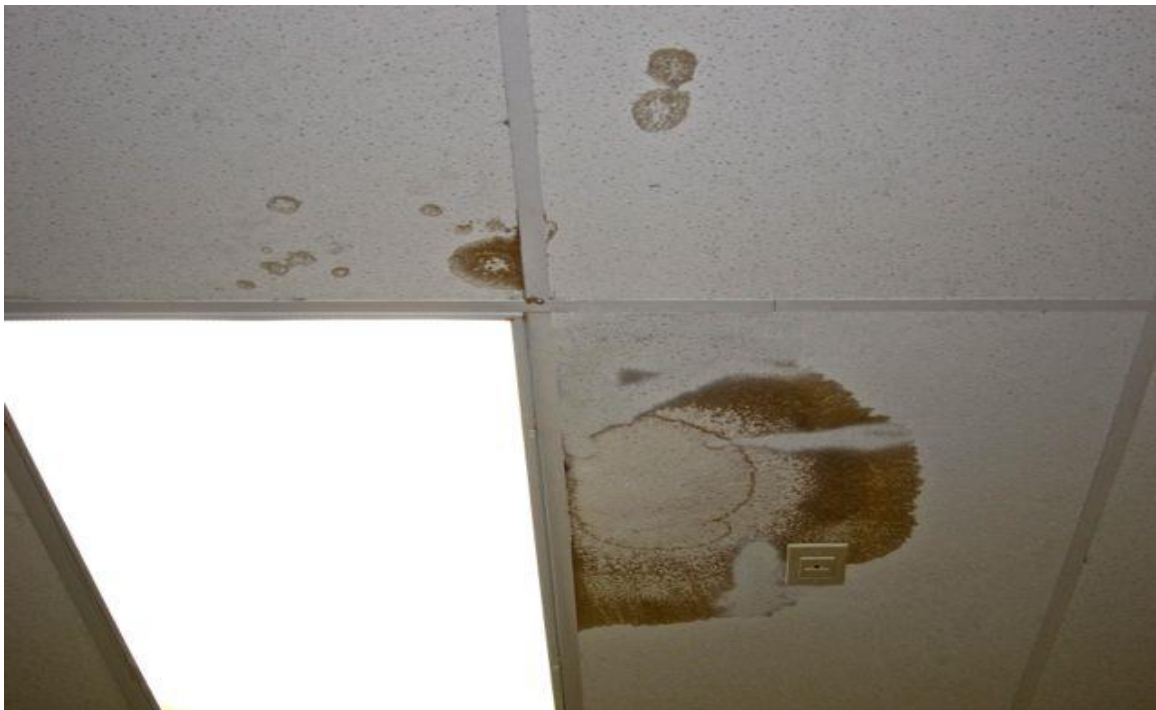
OEC Main Building - 12/2/13 - Library - 3<sup>rd</sup> floor - Water damaged/stained ceiling tiles

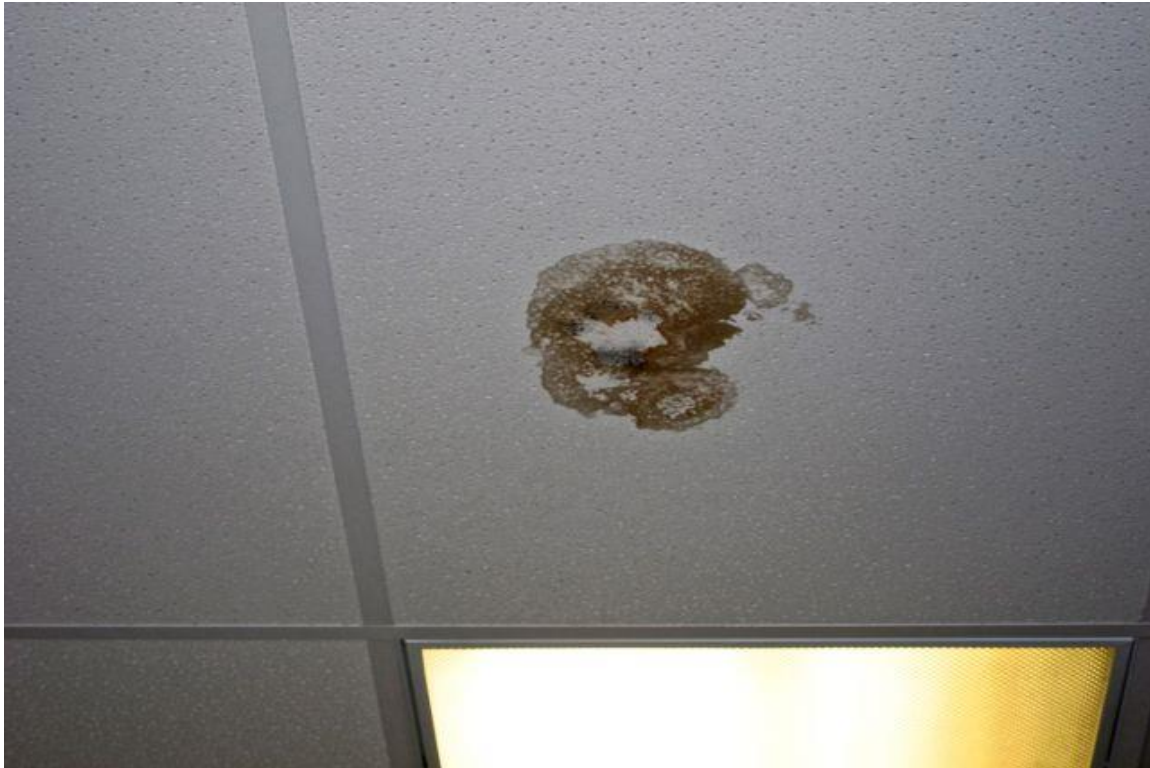
**OEC Main Building - 12/2/13 - Library - 3<sup>rd</sup> - Mold growth on ceiling tile**

**[3] Replacement of Water Stained, Damaged & Moldy Ceiling Tiles & Cleaning of Door Frames and Other Surfaces with Suspect Mold Growth**– Especially given the school population at OEC [and it's Annex], including very young children and those with visual impairments and other disabilities, remediation work related to water damaged and moldy materials should be promptly conducted

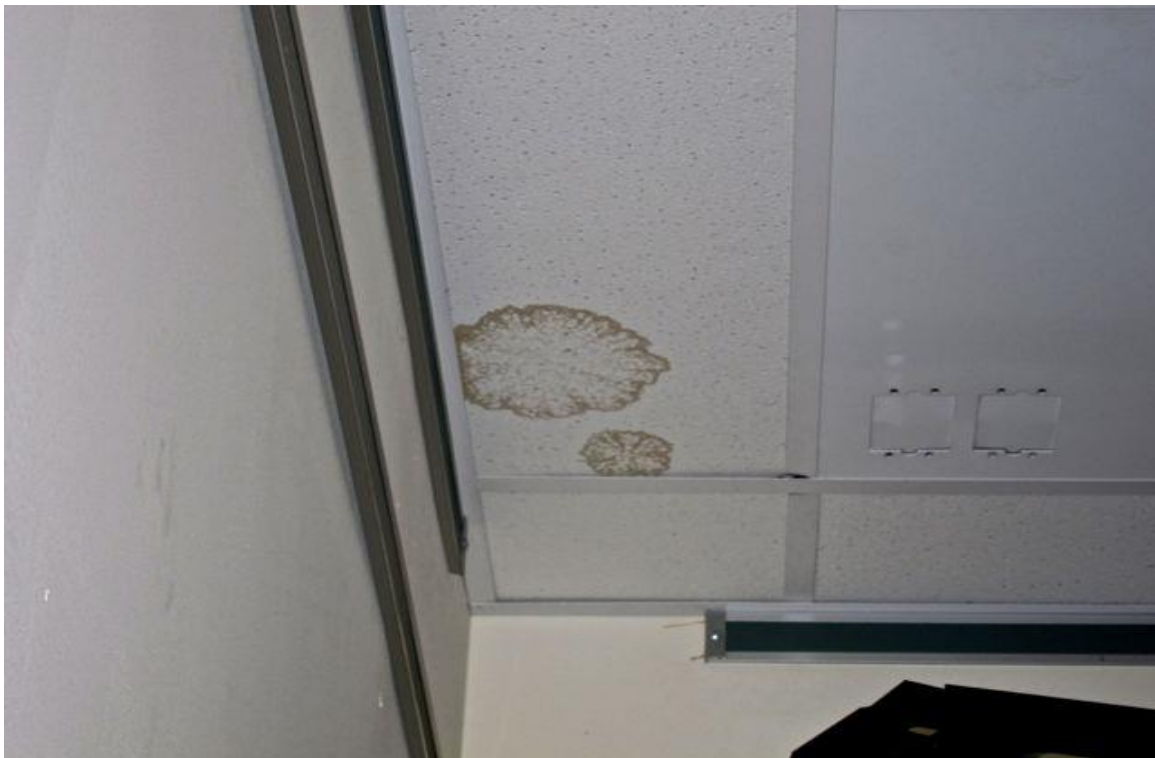
**OEC Main Building - 12/2/13 - Library - 3<sup>rd</sup> floor - water damaged ceiling tiles**

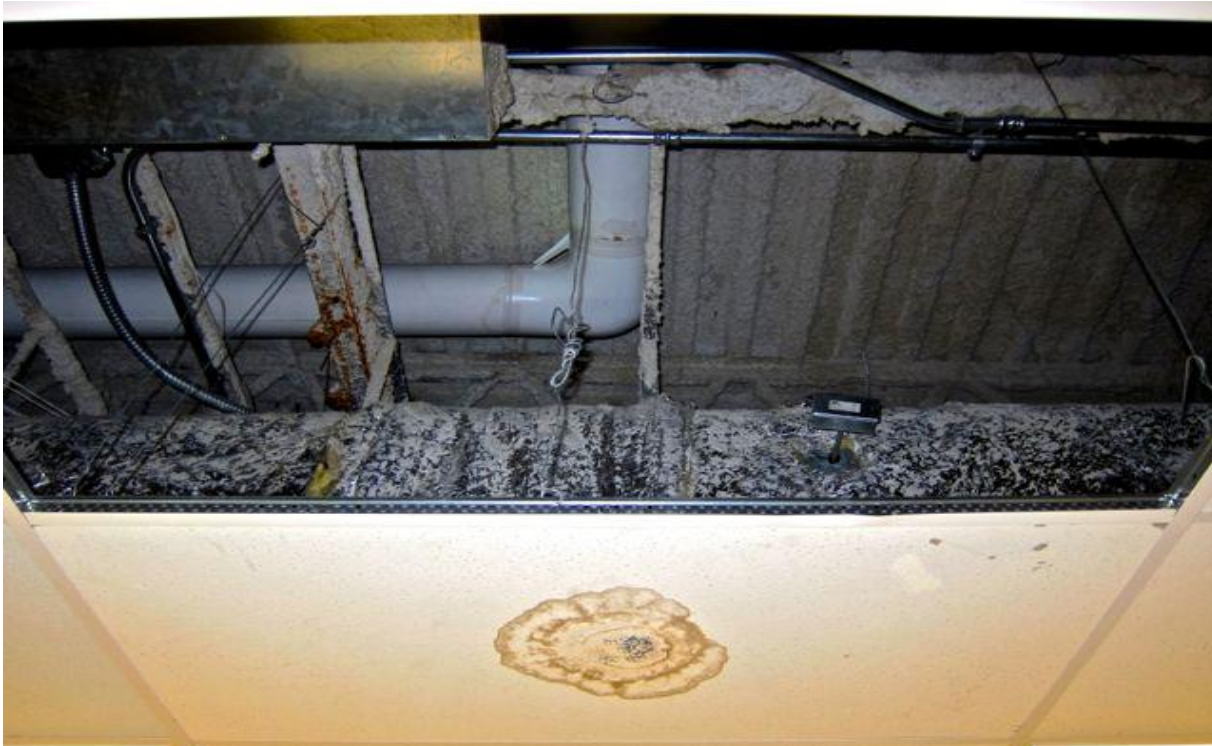
**OEC Main Building - 12/2/13 - Computer Lab - 3<sup>rd</sup> floor - Close Up - Showing chilled water line and HVAC components**

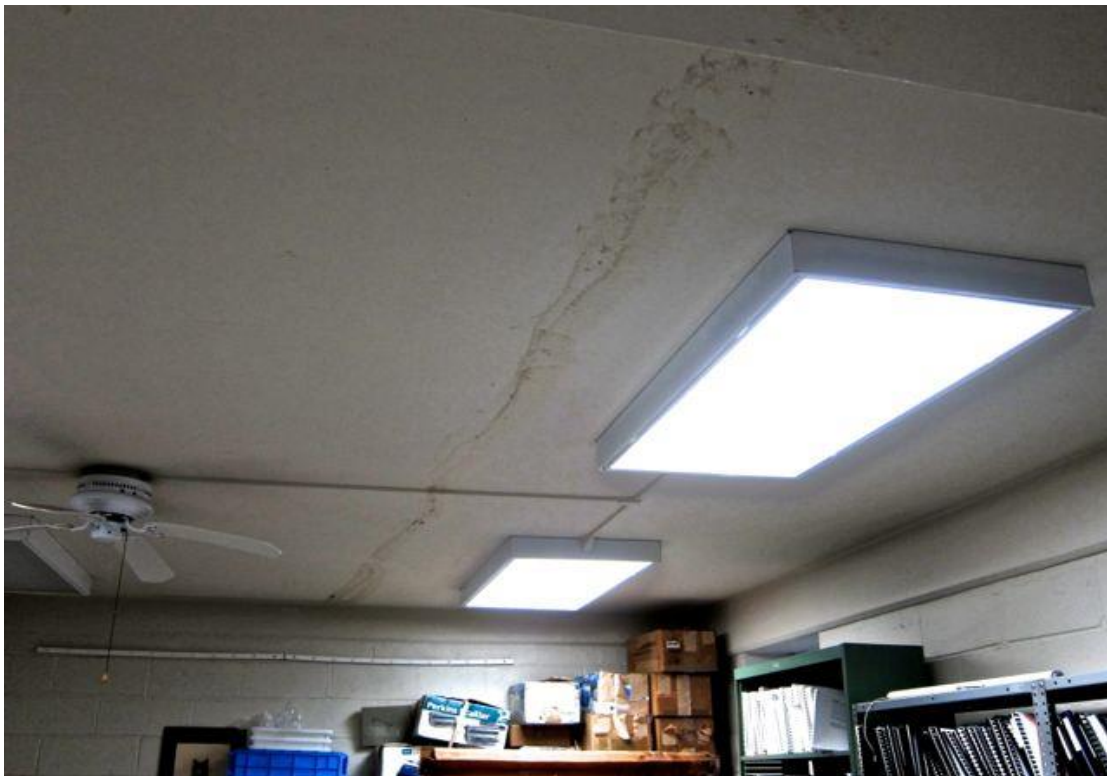
**[5] Mold Remediation – Annex Music Rooms** - Mold remediation and cleaning of musical instruments reportedly began on, or about 11/25 – no notification, information or status was reported to us, nor was there a formal notification reportedly provided to building occupants or others [including parents]. Concern was expressed by several staff about the potential impacts on young children, several of whom reportedly have severe asthma, and also about the health impacts on staff;

**OEC Annex - 12/2/13 - Music Suite Ceiling - Water Damage**

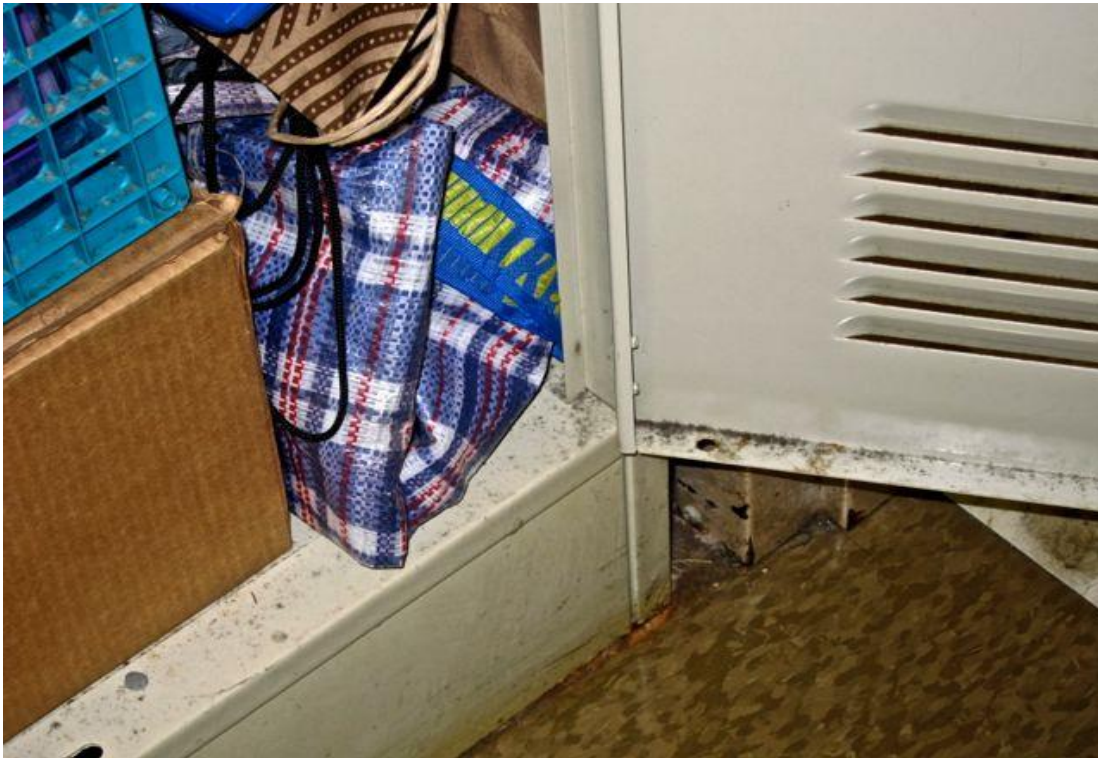
OEC Annex -12/2/13 - Classroom 1 - suspect mold growth in storage cabinet

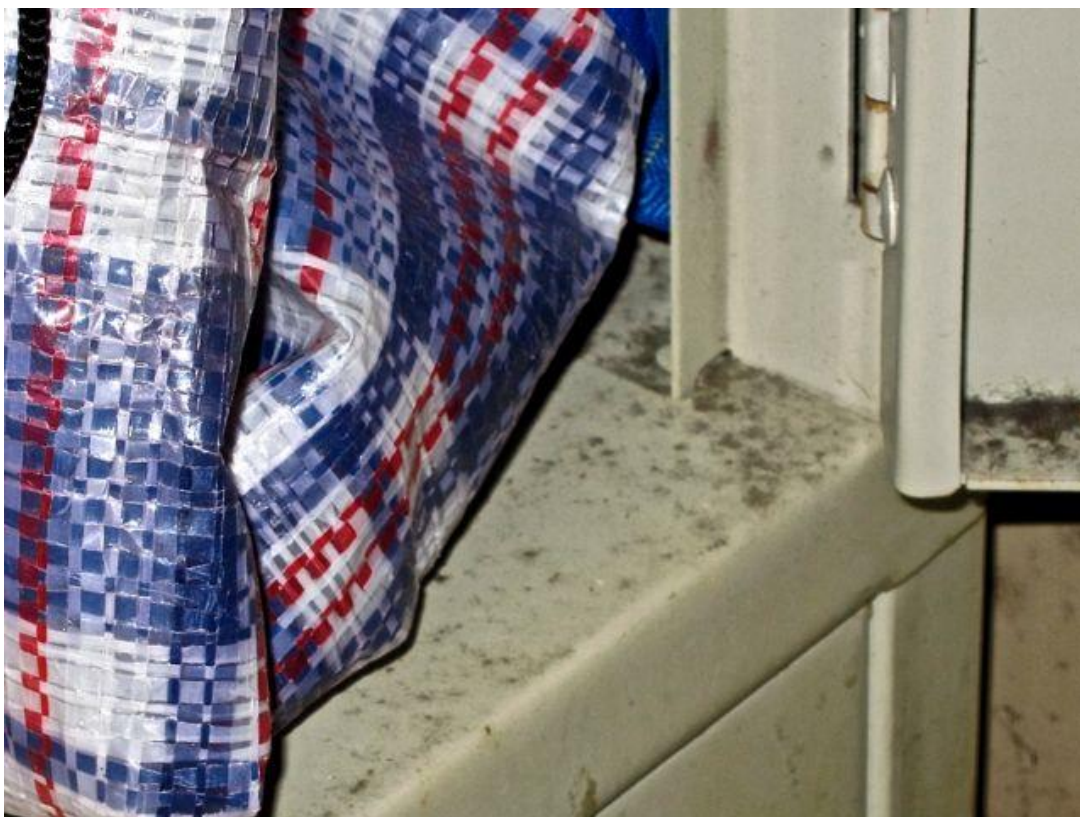
OEC Annex -12/2/13 - Classroom 1 - suspect mold growth in storage cabinet - close up

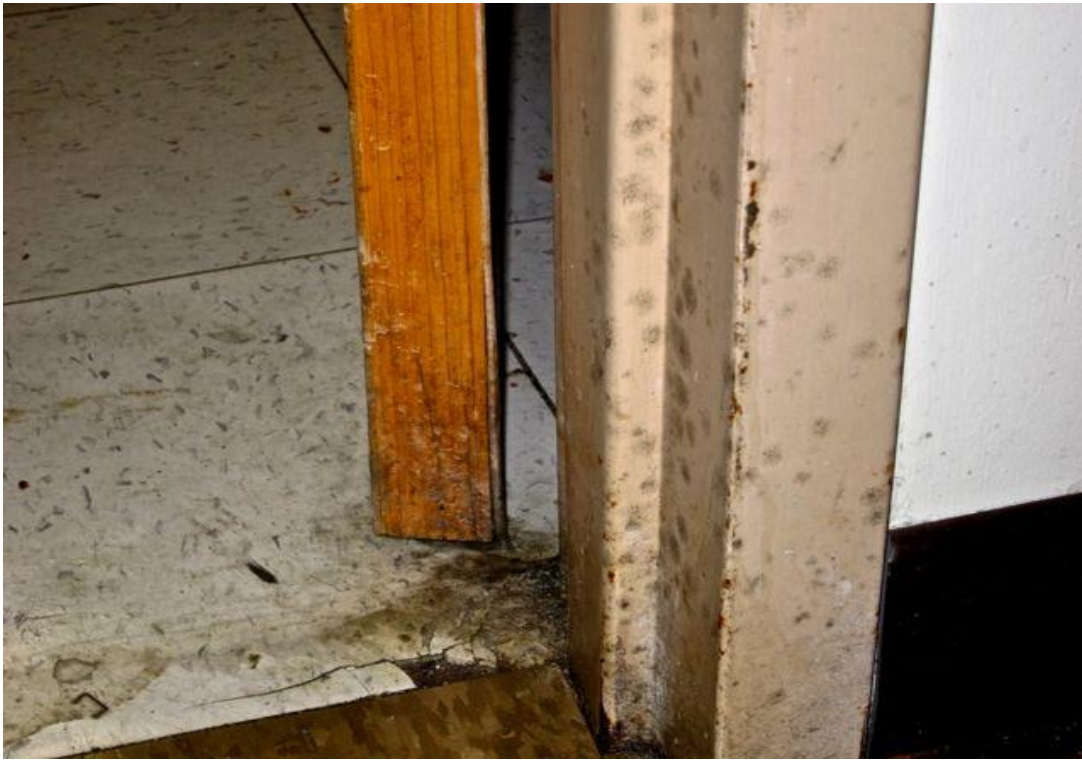
**OEC Annex -12/2/13 - Classroom 1 - suspect mold growth on door frame**

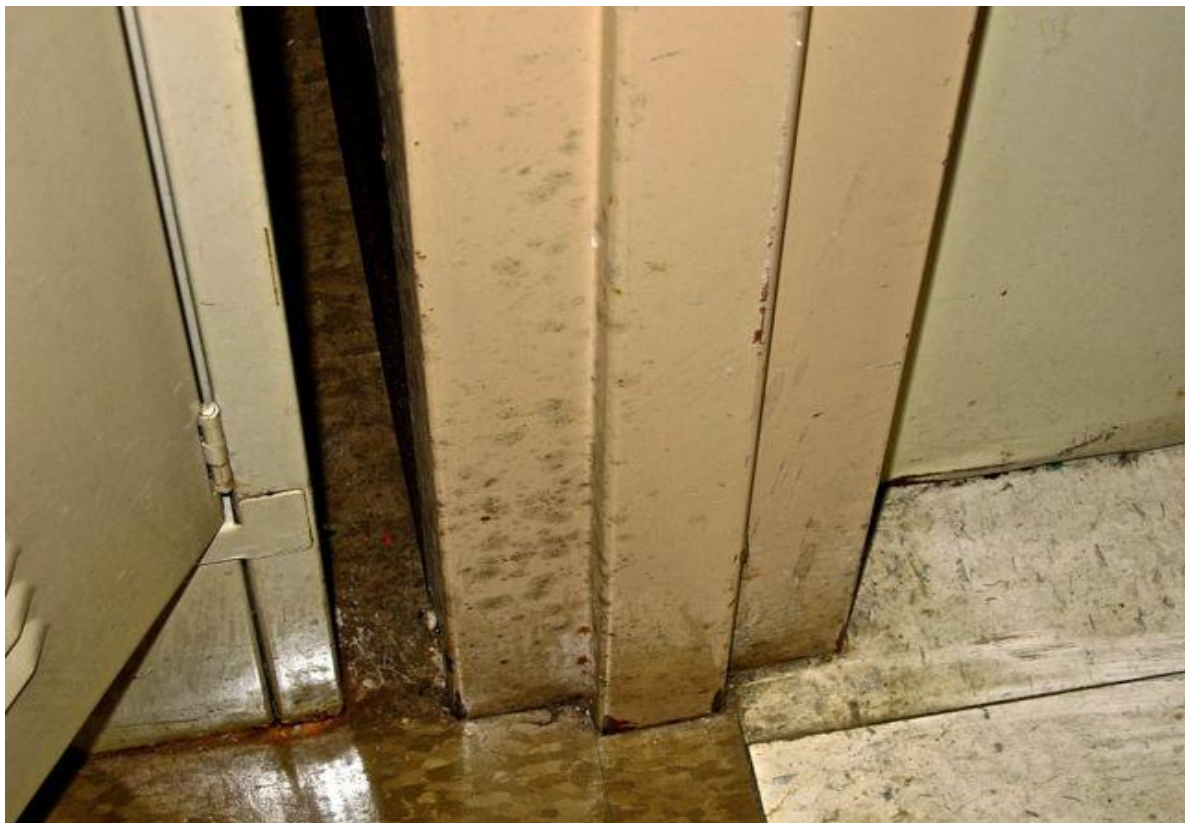
**OEC Annex -12/2/13 - Classroom 23 - suspect mold growth on door frame**

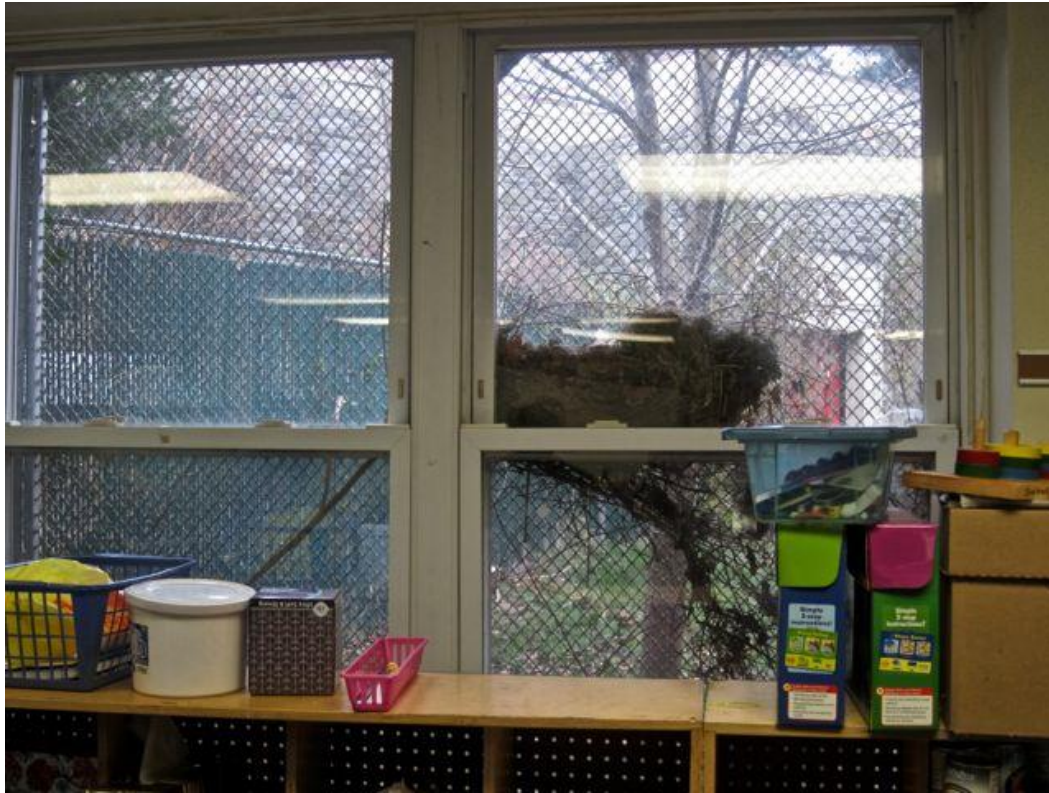
**[5] OEC – Annex Room 1**– As described above [and pictured] classroom windows are unable to be safely opened because of the risk of animal intrusion [the photo below shows what was reported to be an opossum nest built outside of the classroom window]. This situation should be addressed to facilitate the introduction of fresh air into the classroom;

**OEC Annex -12/2/13 - Classroom 1 - rodent nest outside window**

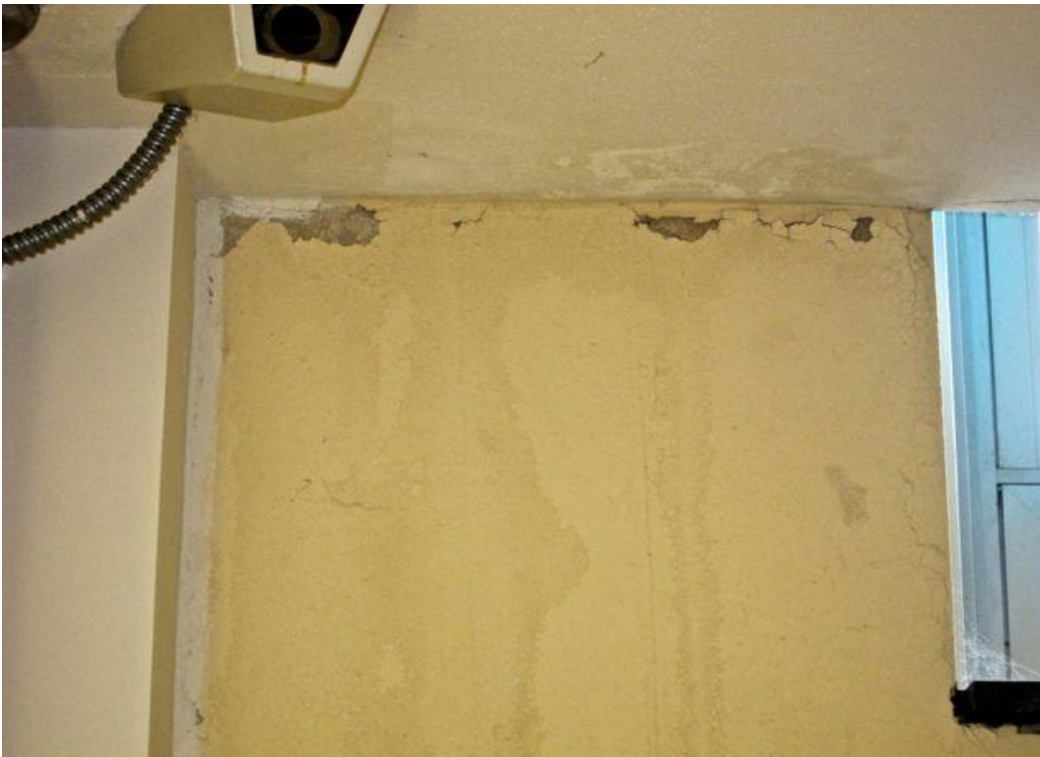
**OEC -12/2/13 - Stairwell G - Top Floor Landing - Chipping Paint and plaster from water damage**
