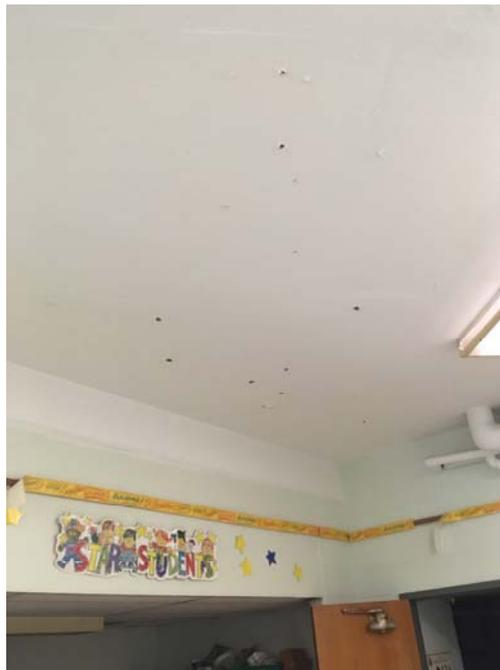
Photo 2 – Kindergarten Room 1  
Small sections of spalling concrete ceiling were observed on the ceiling.

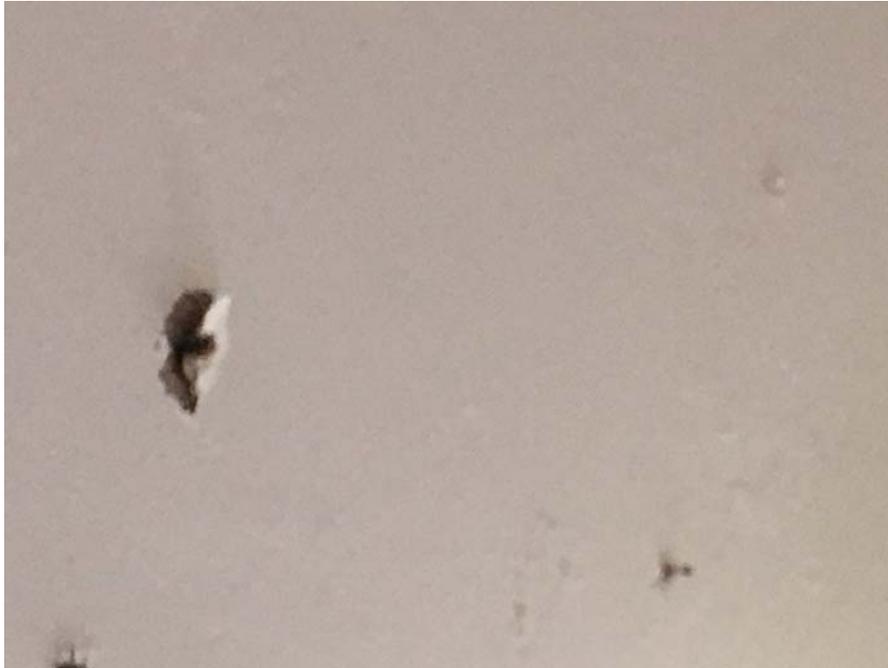
Photo 3 – Kindergarten Room 1  
Small sections of spalling concrete ceiling were observed on the ceiling.

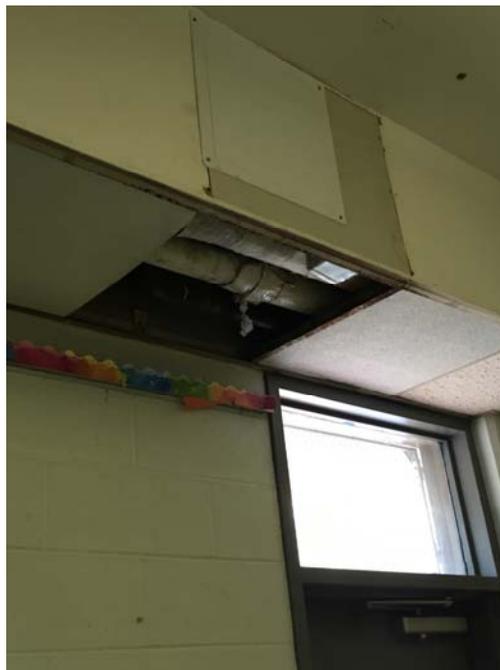
Photo 4 – Kindergarten Room 1  
A missing ceiling tile and condensate was dripping from the ceiling. Wet fiberglass pipe insulation was observed above the suspended ceiling.

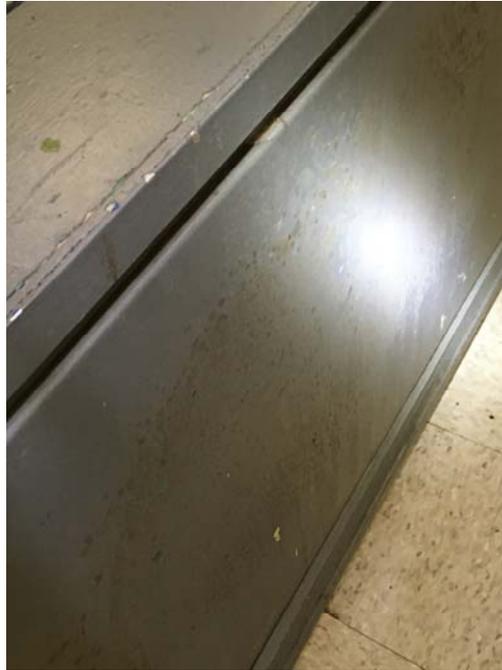
Photo 5 – Kindergarten Room 1  
Mold growth was observed on the unit ventilator.

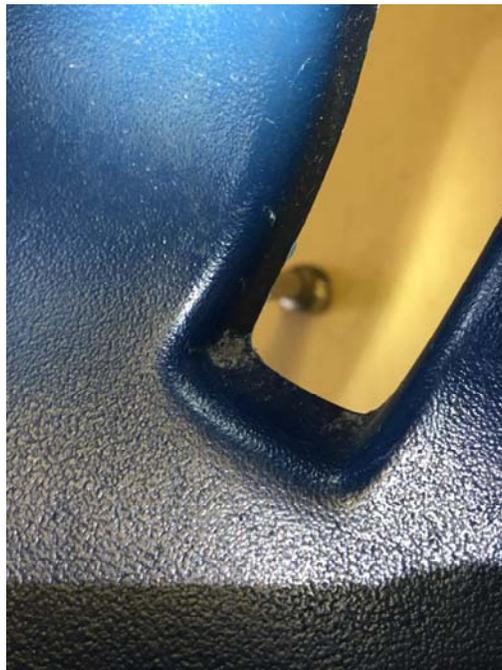
Photo 6 – Kindergarten Room 1  
Mold growth was observed on some of the plastic chairs.

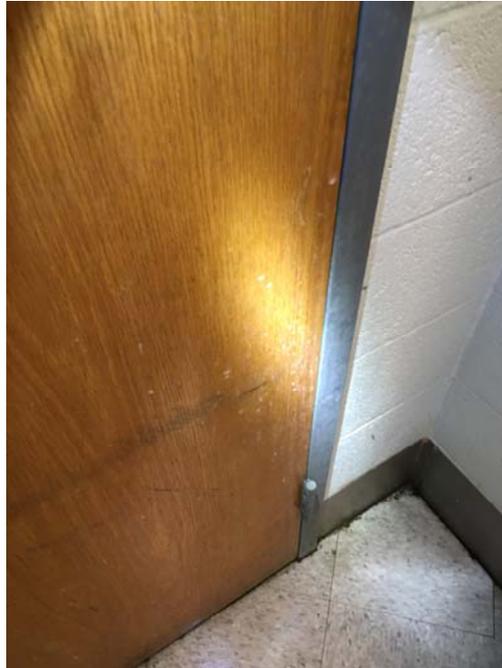
Photo 7 – Kindergarten Room 1  
Mold growth was observed on the wooden door and metal frame.

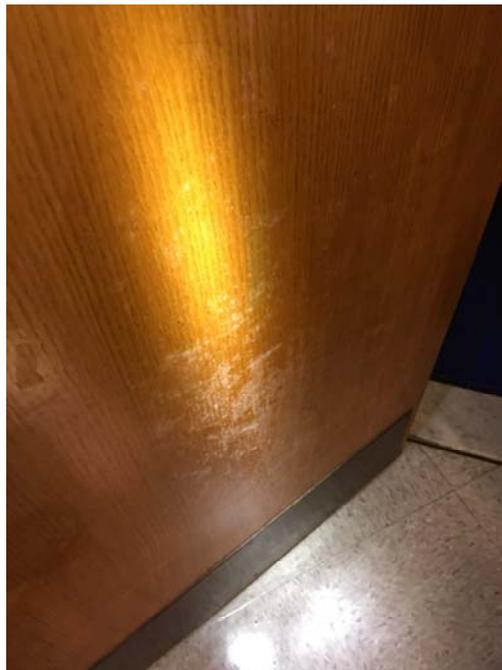
Photo 8 – Kindergarten Room 1  
Mold growth was observed on the wooden door and metal frame.

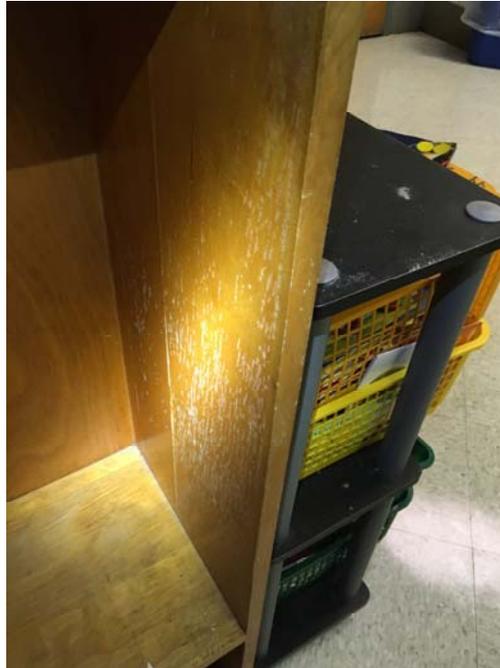
Photo 9 – Kindergarten Room 1  
Mold growth was observed on the wooden built-in cabinetry and coat cubby.

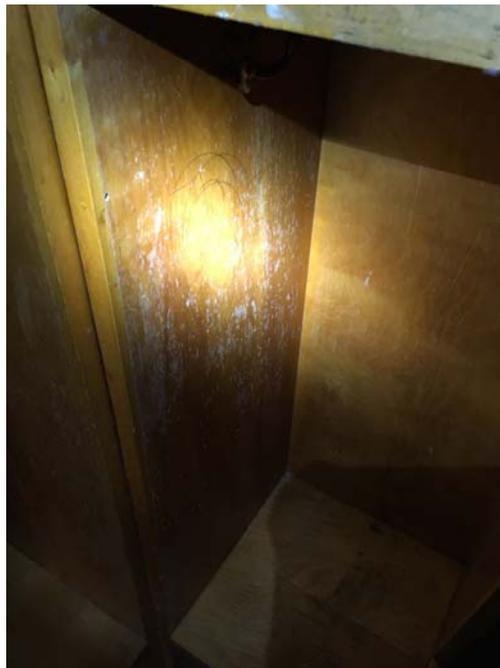
Photo 10 – Kindergarten Room 1  
Mold growth was observed on the wooden built-in cabinetry and coat cubby.

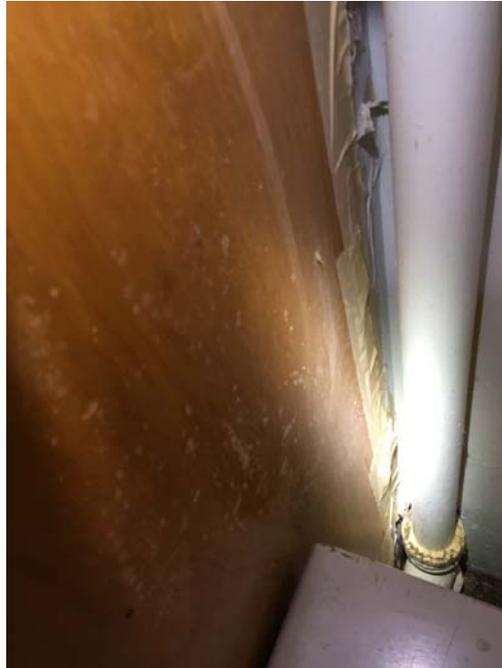
Photo 11– Kindergarten Room 1  
Mold growth was observed on the wooden built-in cabinetry and coat cubby.

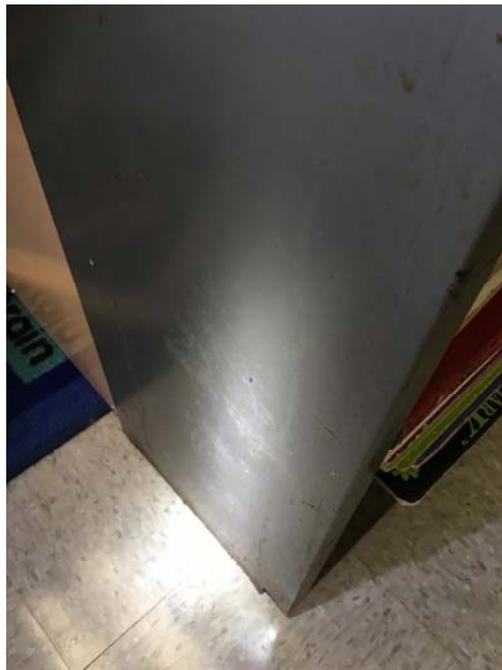
Photo 12 – Kindergarten Room 1  
Mold growth was observed on the metal storage cabinet.

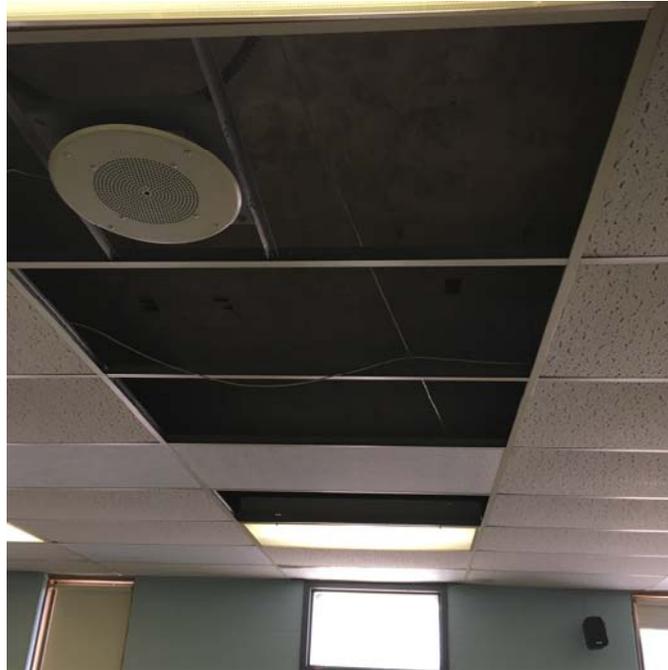
Photo 13 – Kindergarten Room 2  
Missing ceiling tiles were observed.

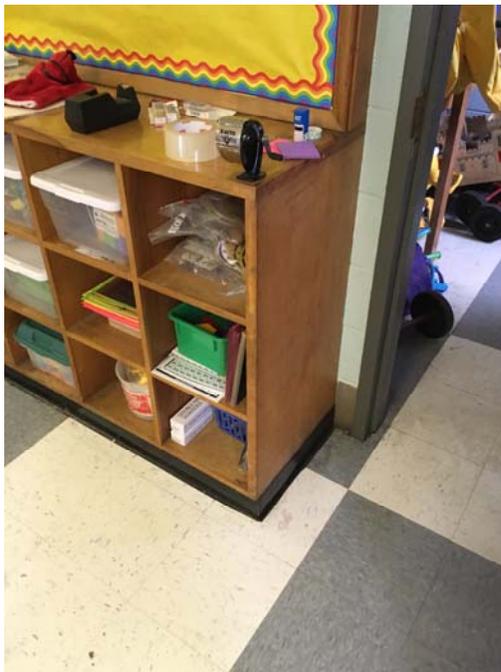
Photo 16 – Kindergarten Room 2

Mold growth was observed on the built-in wooden cabinetry and coat cubby.

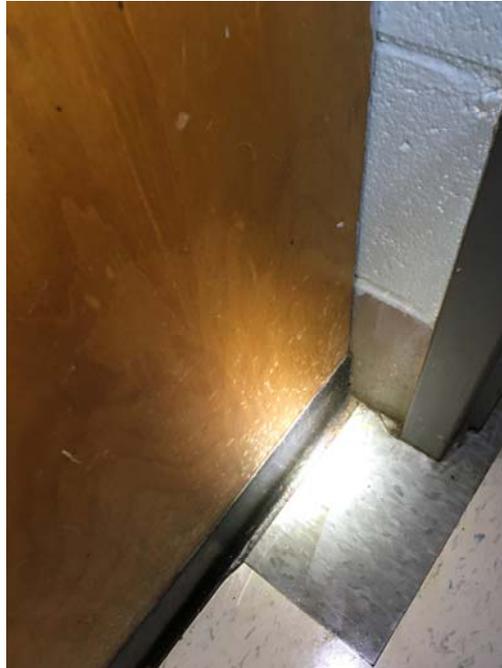
Photo 17 – Kindergarten Room 2  
Mold growth was observed on the built-in wooden cabinetry and coat cubby.

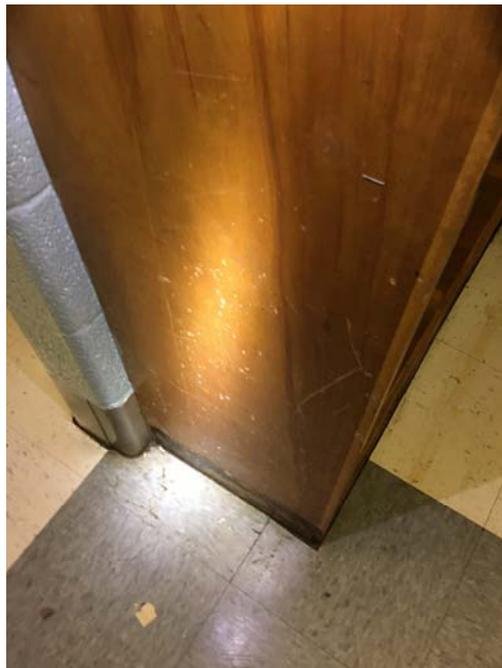
Photo 18 – Kindergarten Room 2  
Mold growth was observed on the built-in wooden cabinetry and coat cubby.

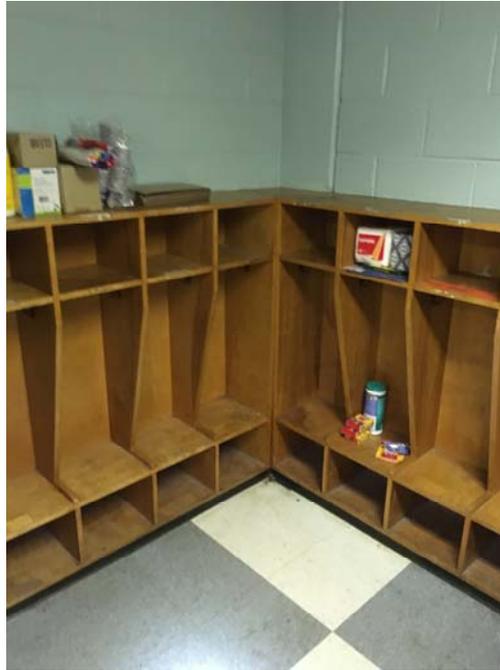
Photo 19 – Kindergarten Room 2  
Mold growth was observed on the built-in wooden cabinetry and coat cubby.

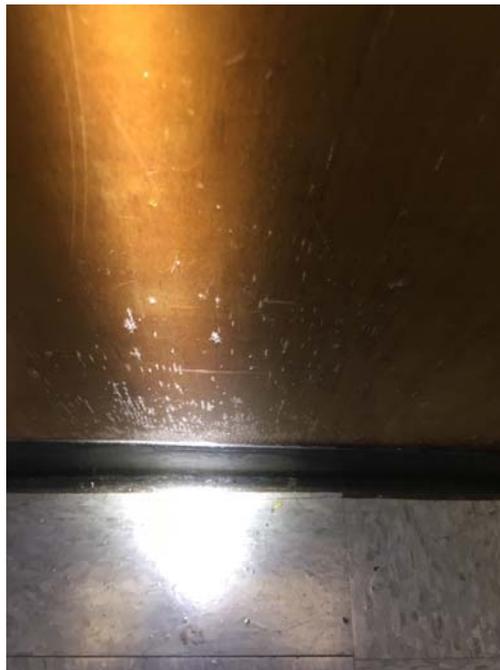
Photo 20 – Kindergarten Room 2  
Mold growth was observed on the built-in wooden cabinetry and coat cubby.

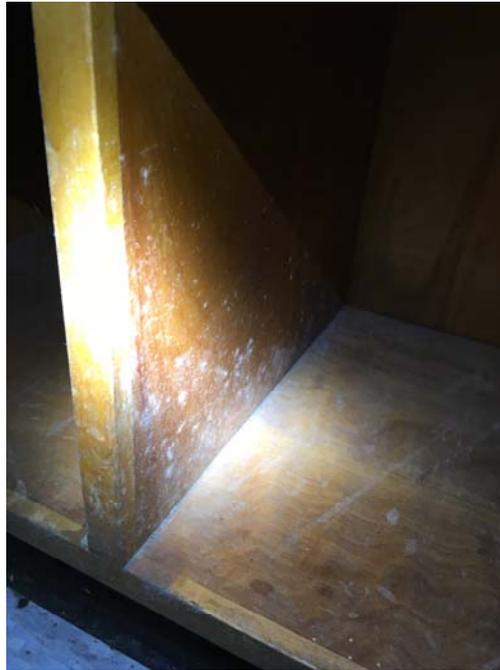
Photo 21 – Kindergarten Room 2  
Mold growth was observed on the built-in wooden cabinetry and coat cubby.

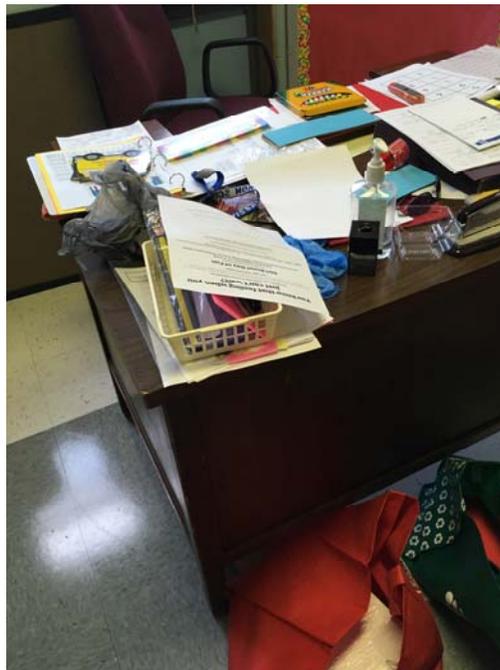
Photo 22 – Kindergarten Room 2  
Mold growth was observed on the teacher's desk.

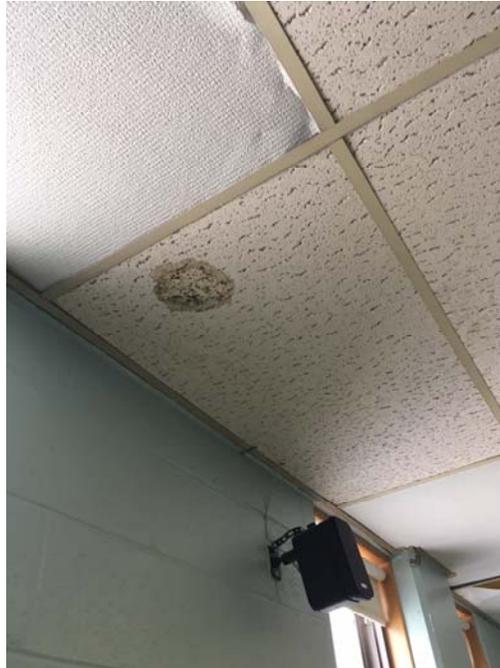
Photo 23 – Kindergarten Room 2  
Mold growth was observed on a ceiling tile.

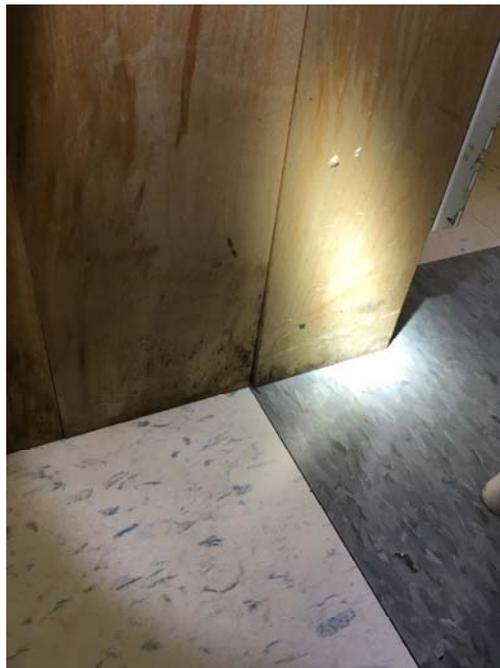
Photo 24 – Kindergarten Room 2  
Mold growth was observed on cabinetry.

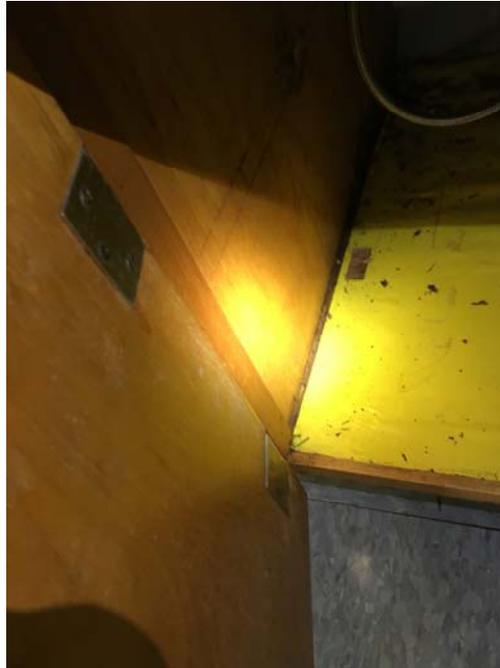
Photo 25 – Kindergarten Room 2  
Mold growth was observed on the sink cabinet.

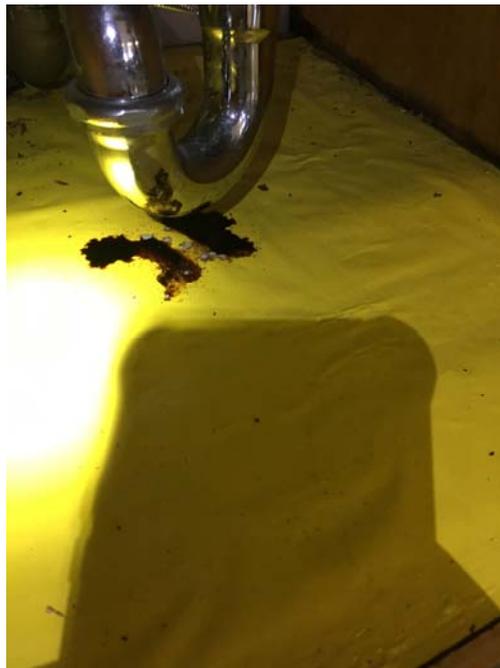
Photo 26 – Kindergarten Room 2  
A leak was observed under the sink.

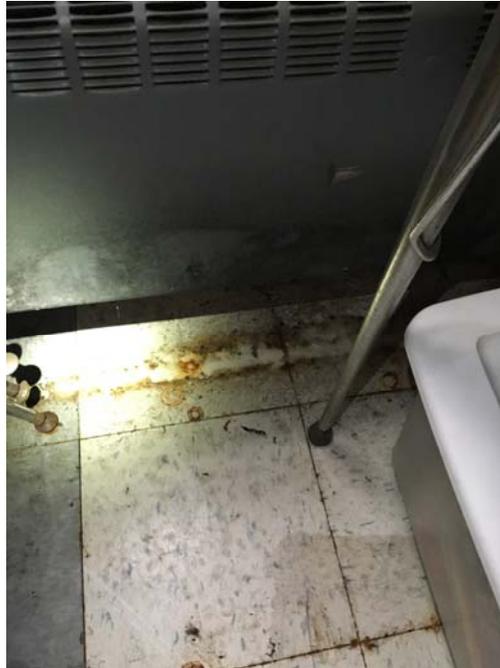
Photo 27 – Kindergarten Room 2 Closet  
Mold growth was observed on the radiator cover and chilled water was passing through the heating convector.

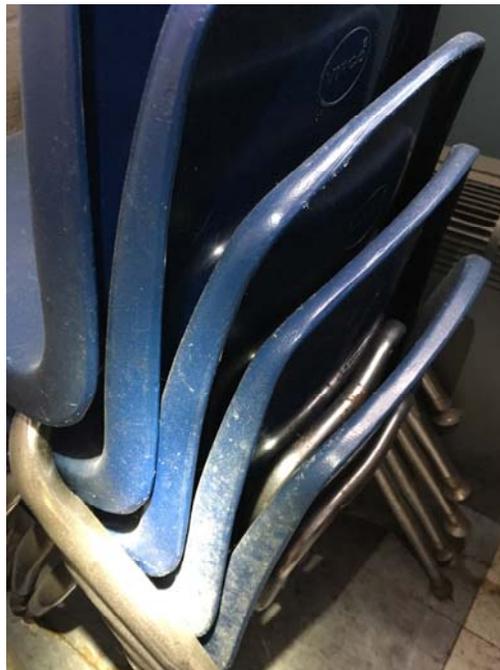
Photo 28 – Kindergarten Room 2 Closet  
Mold growth was observed on the plastic chairs.

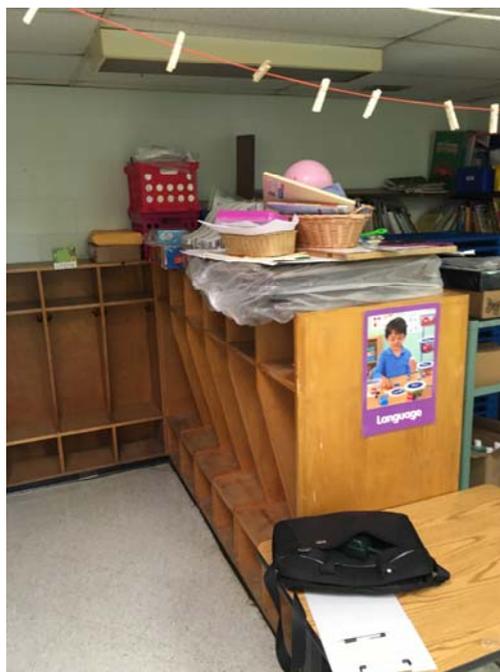
Photo 30 – Kindergarten Room 3

Mold growth was observed on the wooden built-in cabinetry and coat cubby.

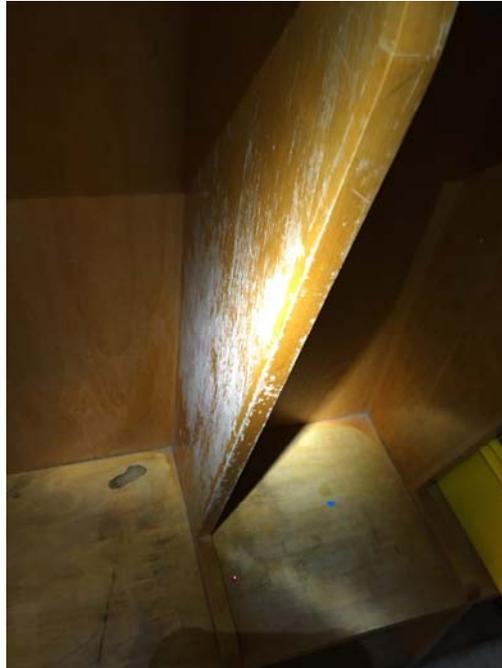
Photo 31 – Kindergarten Room 3  
Mold growth was observed on the wooden built-in cabinetry and coat cubby.

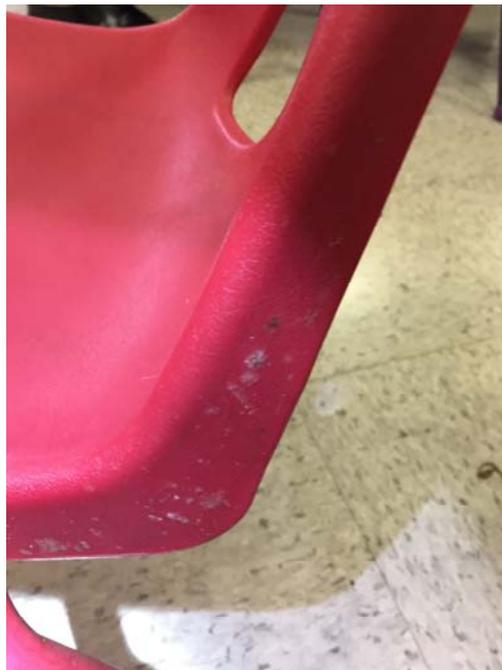
Photo 32 – Kindergarten Room 3  
Mold growth was observed on the plastic chairs.

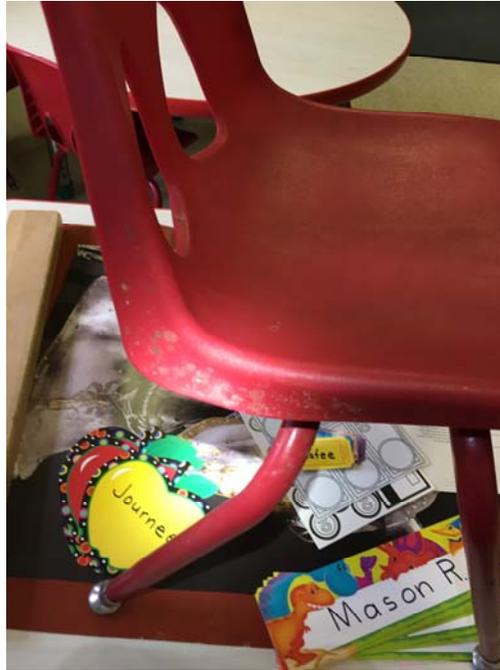
Photo 33 – Kindergarten Room 3  
Mold growth was observed on the plastic chairs.

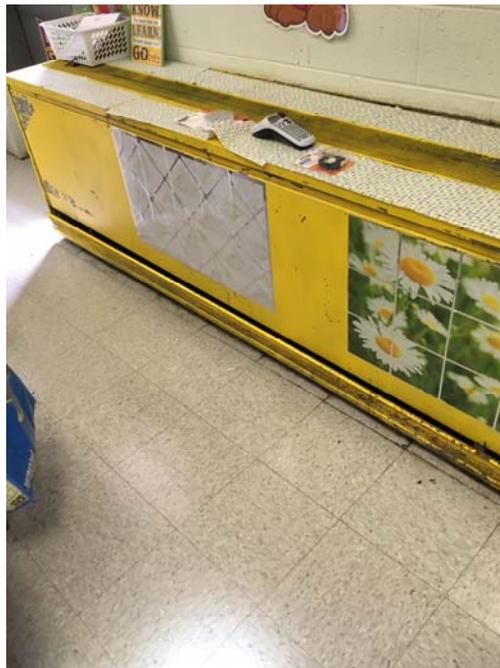
Photo 34 – Kindergarten Room 3  
The return air tray was not seated properly and no air filters were observed inside this unit.

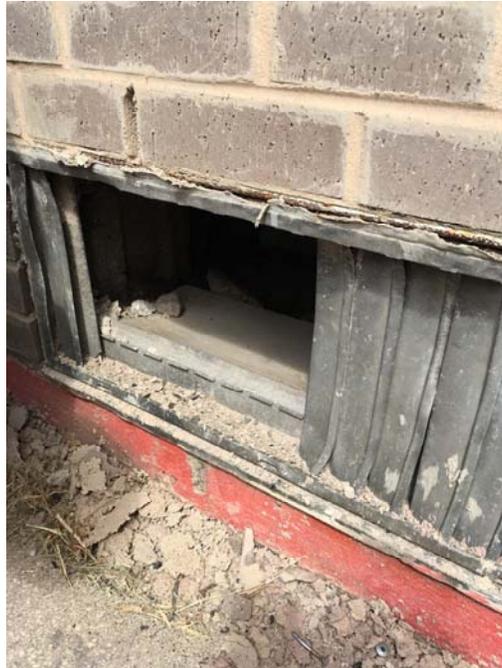
Photo 35 – Kindergarten Room 3  
Outdoor air intake open to the interior from construction activity.

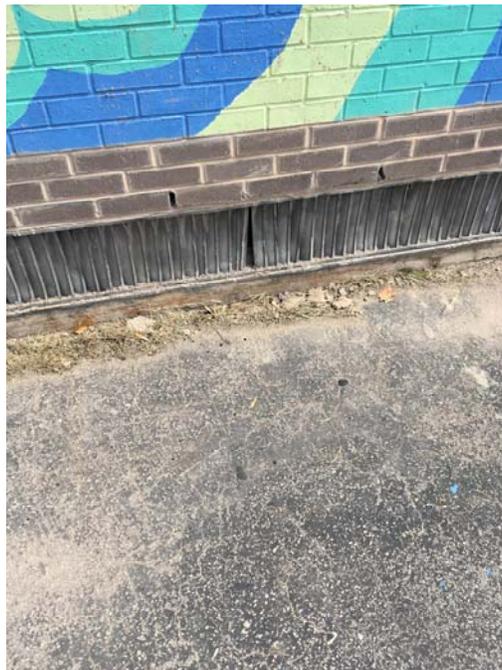
Photo 36 – Kindergarten Room 3  
During the construction activity classrooms were exposed to outdoor air for periods of time during evaluation of the lintel and replacement of the brick.

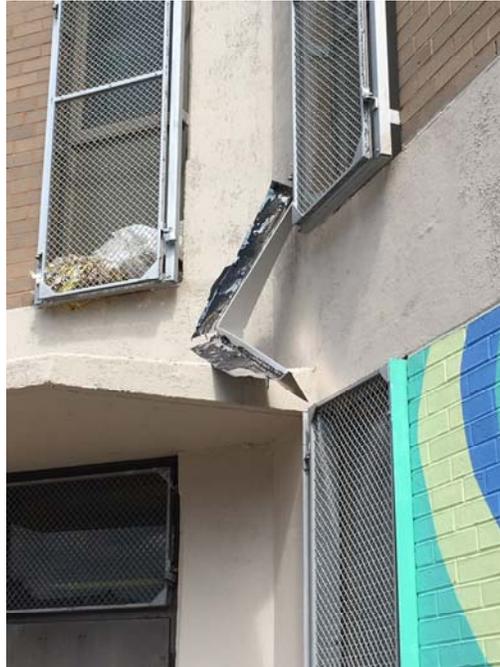
Photo 38 – Kindergarten Room 3

A piece of flashing was hanging above the Kindergarten doorway.

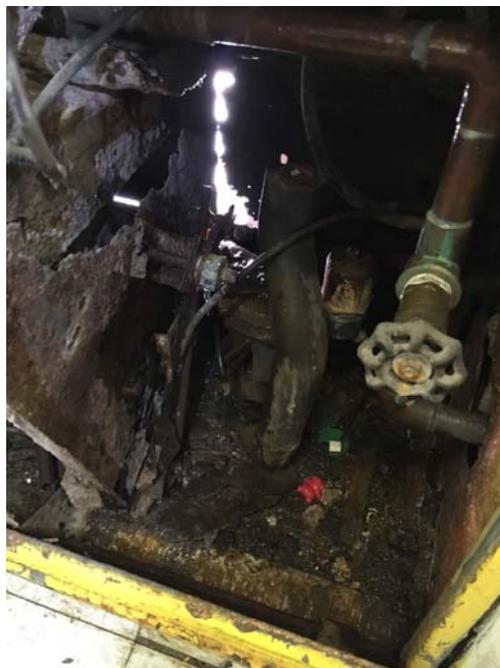
Photo 39 – Kindergarten Room 3

Daylight visible through the back of the unit ventilator.

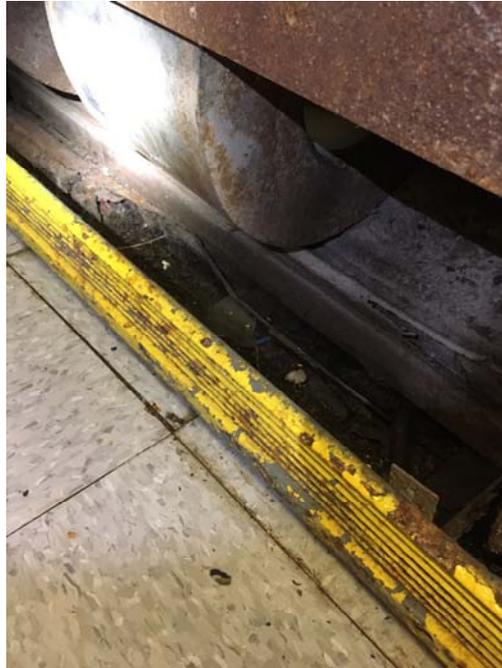
Photo 40 – Kindergarten Room 3  
No air filters were observed in this unit.

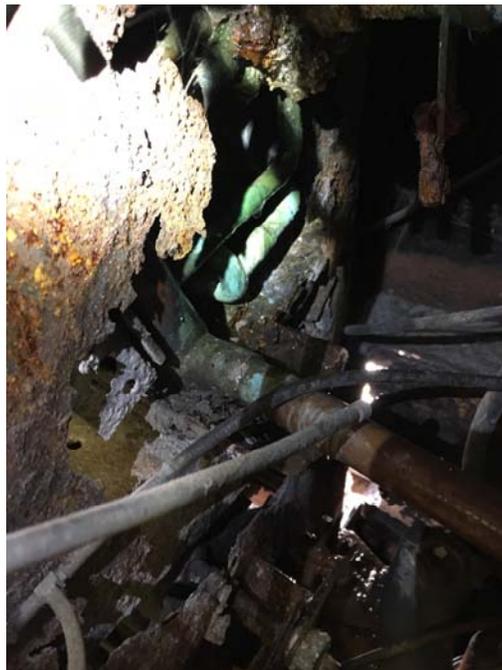
Photo 41 – Kindergarten Room 3  
The condensate drip pan was missing. Condensate was dripping on the floor.

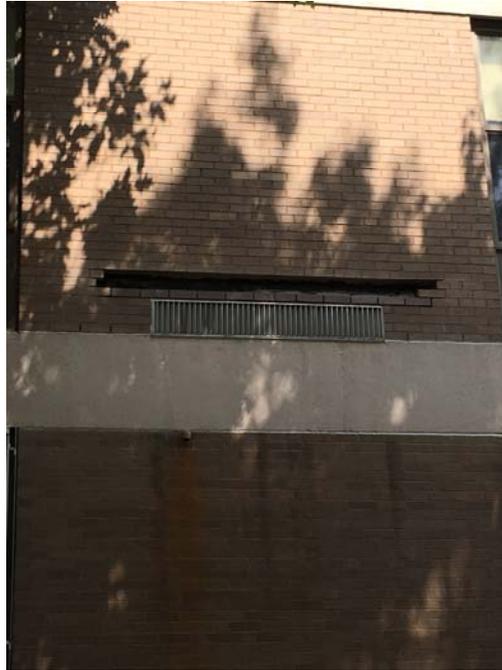
Photo 42 – Front of Building  
Construction activity in progress
