Cook Wissahickon Elementary School
Photographs taken: September 9, 2016 and September 12, 2016

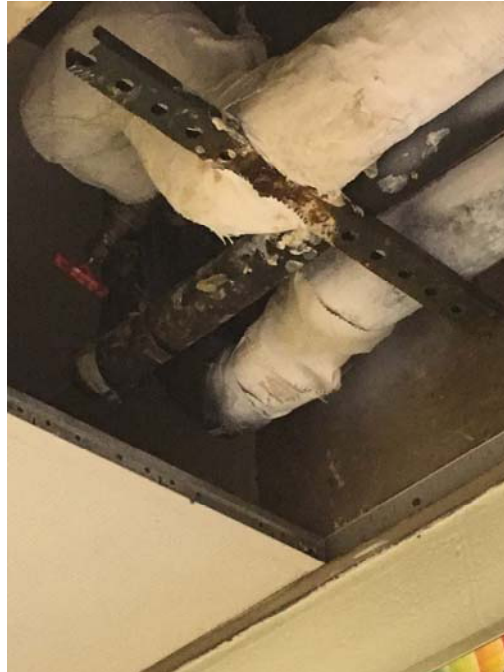
Photo 1 – Room 105
Condensation was leaking from the ceiling and a ceiling tile was missing.

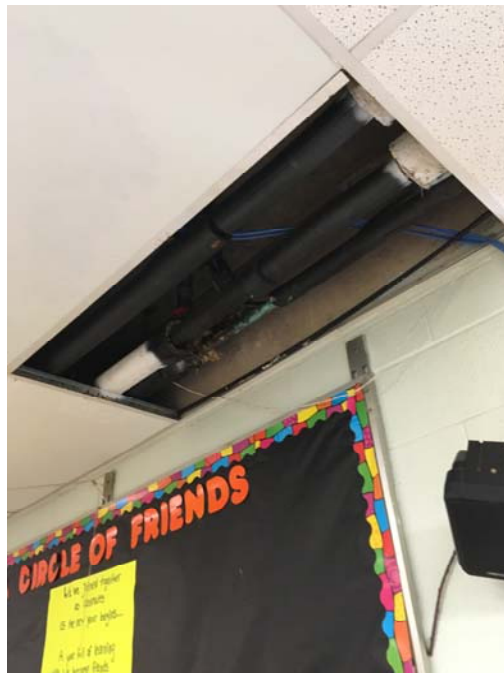
Photo 2 – Room 106
Condensation was leaking from the ceiling and a ceiling tile was missing.

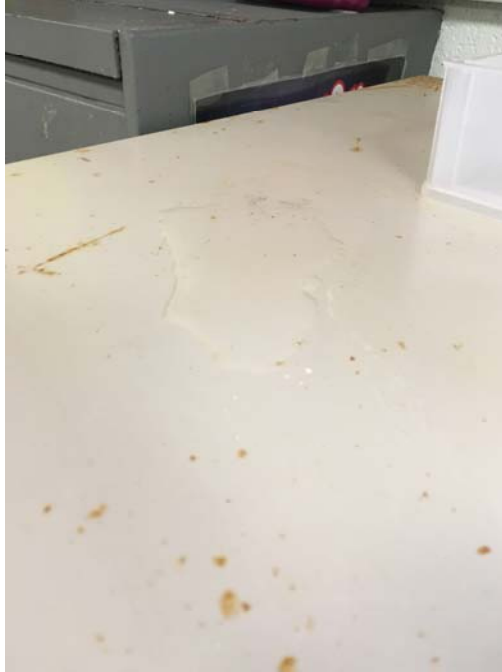
Photo 3 – Room 106
Water was noted on the file cabinet from the condensation leak.

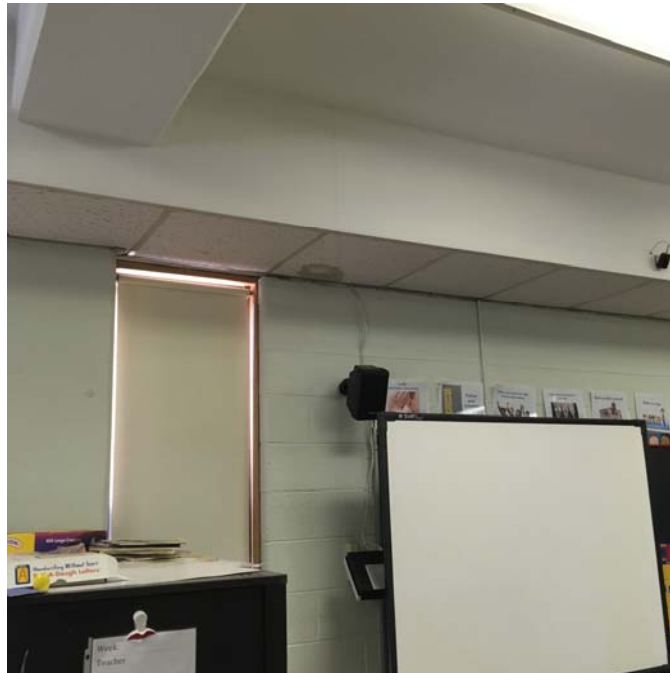
Photo 4 – Room 108
A water stained ceiling tile was observed.

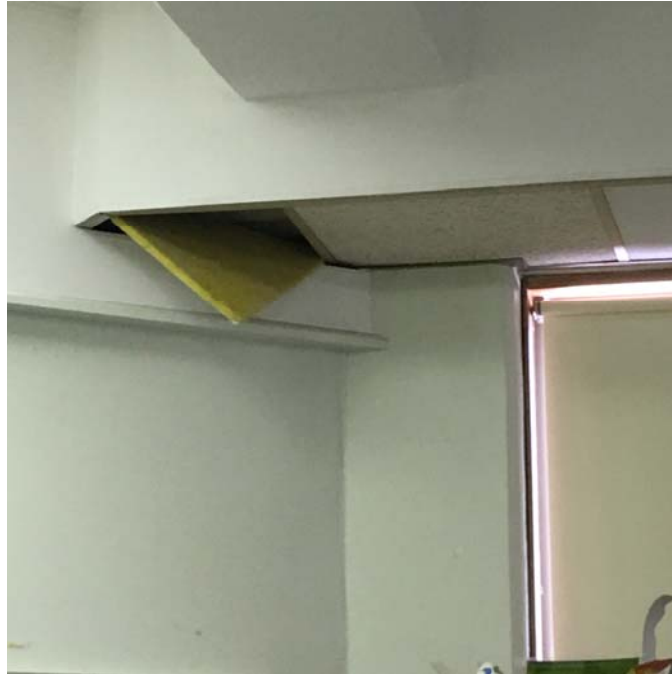
Photo 5 – Room 108
A ceiling tile fell in the corner.

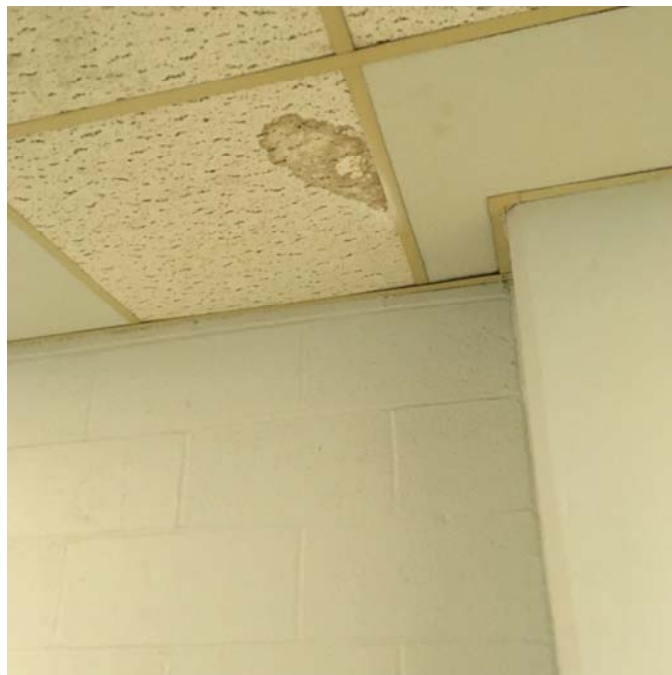
Photo 6 –Room 105
A water stained ceiling tile was observed.

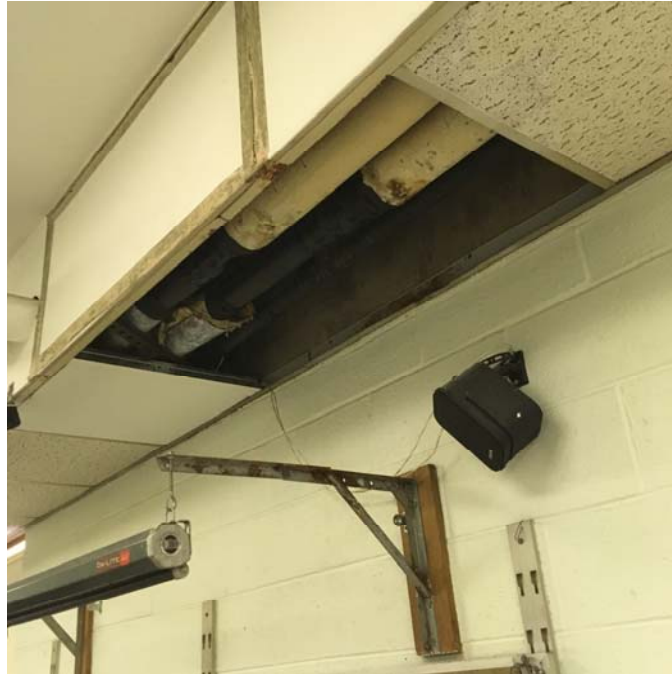
Photo 7 – Room 110

Condensation was leaking from the ceiling and a missing ceiling tile was observed.

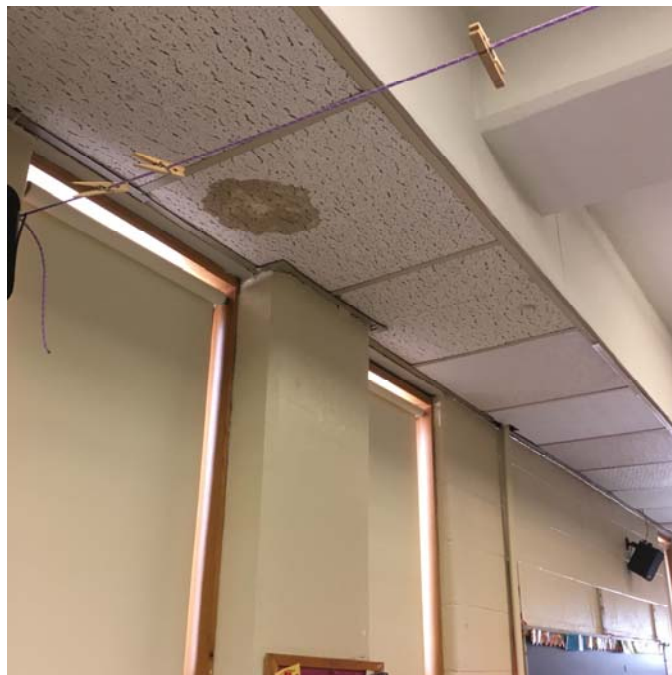
Photo 8 – Room 111

A water stained ceiling tile was observed.

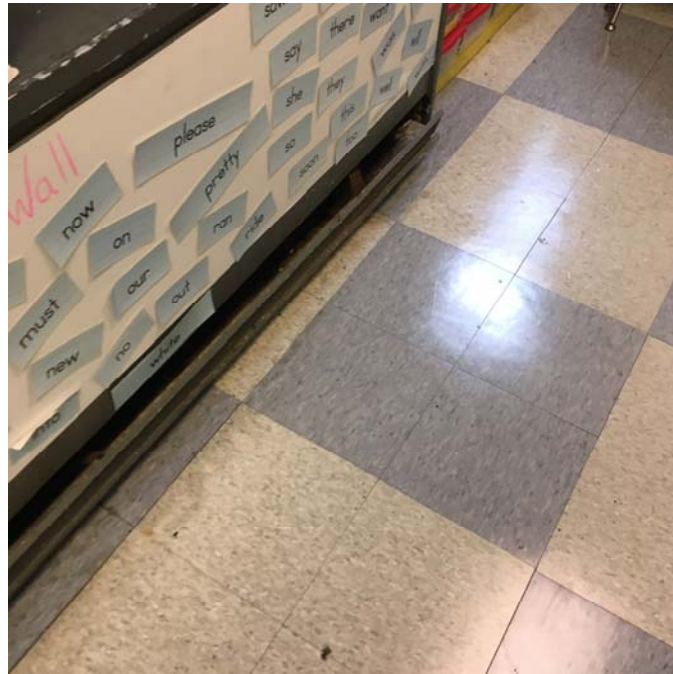
Photo 9 – Room 111
The return air filter tray was not seated properly.

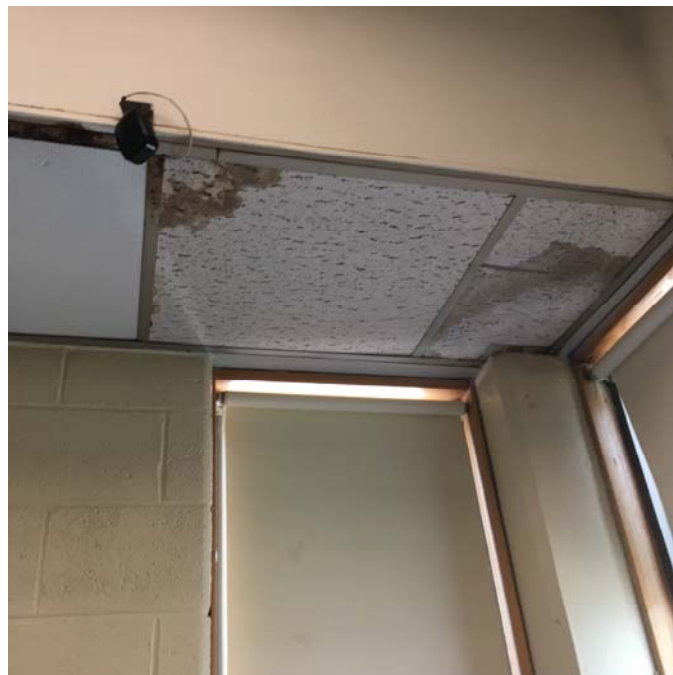
Photo 10 – Room 111
Water stained ceiling tiles were observed.

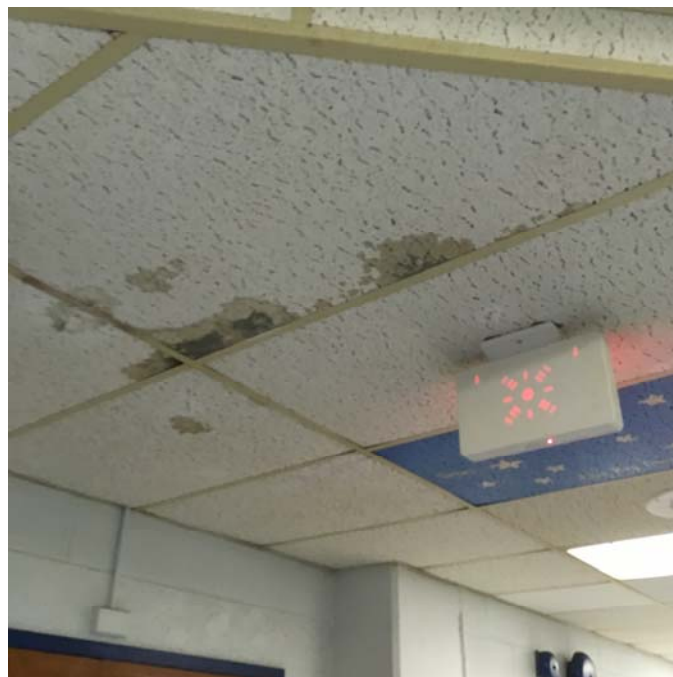
Photo 12 -Basement Hallway
Water stained and moldy ceiling tiles were observed.

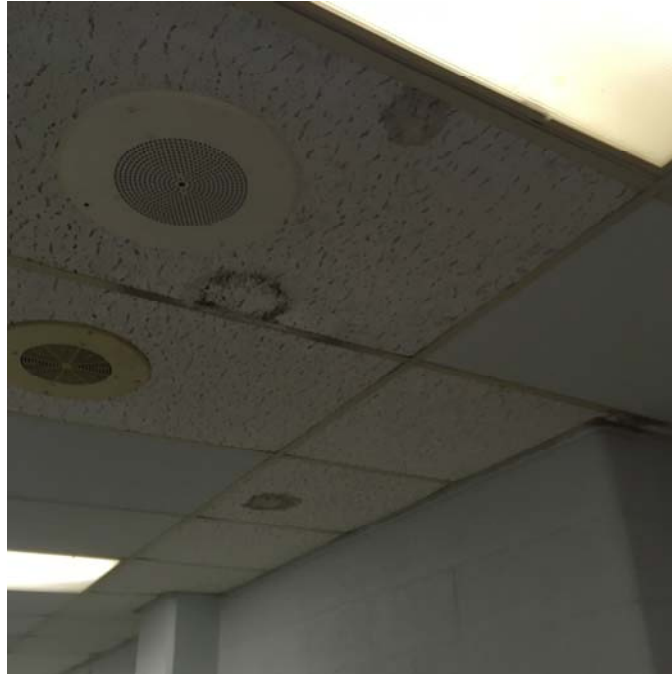
Photo 13 – Basement Hallway
Water stained and moldy ceiling tiles were observed.

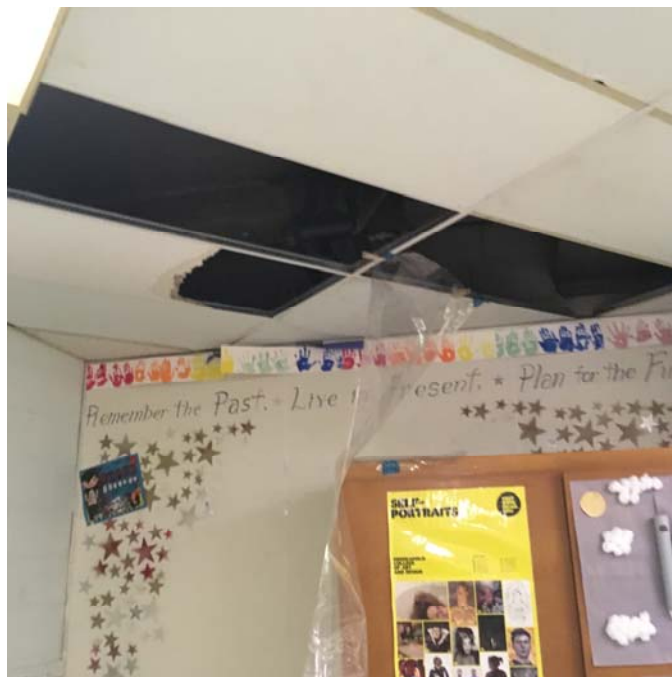
Photo 16 – Art Room 6
Condensation was leaking from the ceiling.

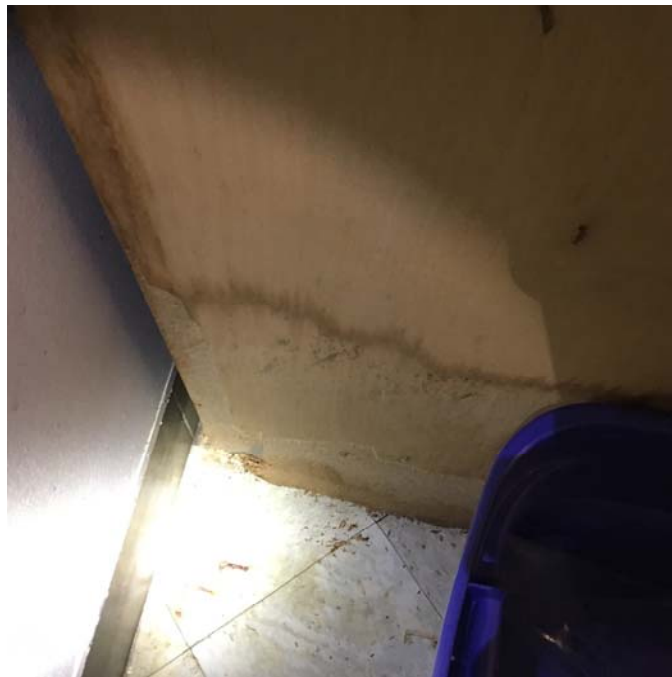
Photo 18 – Art Room 6
Mold growth was observed on the wooden cabinetry.

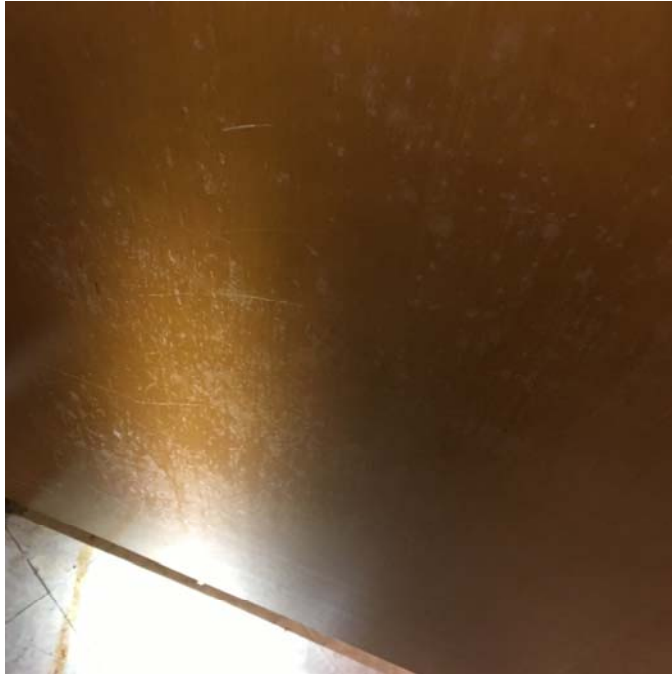
Photo 19 – Art Room 6
Mold growth was observed on the wooden cabinetry.

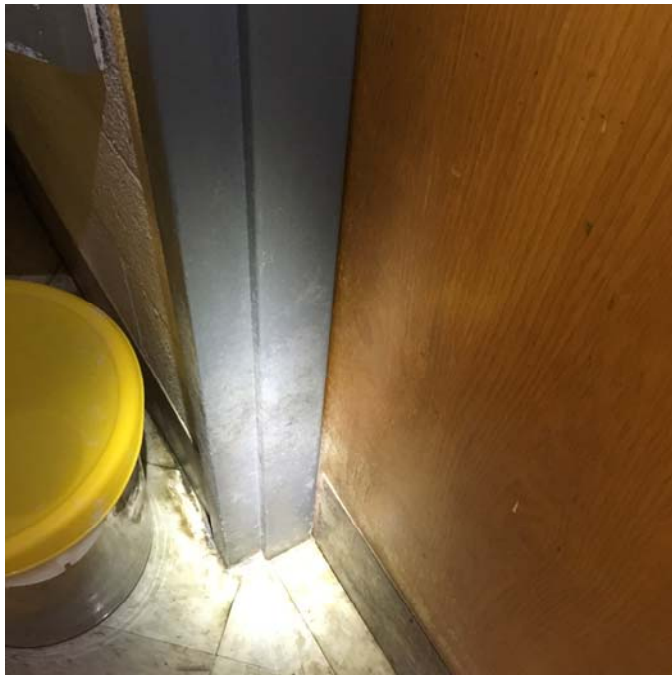
Photo 20 – Art Room 6
Mold growth was observed on the wooden doors and metal frames.

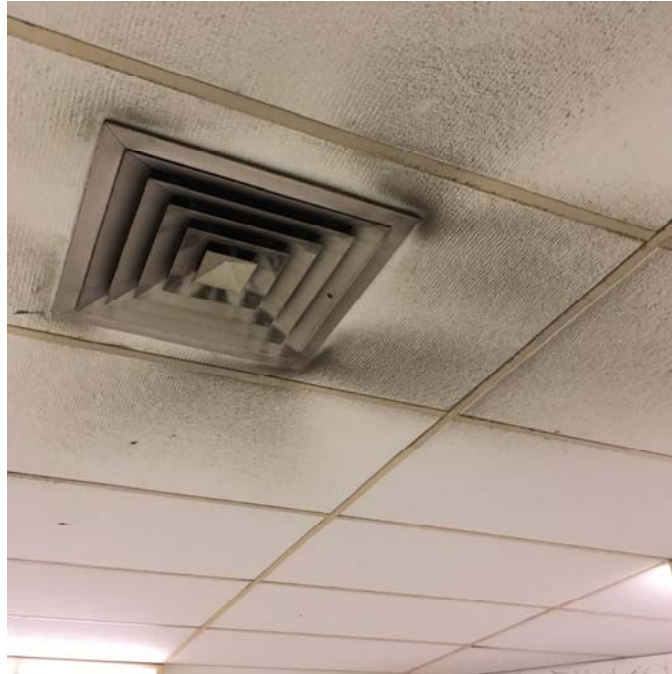
Photo 21 – Art Room 6
Particulate accumulation was observed on the supply diffuser and ceiling tiles.

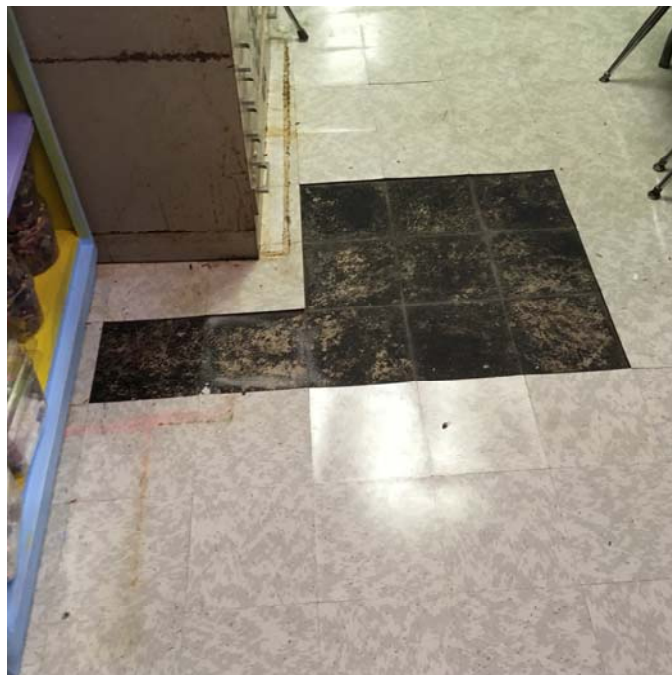
Photo 22 – Art Room 6
Delaminated 9"x9" floor tile was observed.

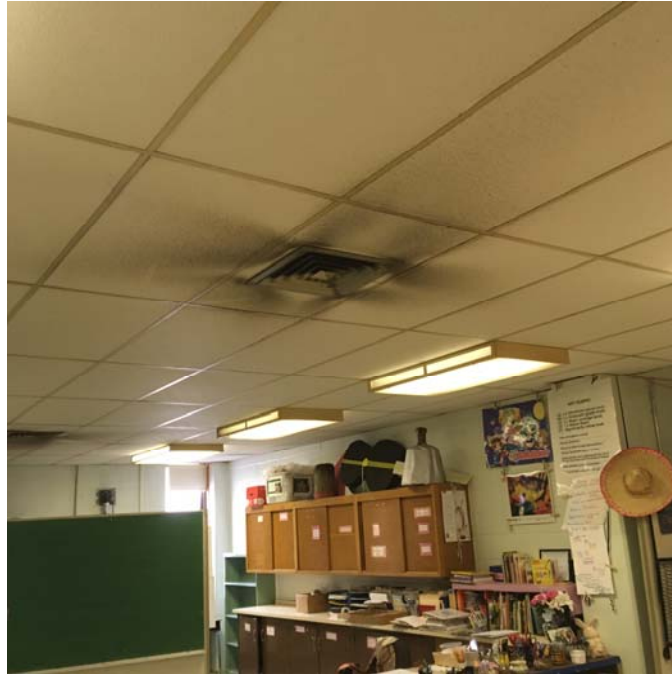
Photo 23 – Art Room 6
Particulate accumulation was observed on the supply diffusers and ceiling tiles.

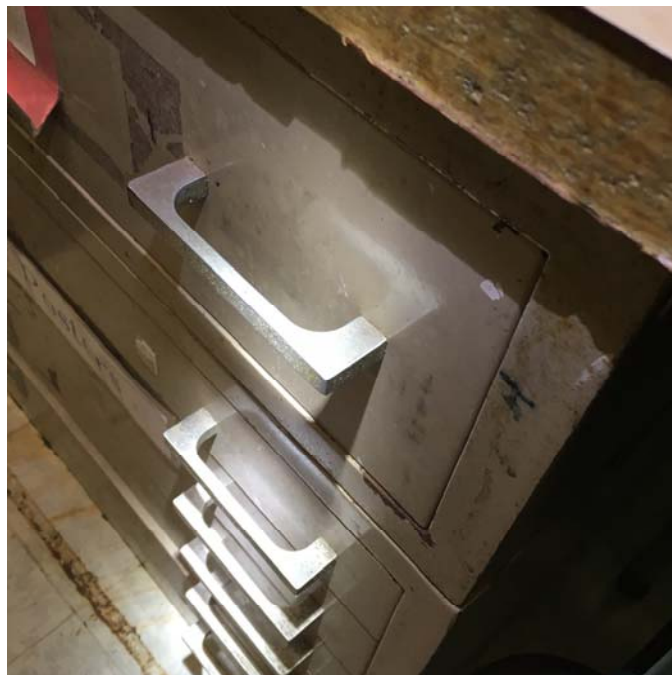
Photo 24 – Art Room 6
Mold growth was observed on the metal cabinetry.

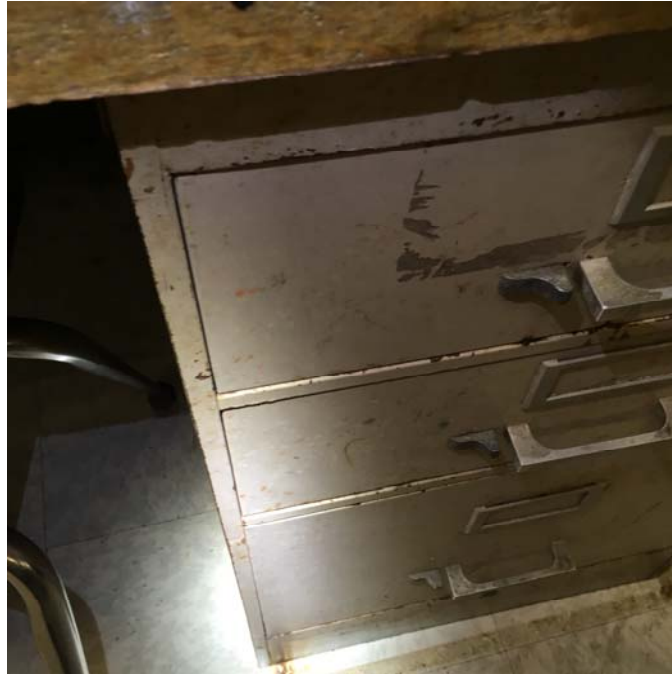
Photo 25 – Art Room 6
Mold growth was observed on the metal cabinetry.

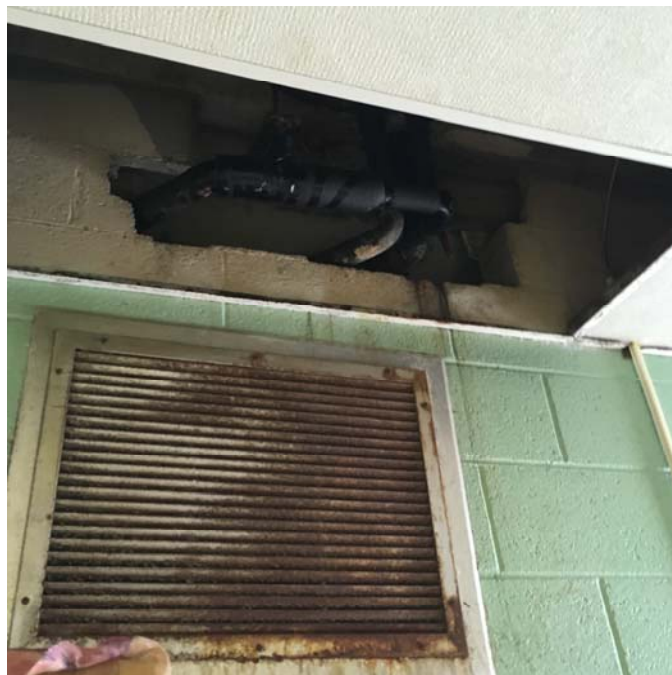
Photo 26 – Art Room 6
Condensation was leaking from the ceiling.

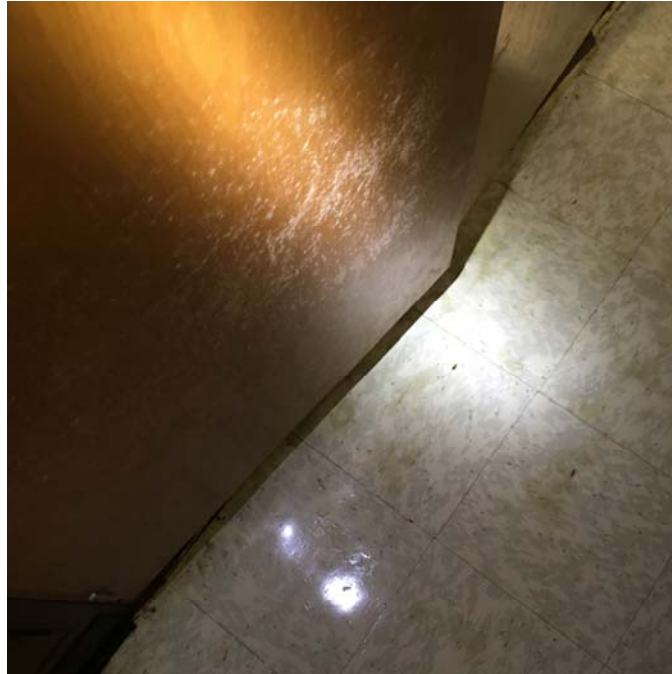
Photo 27 – Art Room 6
Mold growth was observed on the wooden cabinetry.

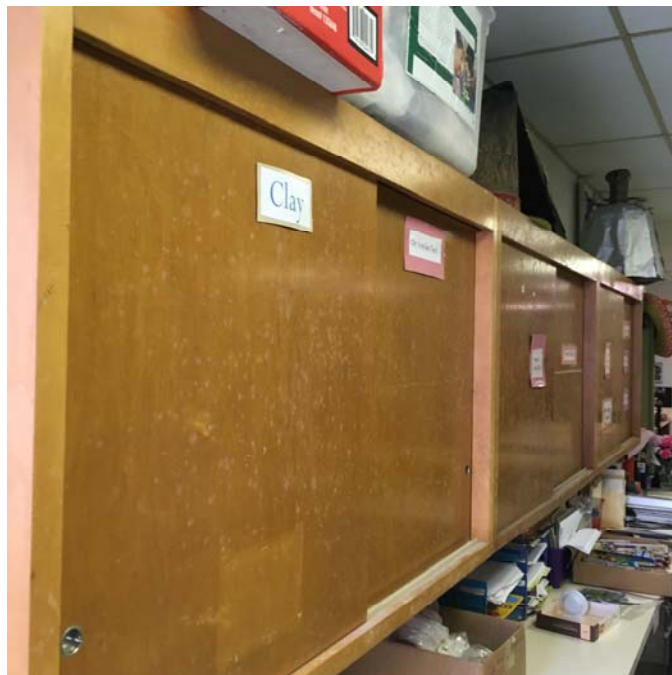
Photo 28 – Art Room 6
Mold growth was observed on the wooden cabinetry.

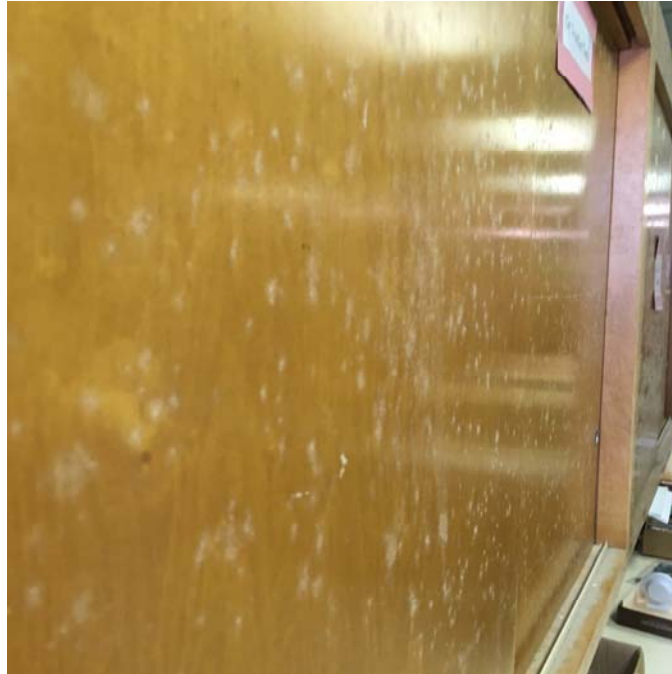
Photo 29 – Art Room 6
Mold growth was observed on the wooden cabinetry.

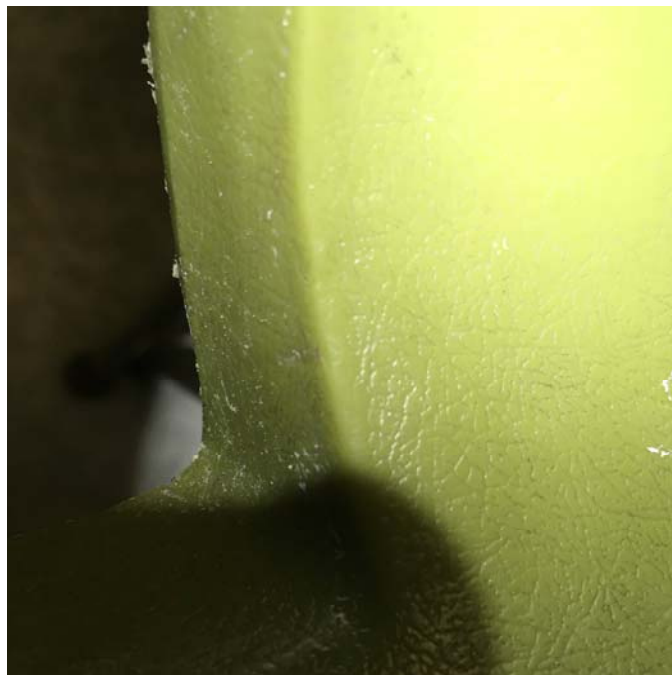
Photo 30 – Art Room 6
Mold growth was observed on the plastic chairs.

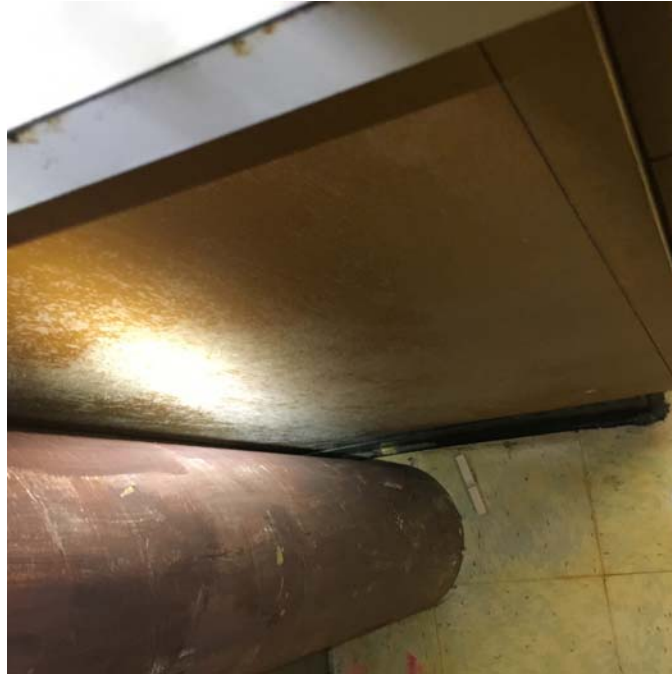
Photo 31 – Art Room 6
Mold growth was observed on the wooden cabinetry.

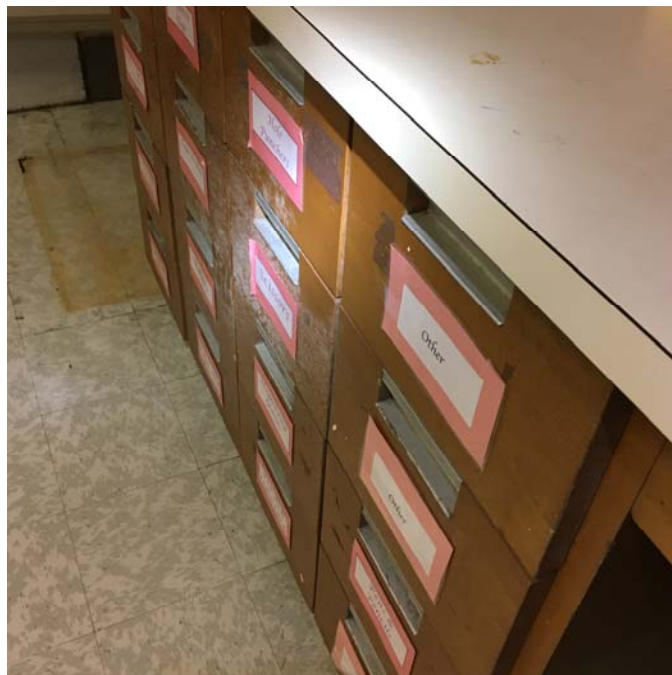
Photo 32 – Art Room 6
Mold growth was observed on the wooden cabinetry.

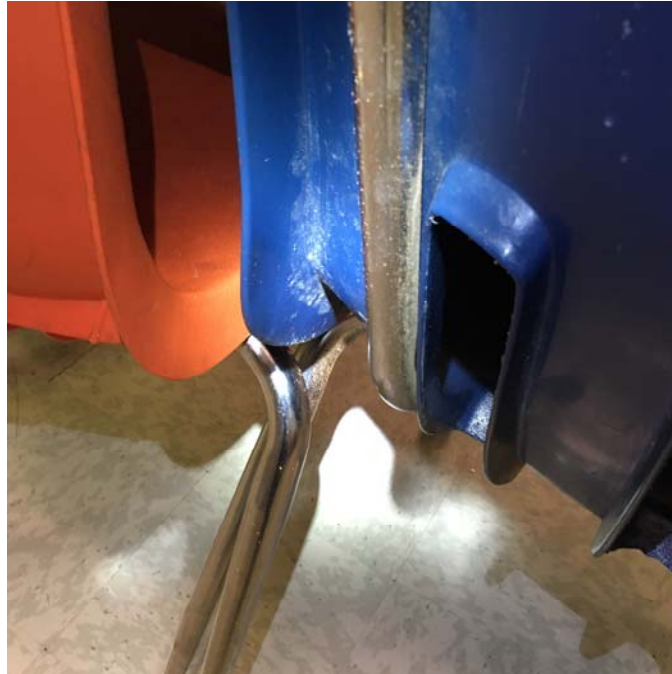
Photo 33 – Art Room 6
Mold growth was observed on the plastic chairs.

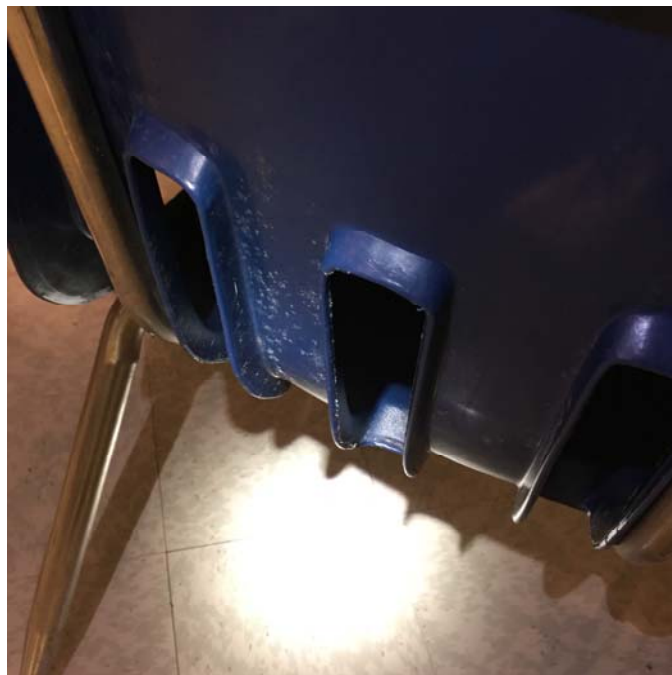
Photo 34 – Art Room 6
Mold growth was observed on the plastic chairs.

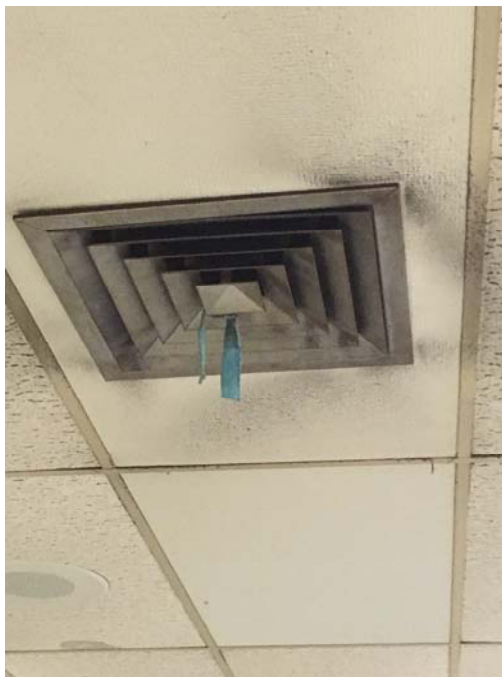
Photo 36 – Music Room 5

Particulate accumulation was observed on the supply diffusers and ceiling tiles.

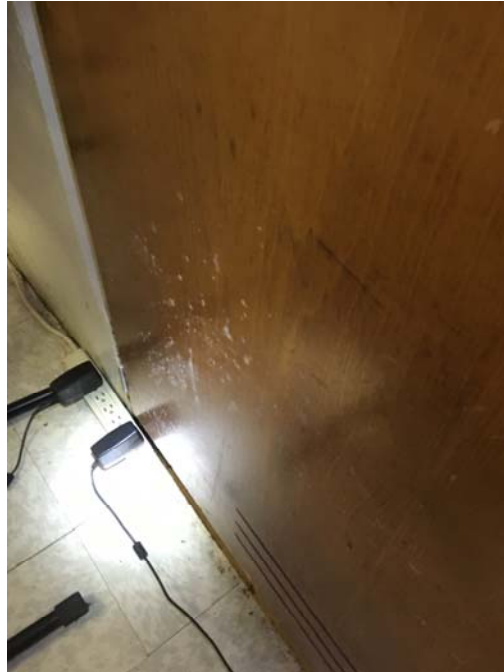
Photo 37 – Music Room 5
Mold growth was observed on the wooden cabinetry.

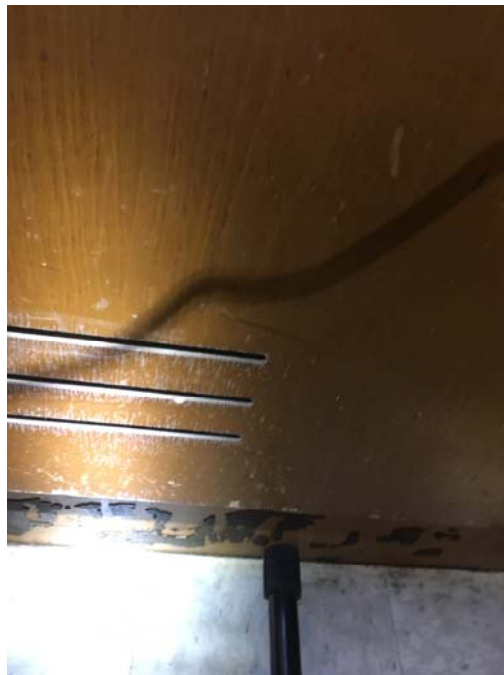
Photo 38 – Music Room 5
Mold growth was observed on the wooden cabinetry.

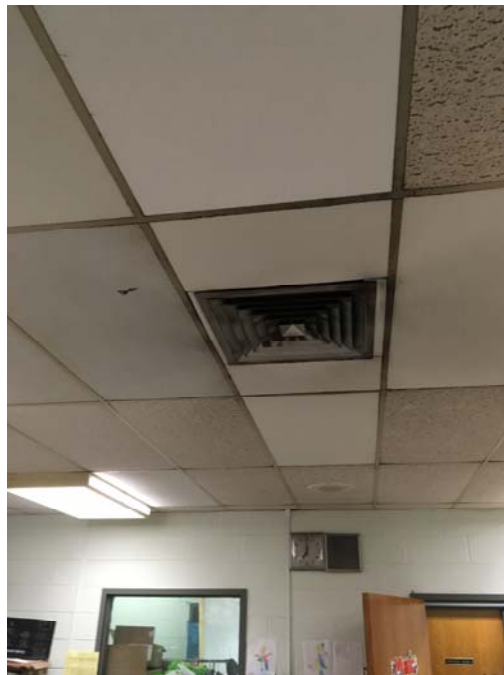
Photo 40 – Instrumental Room

Particulate accumulation was observed on the supply diffusers and ceiling tiles.

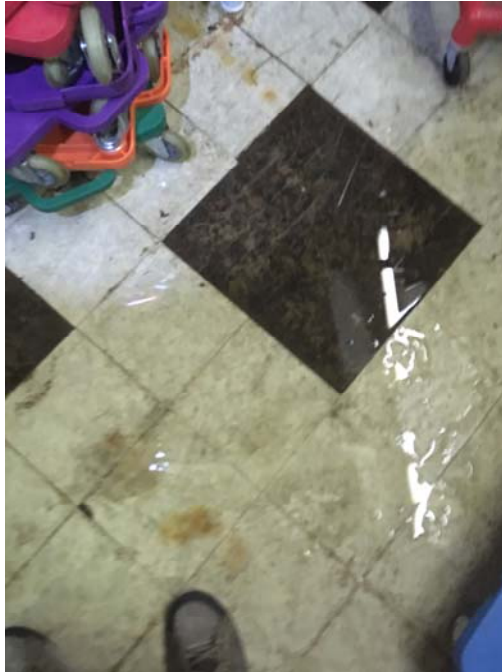
Photo 41- Music Suite Air Handler Room
Standing water was observed on the floor and delaminated 9"x9" floor tile was observed.

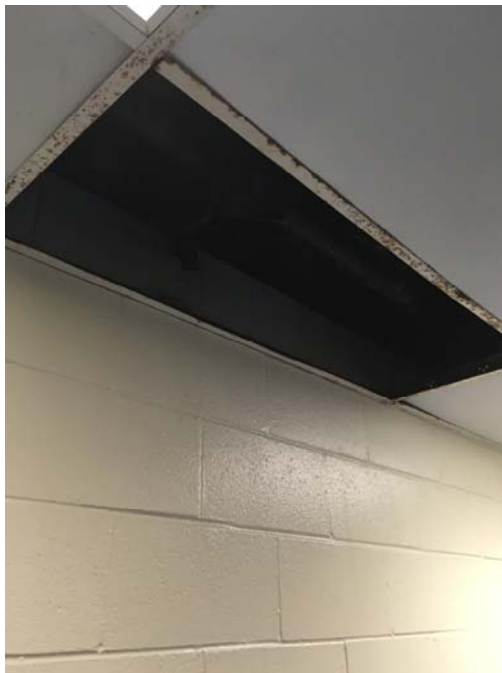
Photo 42- Gym Boy's Room
A missing ceiling tile was observed and condensate appeared to be leaking from a pipe.

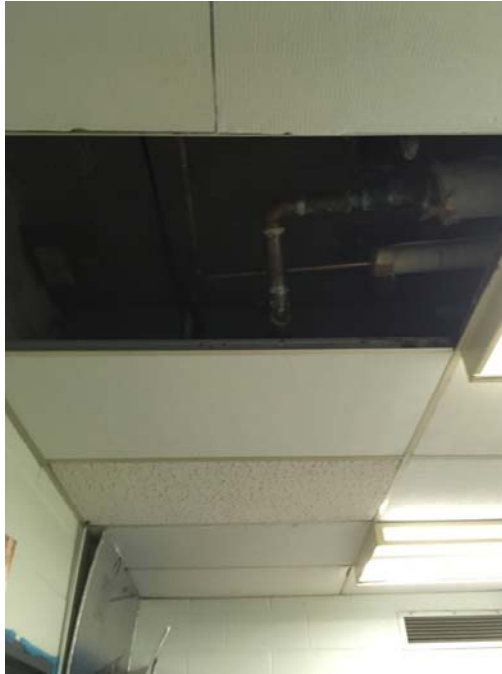
Photo 43- Practice Room A
A missing ceiling was noted, no signs of active leaks were observed.

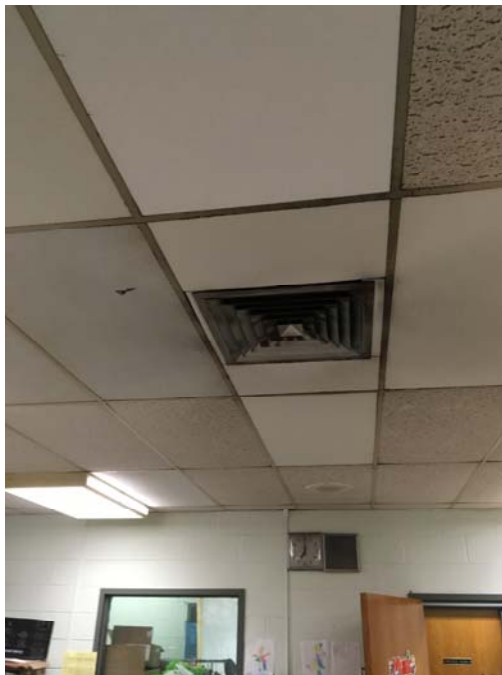
Photo 44- Instrumental Room
Particulate accumulation was observed on the supply diffusers.

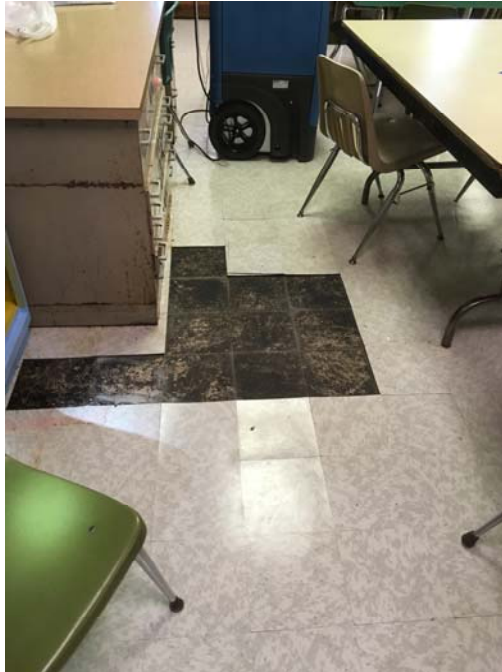
Photo 44- Art Room
A section of delaminated floor tile was observed.

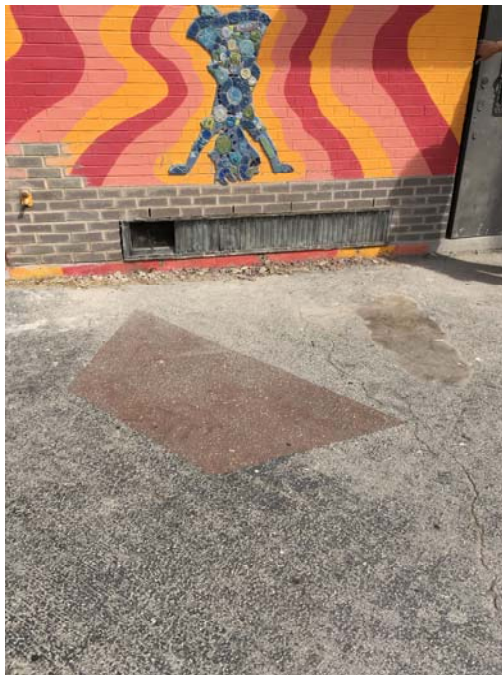
Photo 45- Exposed intake grille

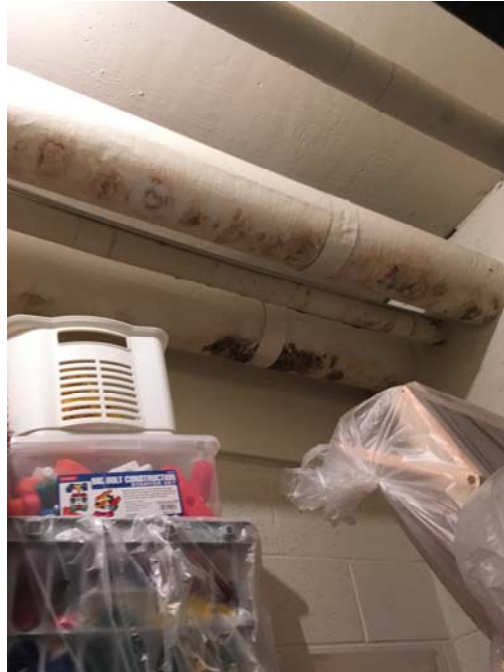
Photo 46- Room 1 closet
Mold growth was observed fiberglass pipe insulation.

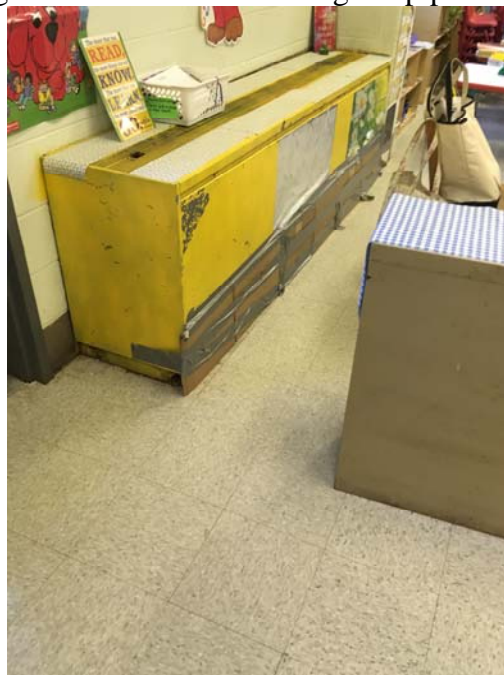
Photo 47- Room 1
The back of the cabinet is rotted allowing outdoor air into the room.

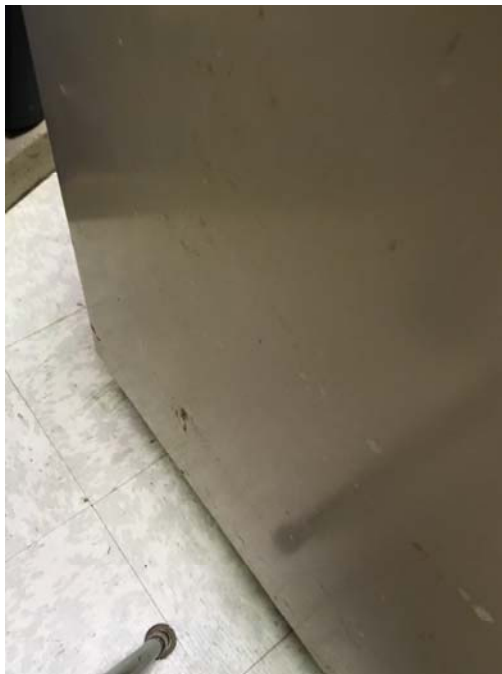
Photo 49- Music Office
Mold growth was observed on the metal desk.

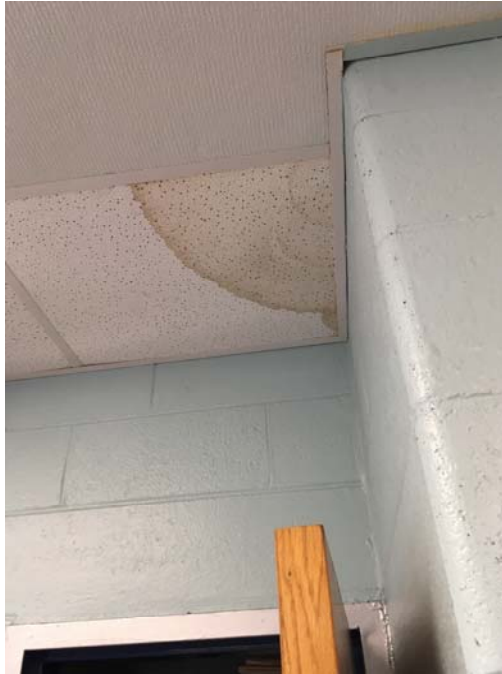
Photo 50- Room 211
A water stained ceiling tile was observed next to the closet.

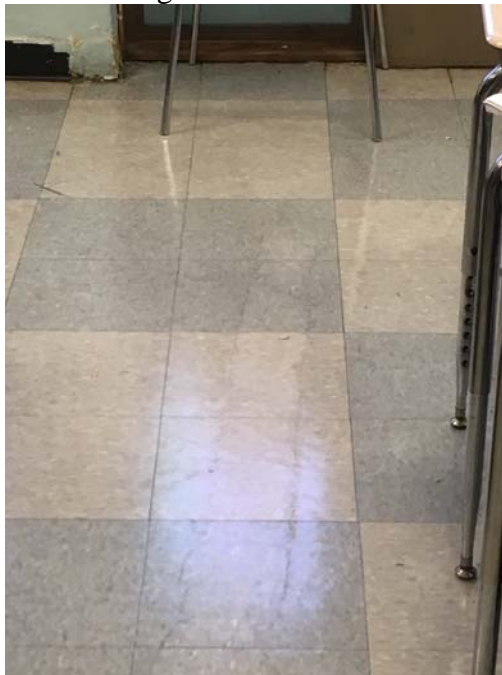
Photo 51- Room 211
A water stain trail appeared to be coming from the window. The occupant reported water intrusion on the floor during heavy rain.

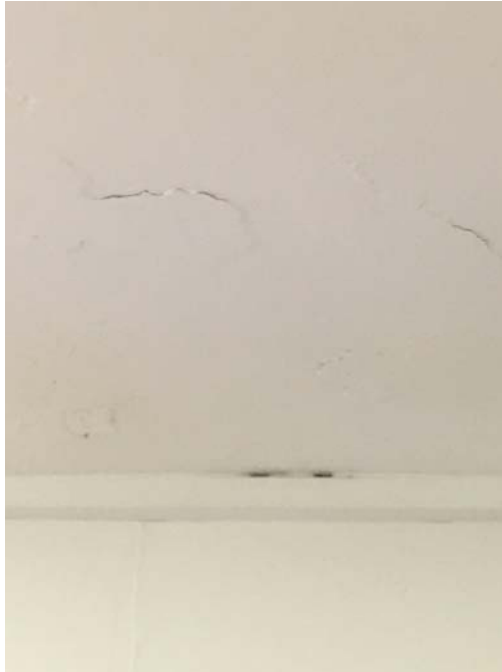
Photo 52- Room 210
Small delaminated sections of the concrete ceiling were observed.
