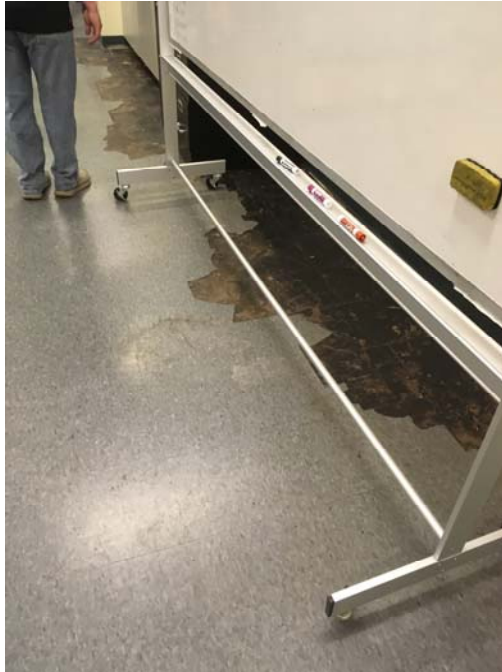
Photo 1 – Room 102

A missing section of floor tile was observed in front of the unit ventilator.

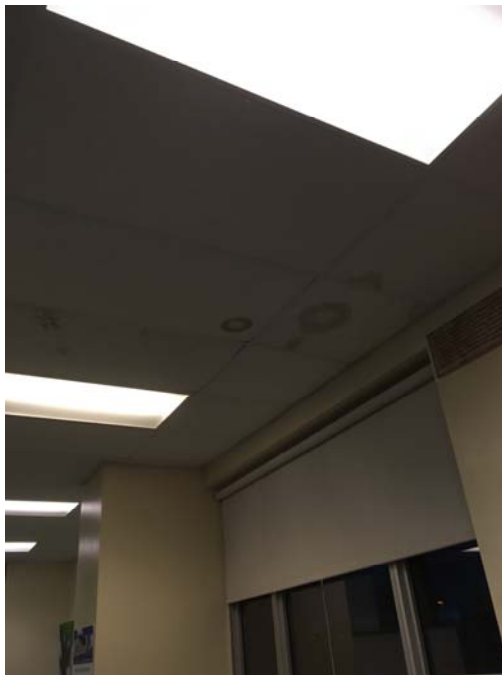
Photo 2 – Room 102

Water stained ceiling tiles were observed above the unit ventilator.

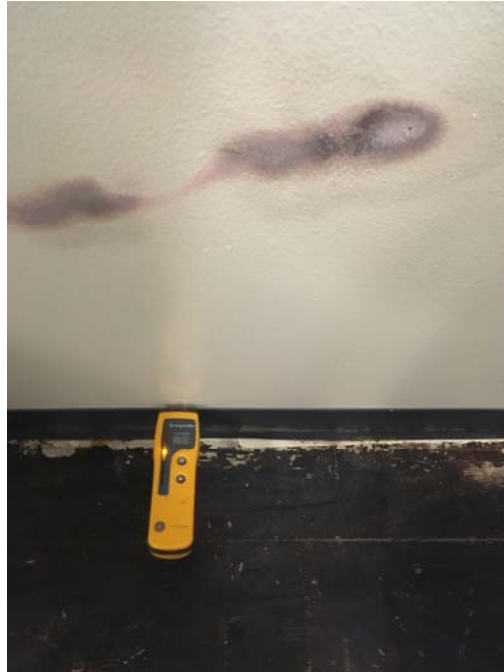
Photo 3 – Room 102
Mold growth was observed on the wallboard to the right of the unit ventilator.

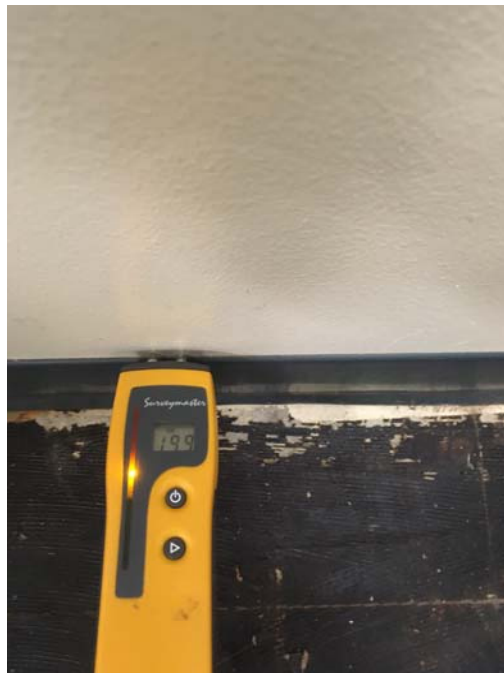
Photo 4 – Room 102
Elevated moisture content was detected on the wallboard below the section of mold growth.

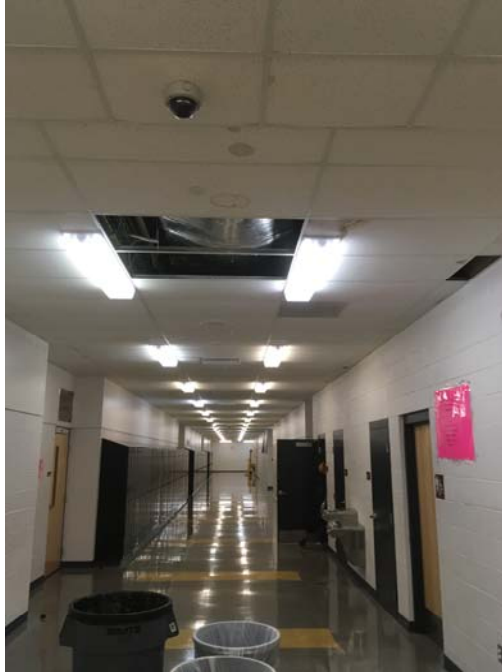
Photo 5 – Hallway outside Room 106
Condensate was leaking from a section of duct work located above the suspended ceiling.

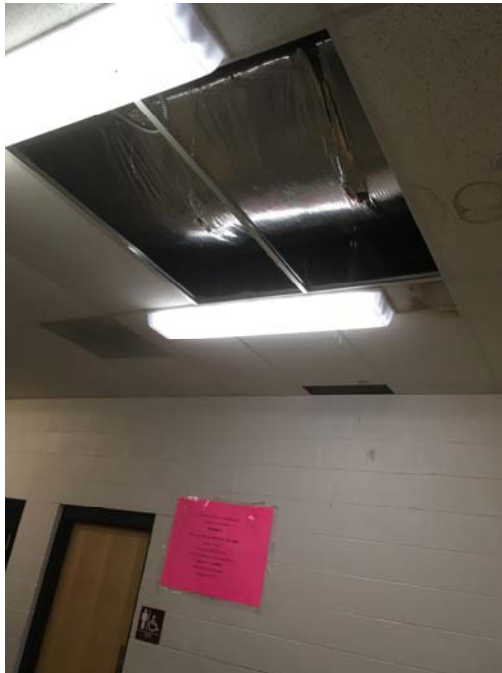
Photo 6 – Hallway outside Room 106
Condensate was leaking from a section of duct work located above the suspended ceiling.

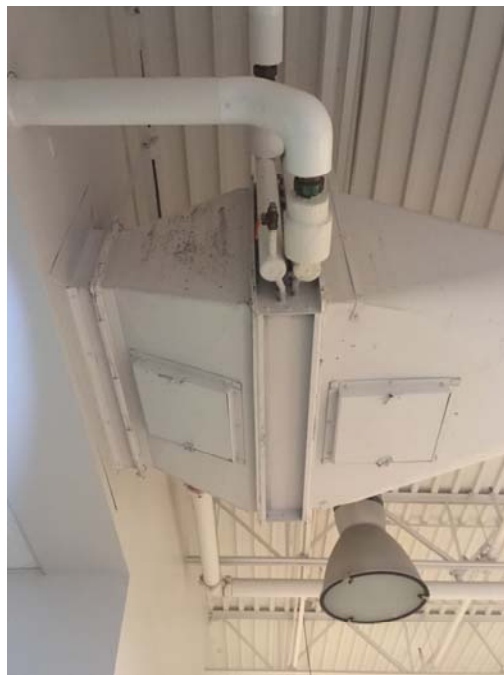
Photo 8 –IMC

Mold growth was observed on sections of the exposed duct work.

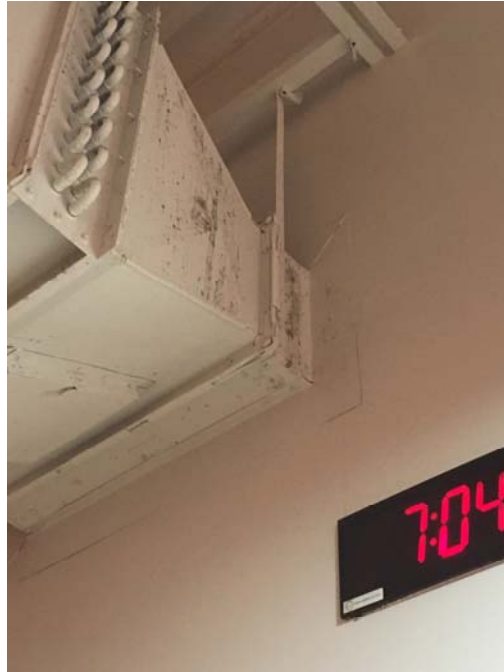
Photo 9 – IMC
Mold growth was observed on sections of the exposed duct work.

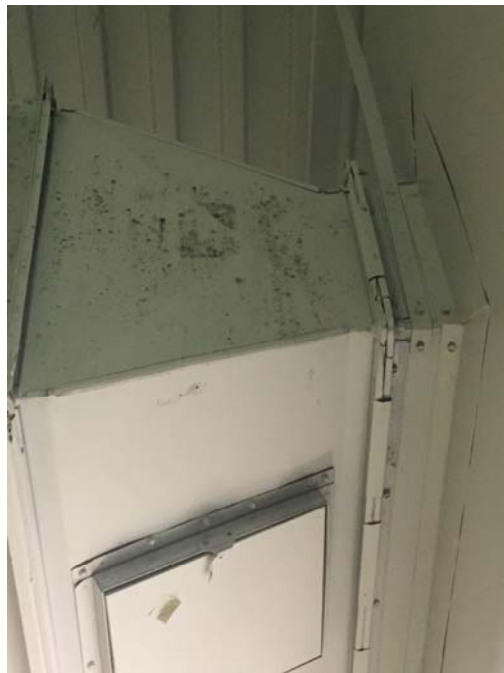
Photo 10 – IMC
Mold growth was observed on sections of the exposed duct work.

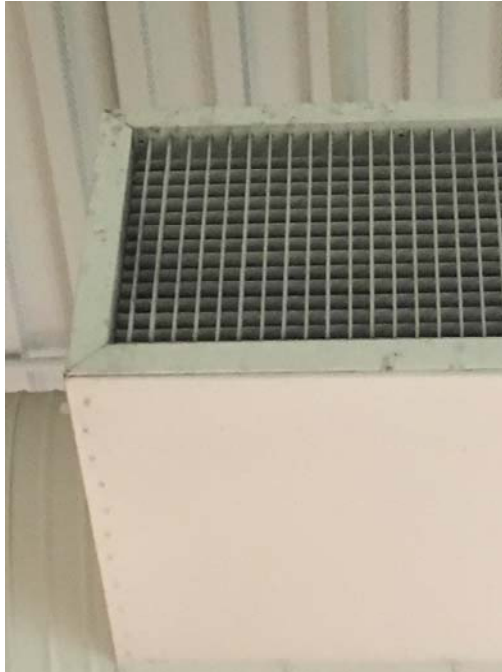
Photo 11– IMC
Mold growth was observed on sections of the exposed duct work.

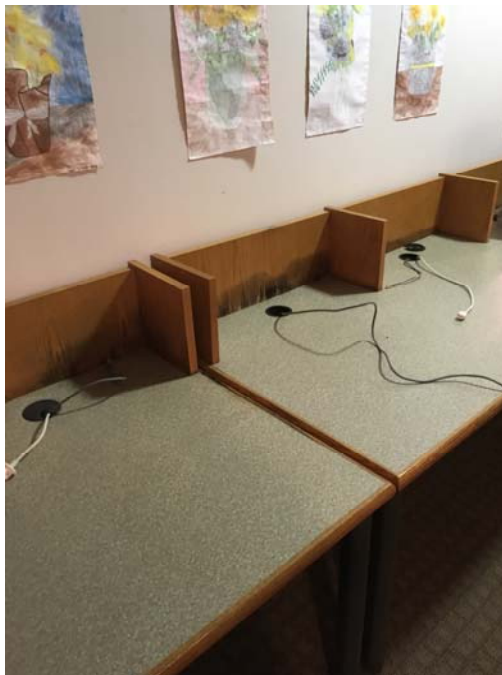
Photo 12 – IMC
Suspect mold growth was observed on the work stations below the center supply branch.

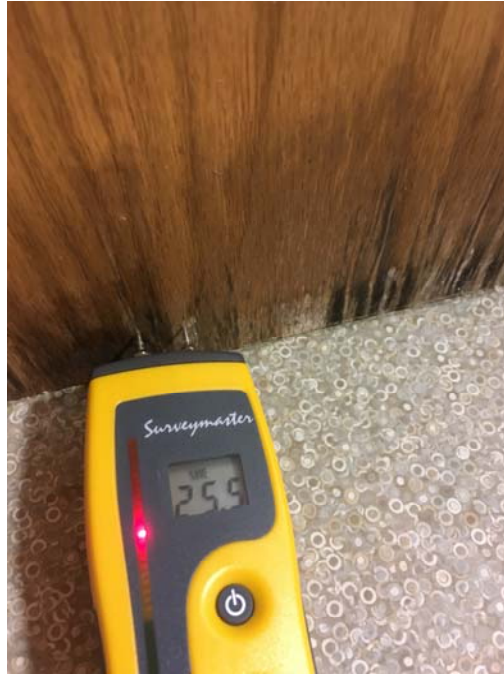
Photo 13 – IMC

Elevated moisture content was detected on the work stations below the center supply branch.

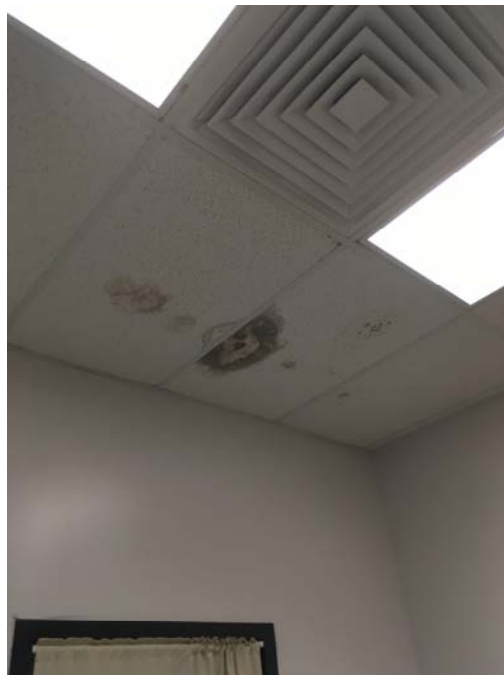
Photo 14 – IMC Office 136

Water stained and moldy ceiling tiles were observed.

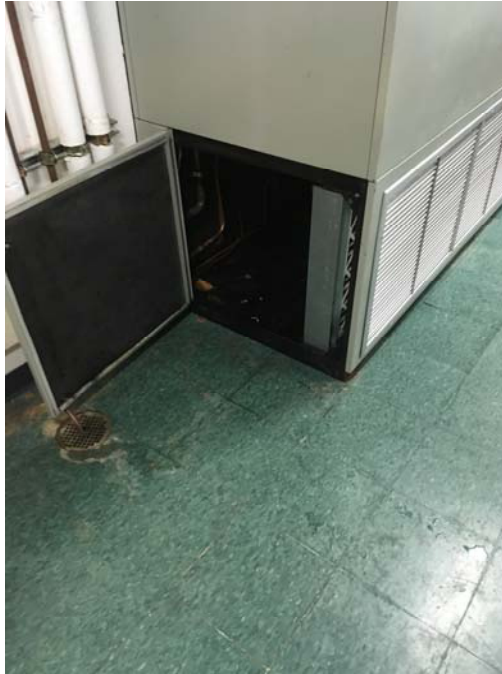
Photo 15 – IMC 134 MDF Room
Water was leaking from the condensate pump.

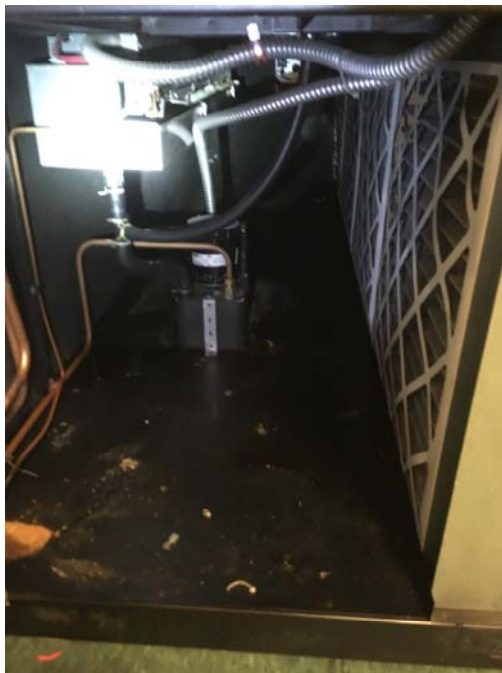
Photo 16 – IMC 134 MDF Room
Water was leaking from the condensate pump.

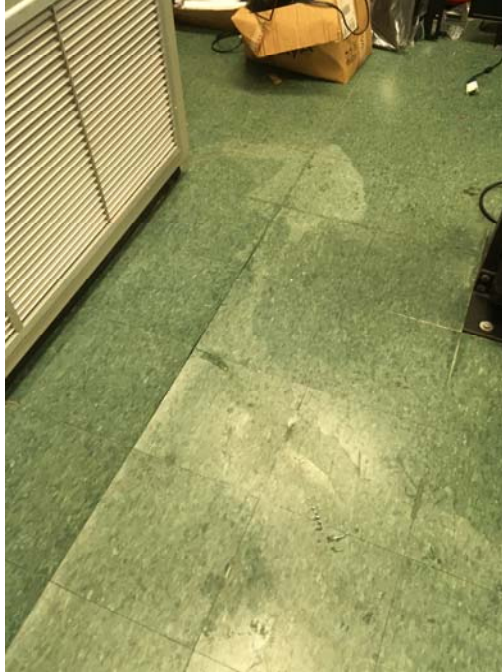
Photo 17 – IMC 134 MDF Room
A delaminated section of floor tile was observed from the leaking condensate pump.
