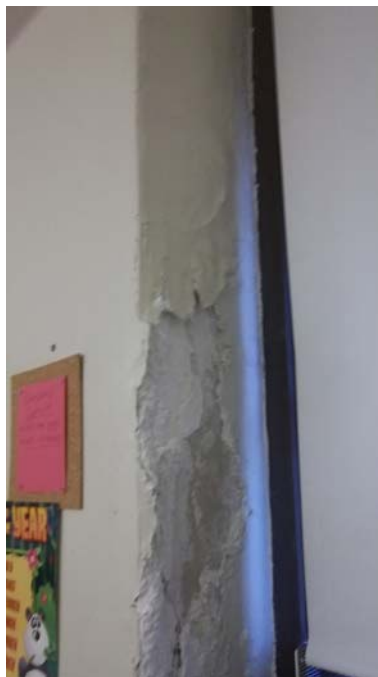
Photo 2 – Room 106

Moisture damaged paint and plaster was observed around the windows.

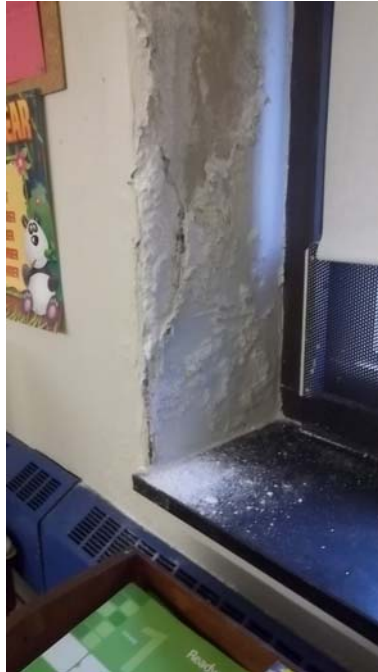
Photo 3 – Room 106
Paint and plaster debris was observed on the window sills.

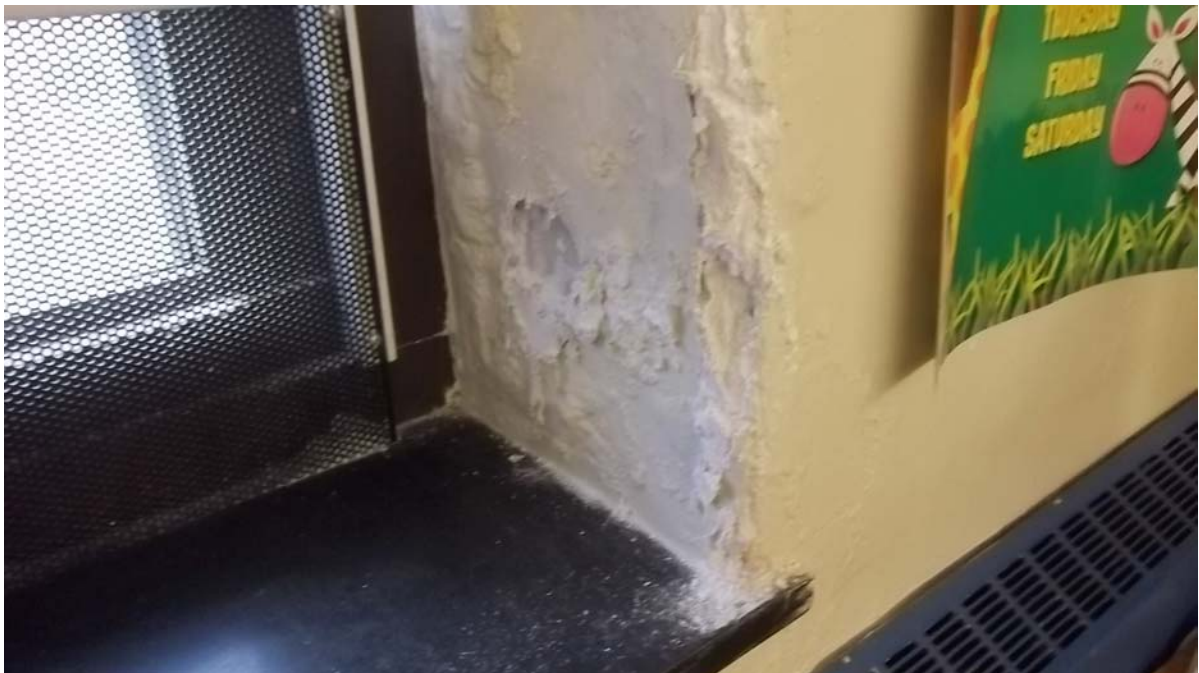
Photo 4 – Room 106
Moisture damaged paint and plaster was observed around the windows.

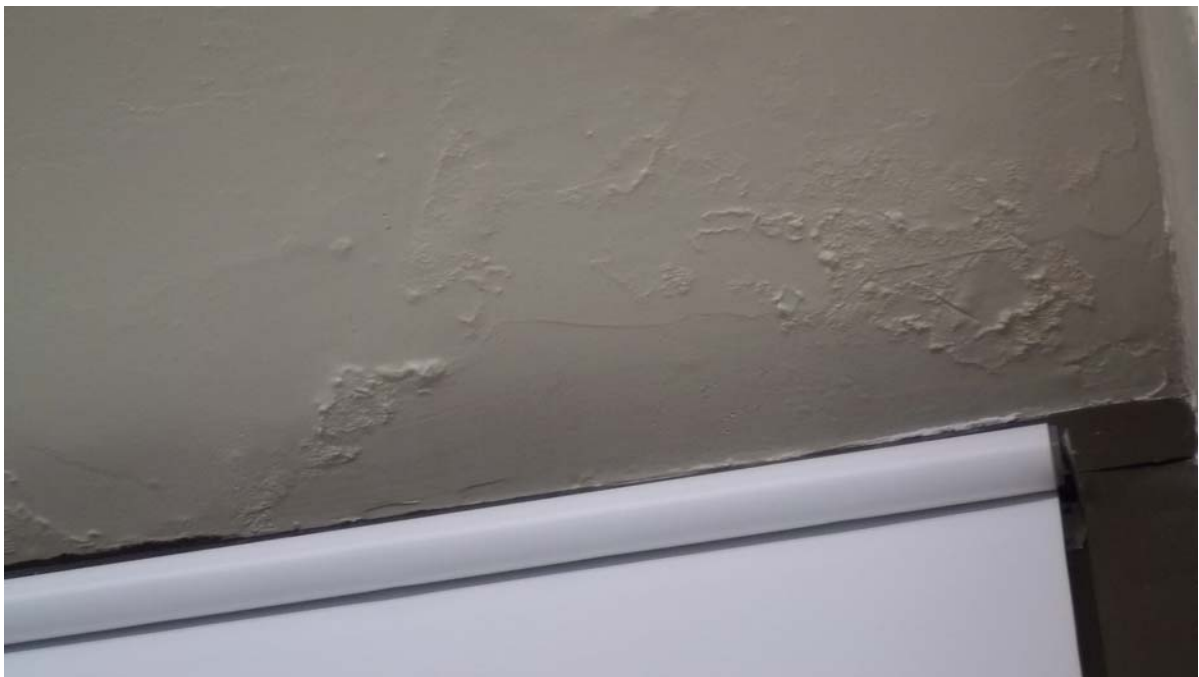
Photo 6 – Room 104

A minimum amount of efflorescence was observed around 2 windows.

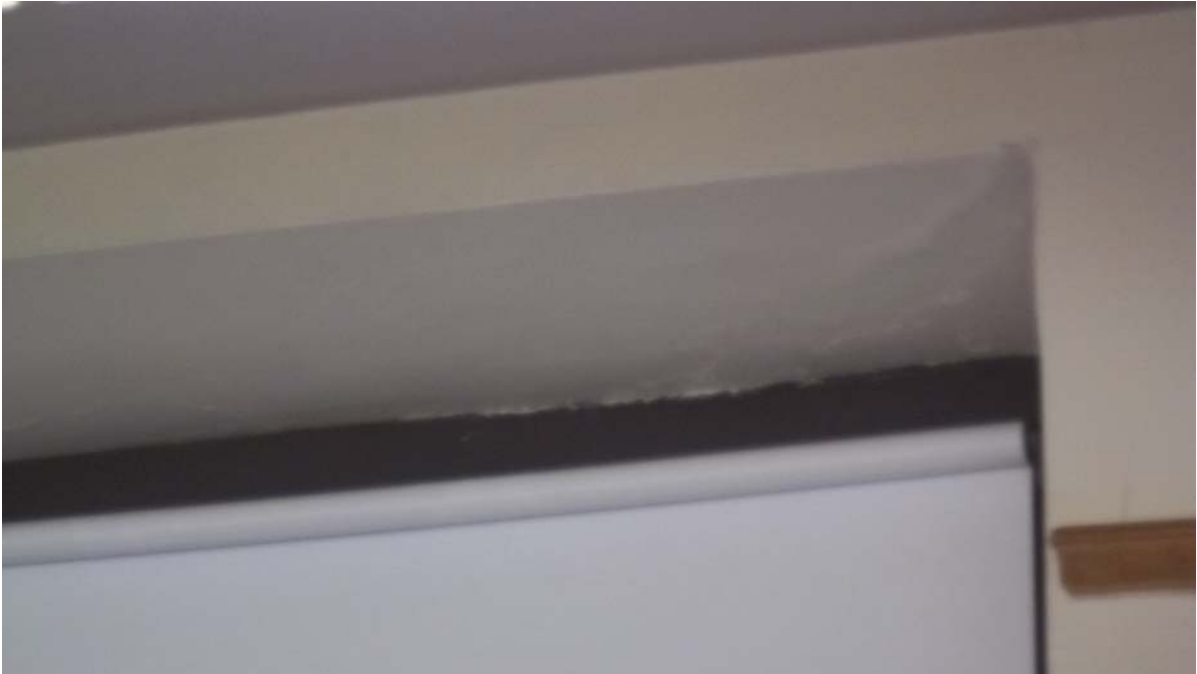
Photo 7 – Room 103

A minimum amount of efflorescence was observed around the windows on the right.

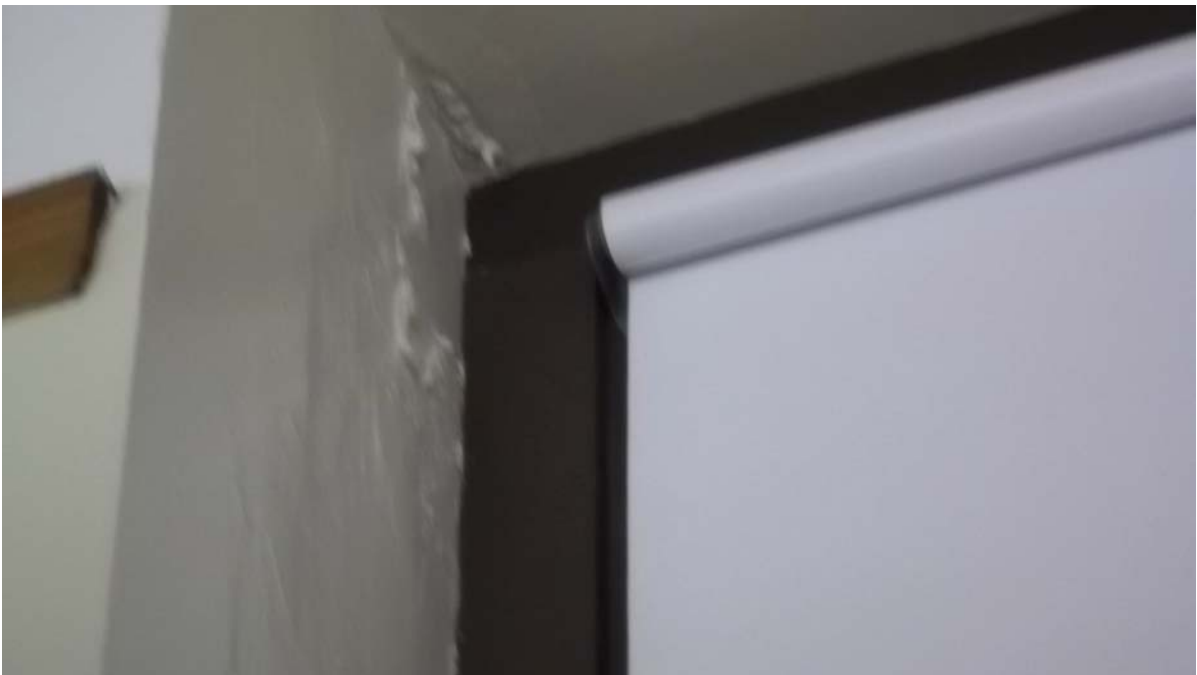
Photo 8 – Room 102

Moisture damaged paint and plaster was observed around 5 windows.

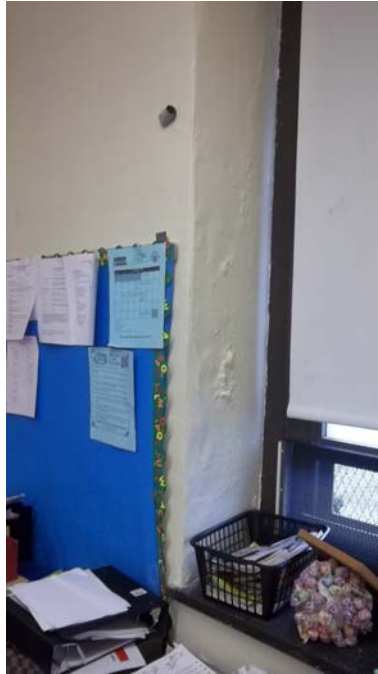
Photo 9 – Room 102
Moisture damaged paint and plaster was observed around 5 windows.

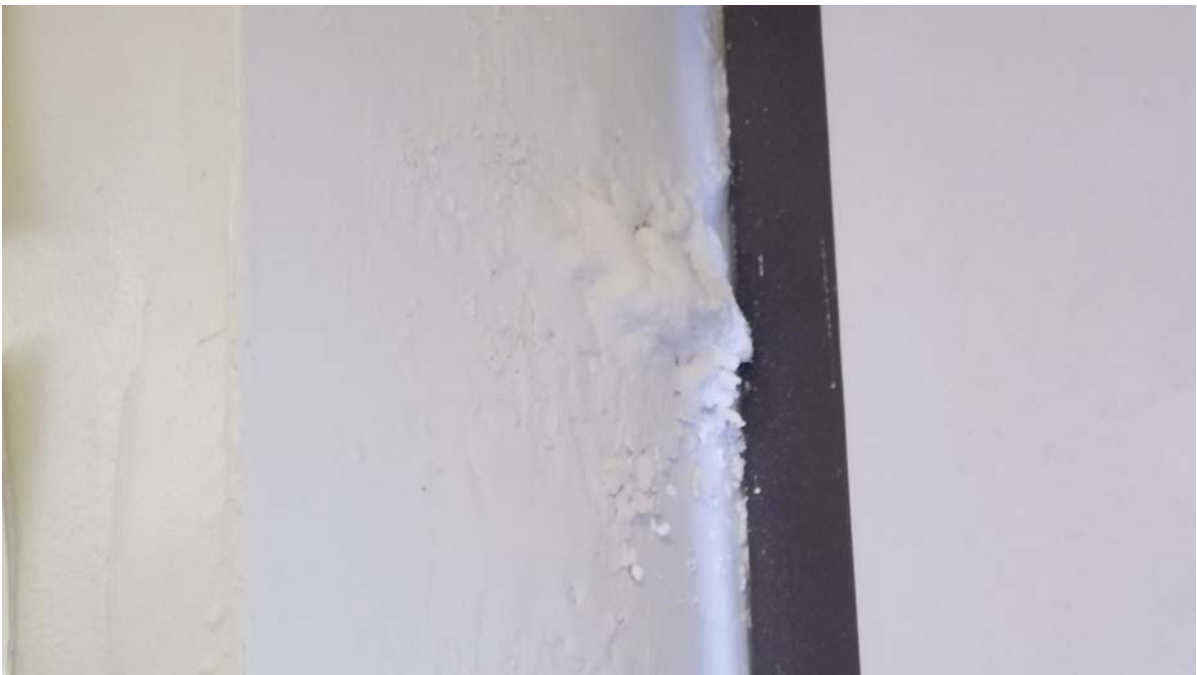
Photo 10 – Room 102
Moisture damaged paint and plaster was observed around 5 windows.

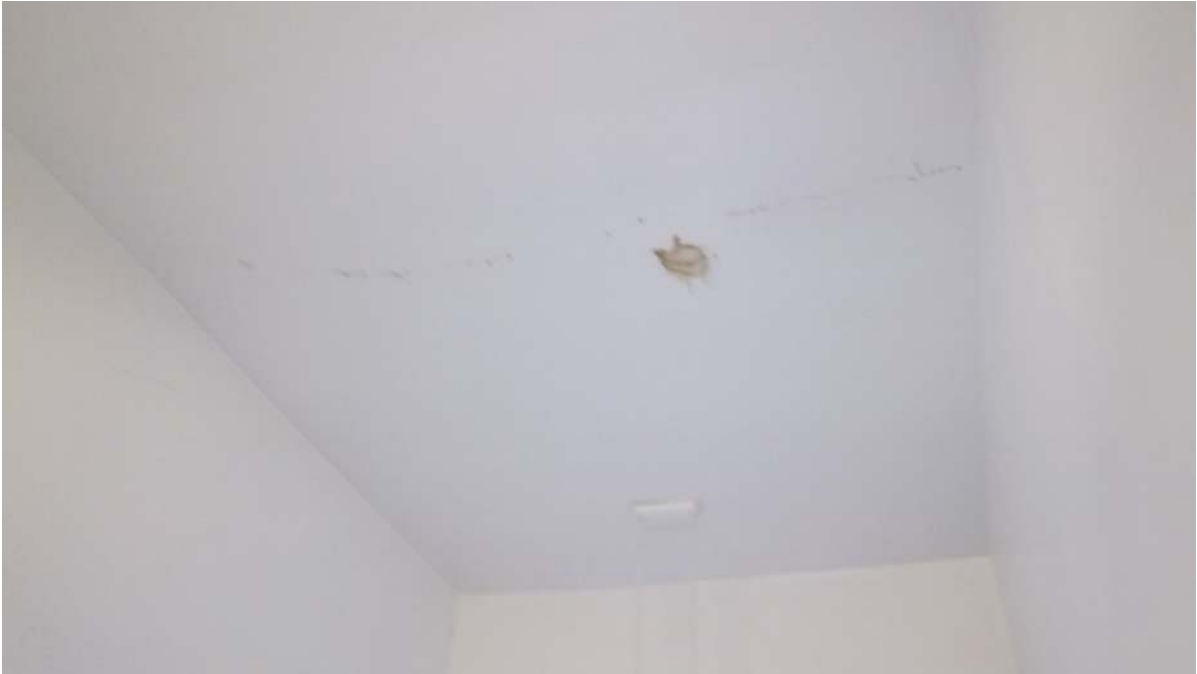
Photo 11– East Stairwell

A moisture damaged section of the ceiling was observed from a roof leak that was stabilized.

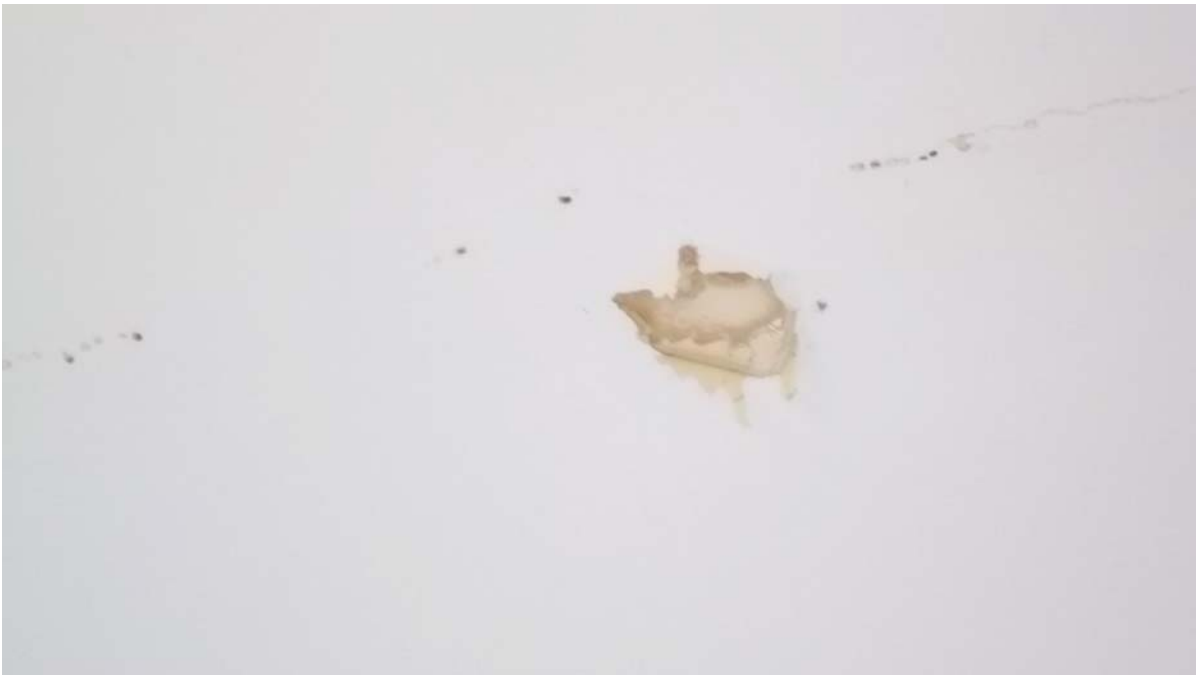
Photo 12 – East Stairwell

moisture damaged section of the ceiling was observed from a roof leak that was stabilized.

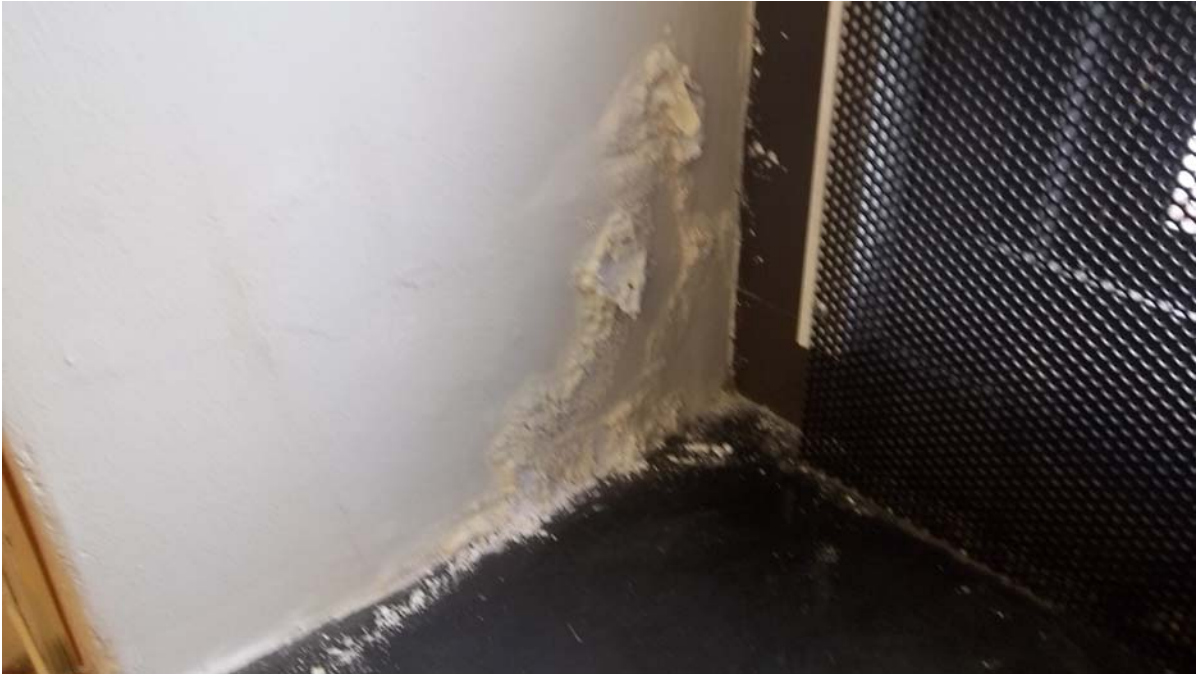
Photo 13 – Room 202

Moisture damaged paint and plaster was observed around the windows and in the corner of the room. Paint and plaster debris was observed on the windows sills.

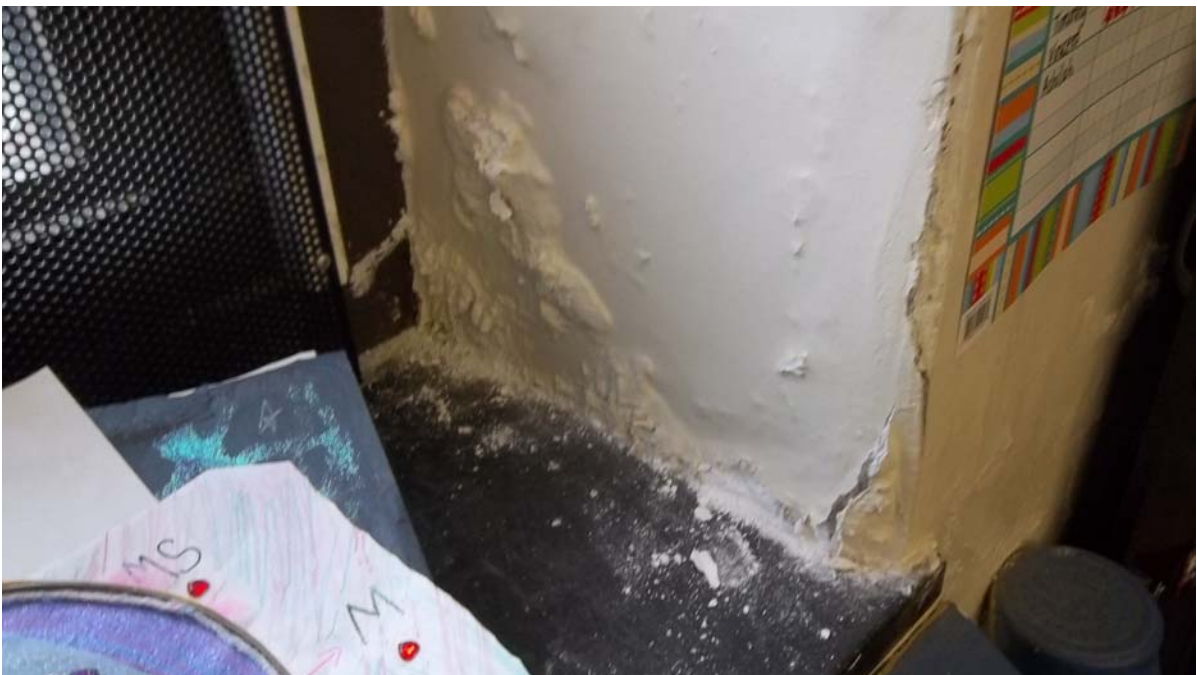
Photo 14 – Room 202

Moisture damaged paint and plaster was observed around the windows and in the corner of the room. Paint and plaster debris was observed on the windows sills.

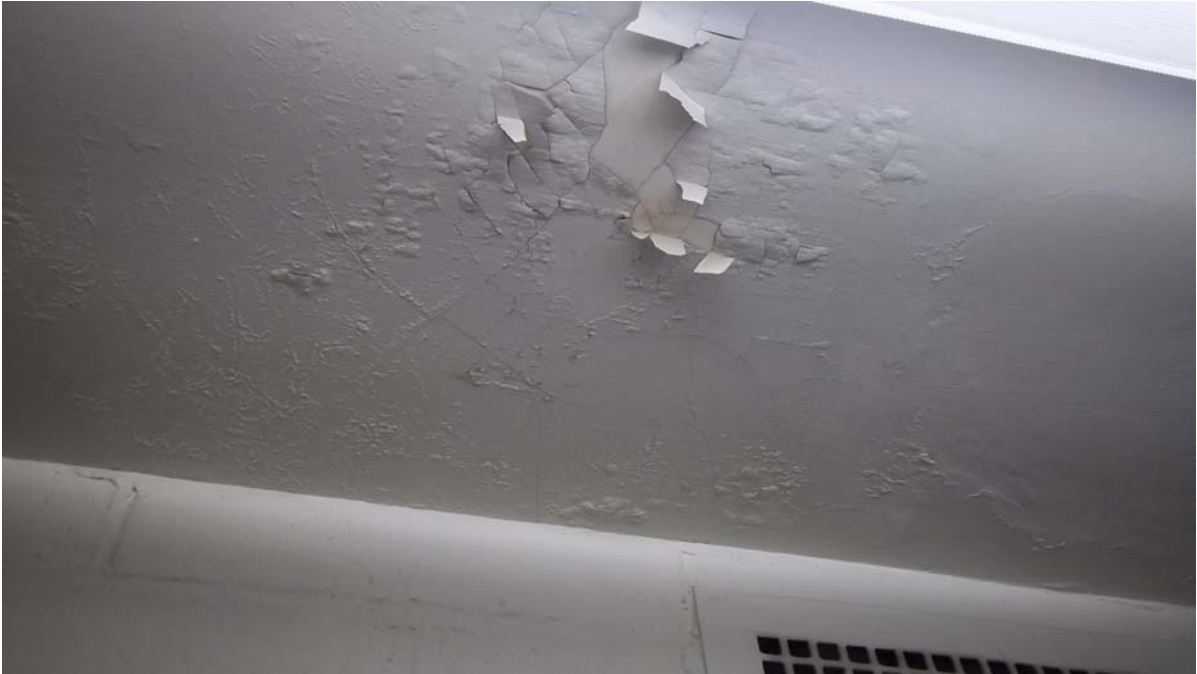
Photo 15 – Room 202 Closet
Flaking paint was observed on the ceiling of the closet.

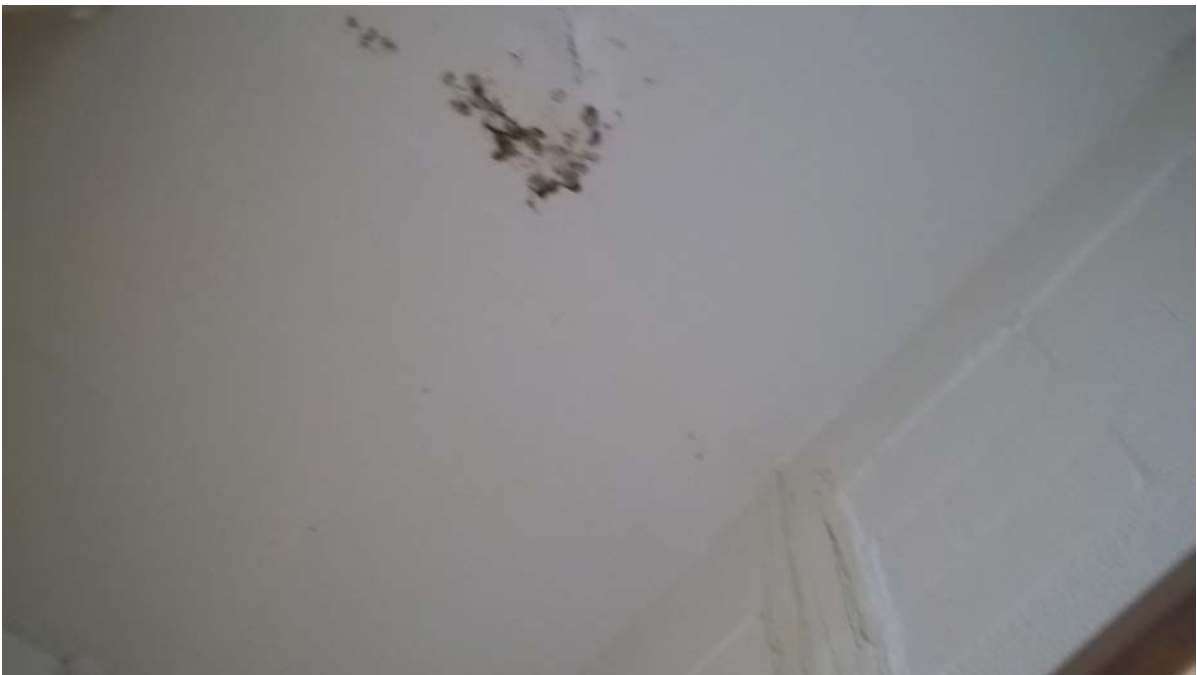
Photo 16 – Room 202 Closet
Staining was observed on the ceiling from a leak that was stabilized.

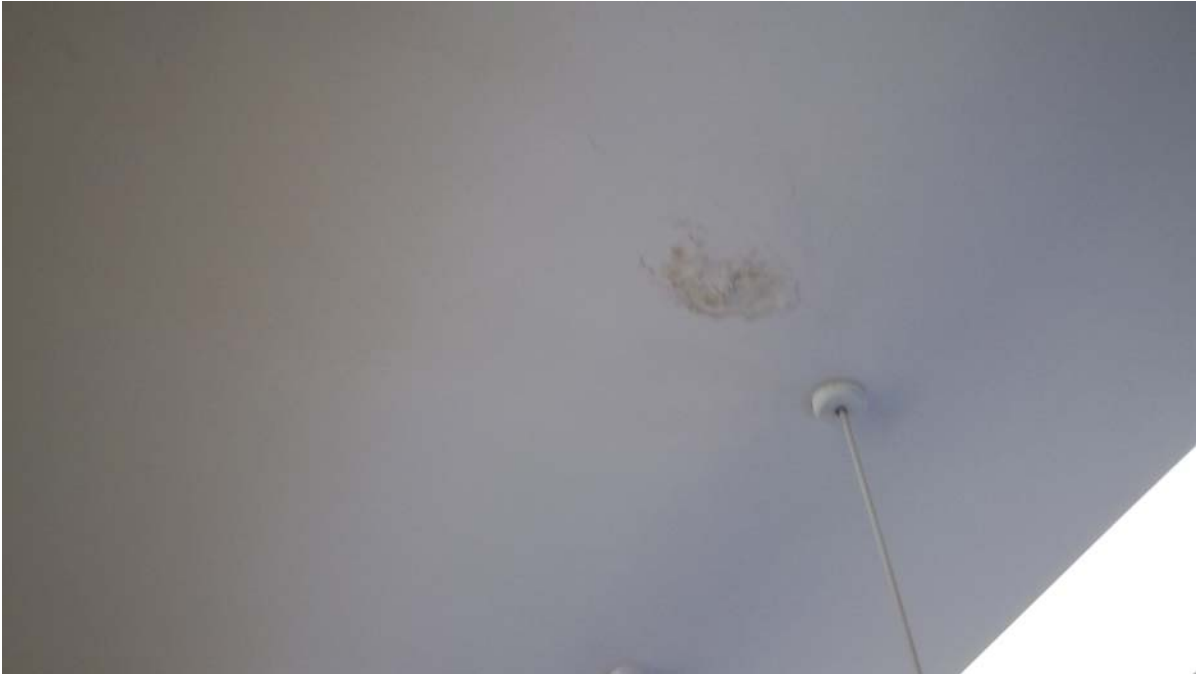
Photo 17 – Room 203

Flaking paint and staining was observed on the ceiling from a leak that was stabilized.

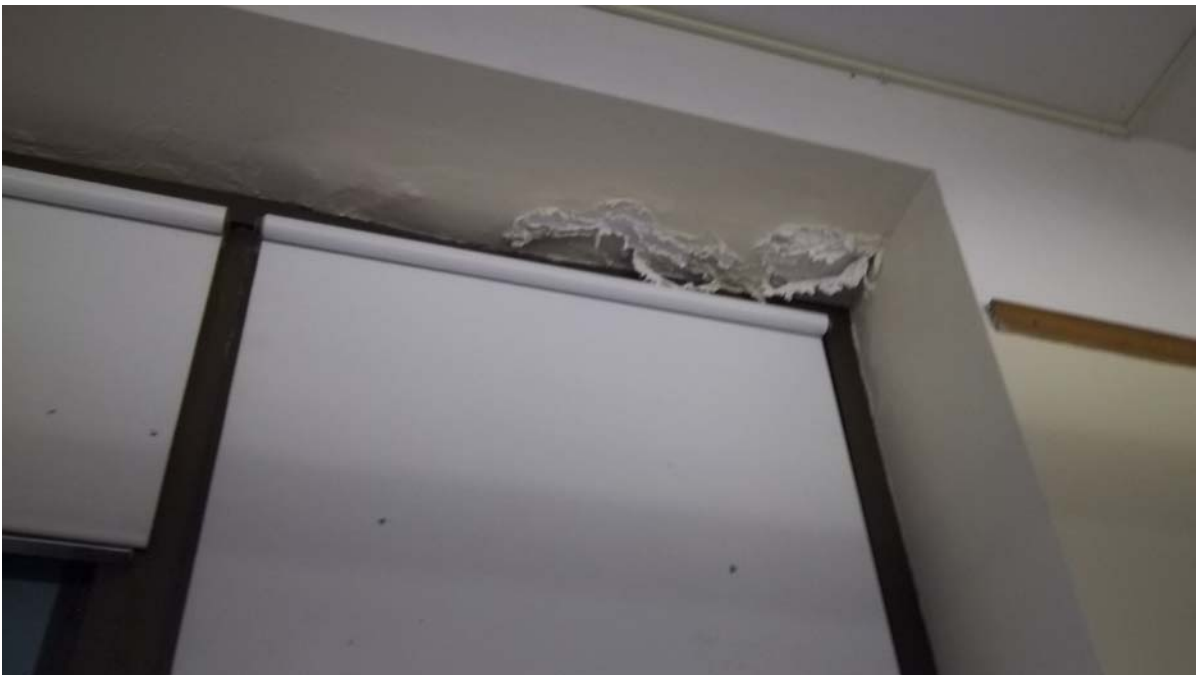
Photo 18 – Room 203

Moisture damaged paint and plaster was observed around the right windows.

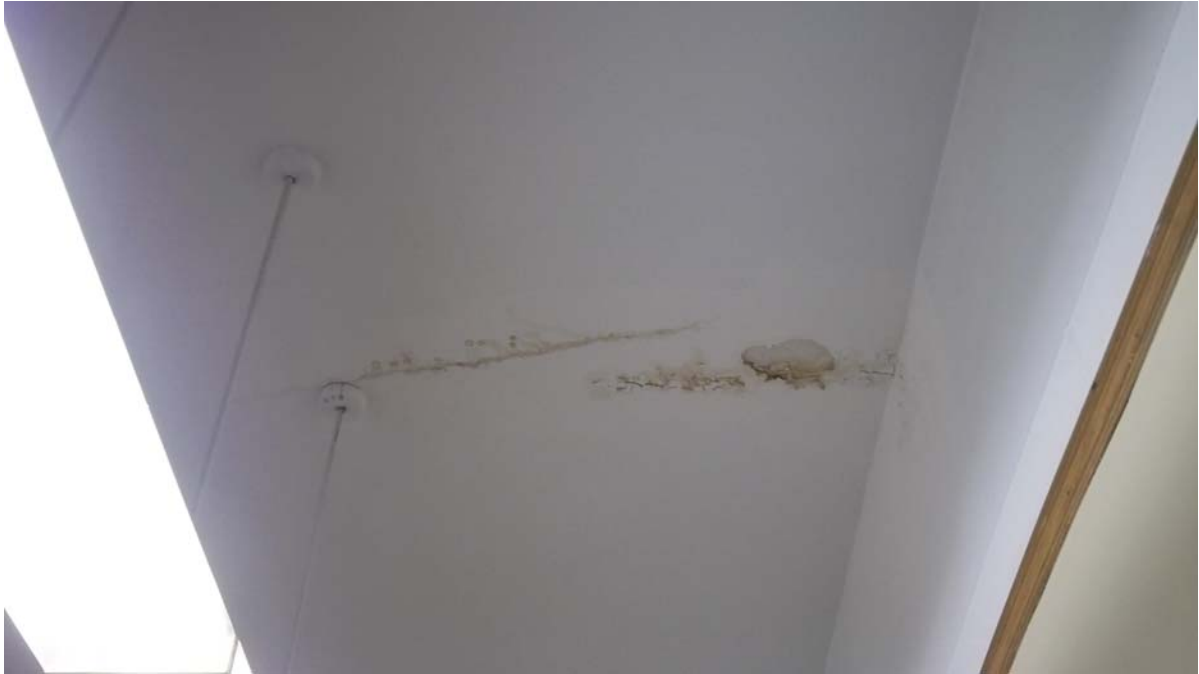
Photo 19 – Hallway outside Room 207
Flaking paint and staining was observed on the ceiling from a leak that was stabilized.

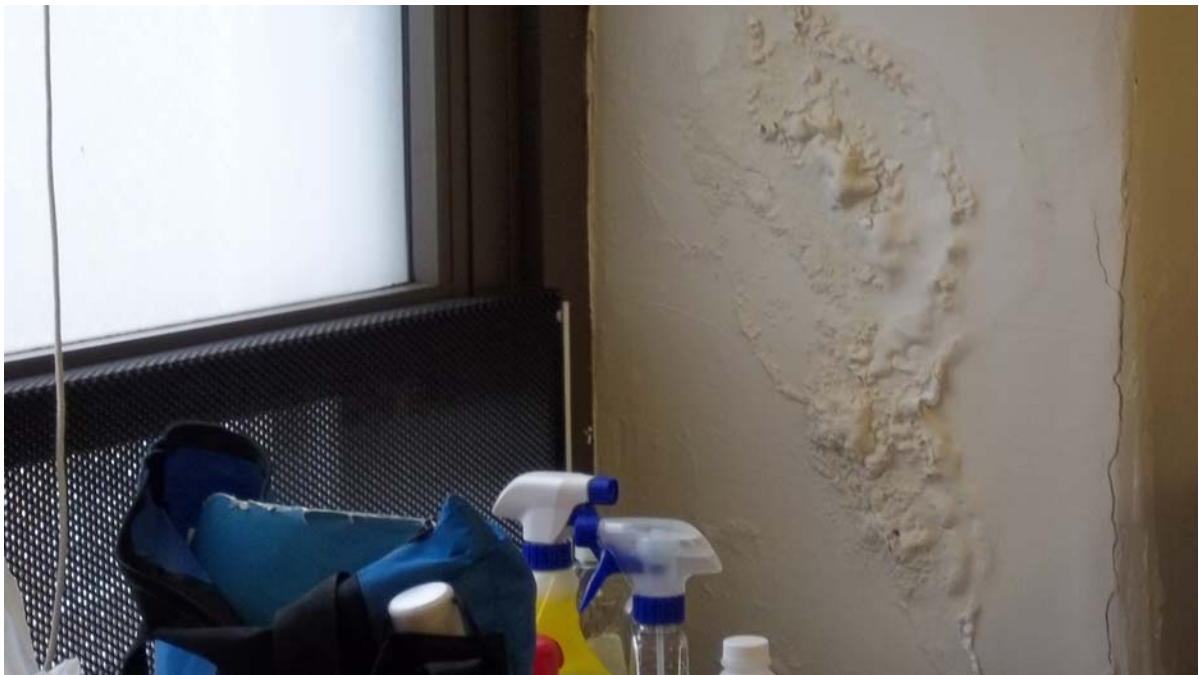
Photo 20 – Room 204
Moisture damaged paint and plaster was observed around 2 windows.

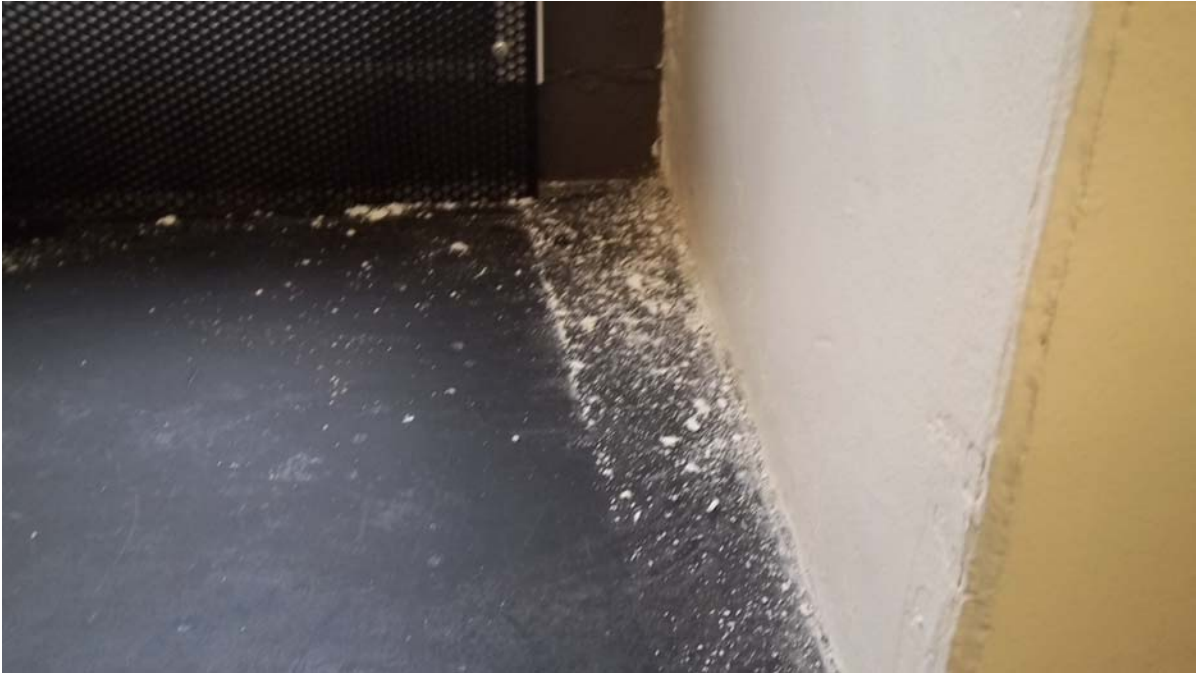
Photo 21 – Room 204
Paint and plaster debris was observed on one of the window sills.

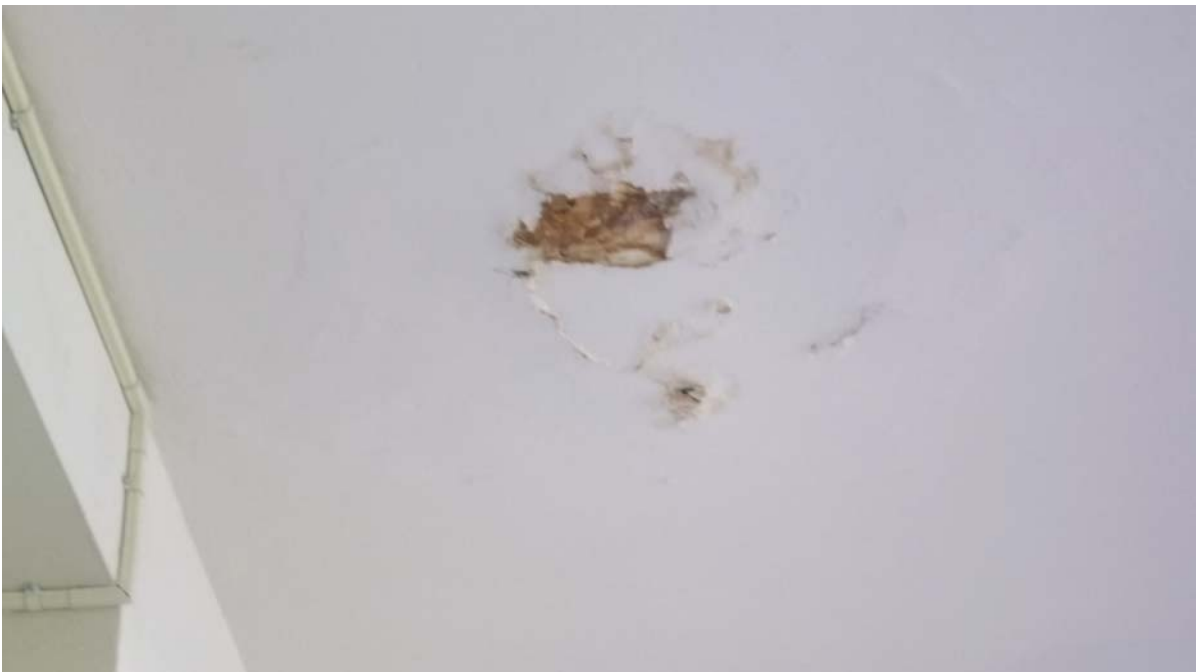
Photo 22 – Room 205
Flaking paint and staining was observed on the ceiling from a leak that was stabilized.

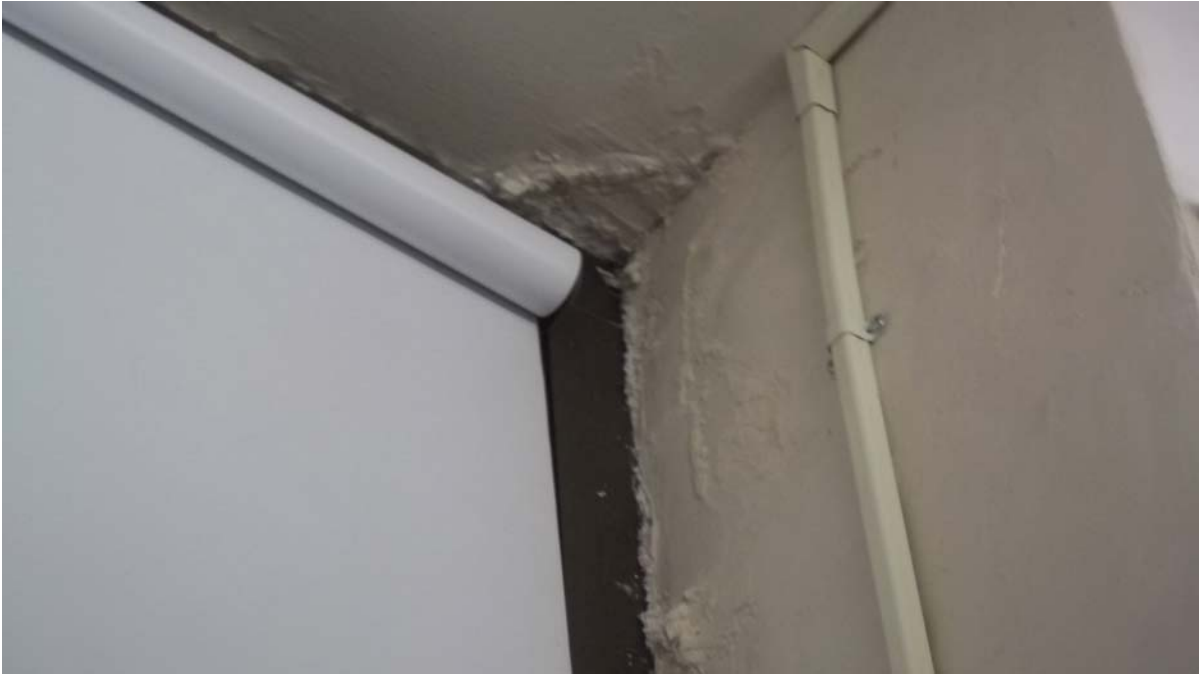
Photo 23 – Room 205
Moisture damaged paint and plaster was observed around a window.

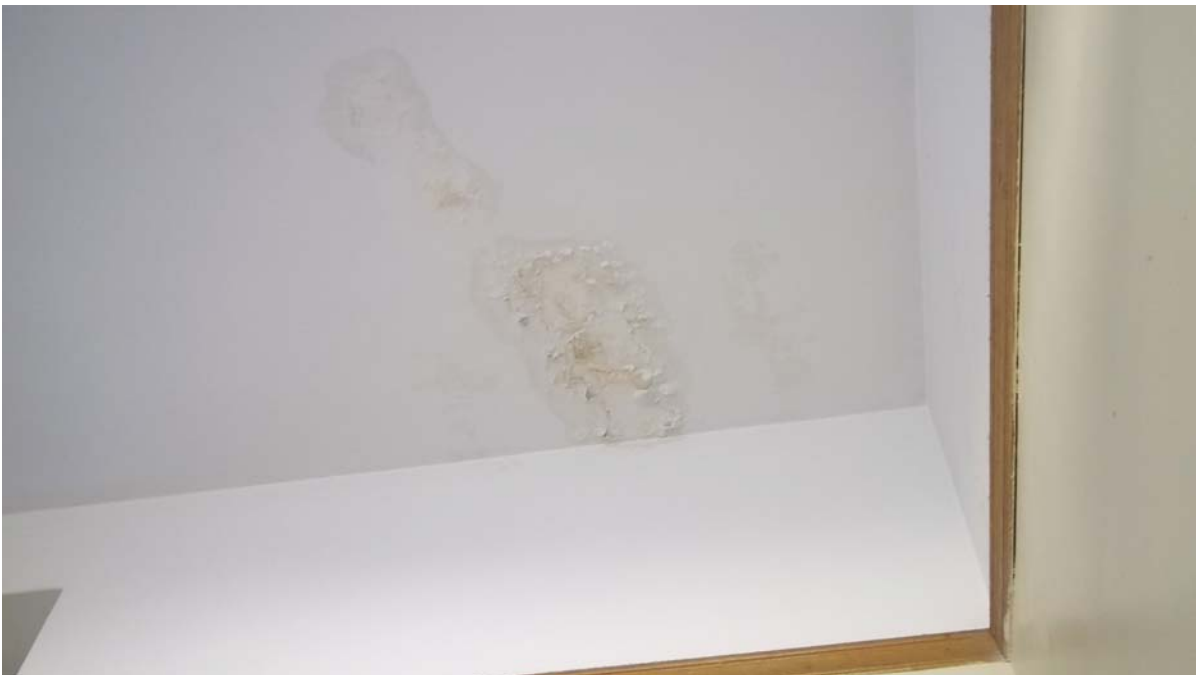
Photo 24 – Room 206
Flaking paint and water staining was observed on the ceiling from a leak that was stabilized.

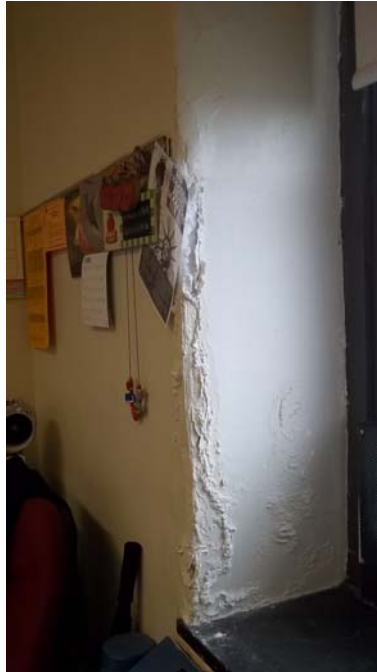
Photo 25 – Room 206
Moisture damaged paint and plaster was observed around 2 windows.

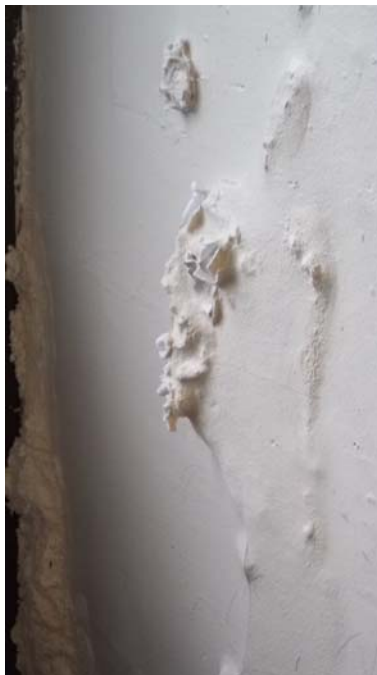
Photo 26 – Room 206
Moisture damaged paint and plaster was observed around 2 windows.

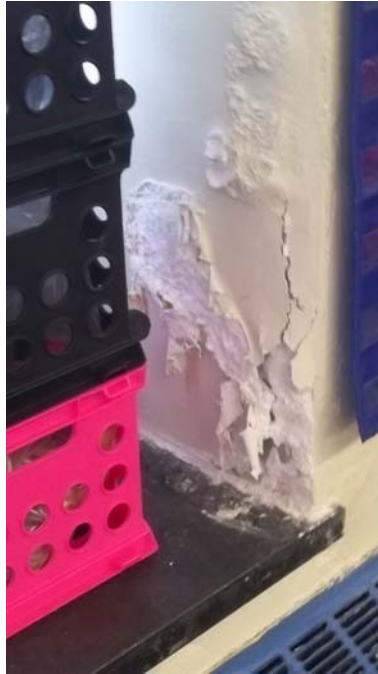
Photo 27 – Room 206
Moisture damaged paint and plaster was observed around 2 windows.

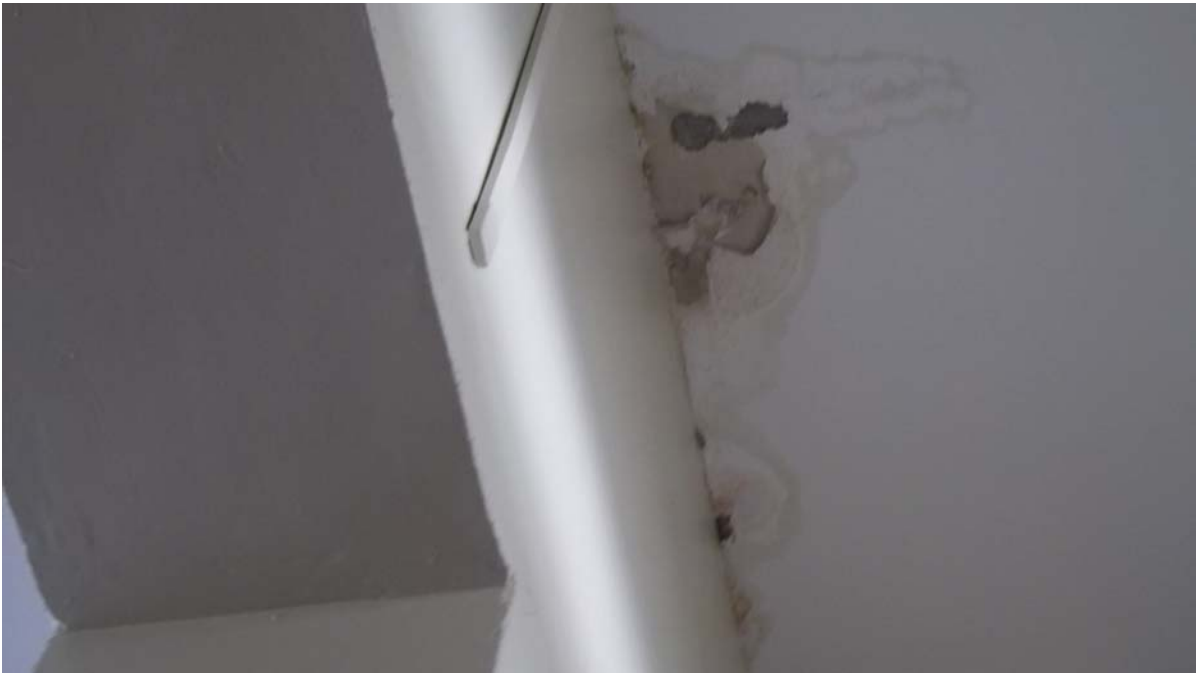
Photo 28 – Room 207
Flaking paint and water staining was observed on the ceiling from a leak that was stabilized.

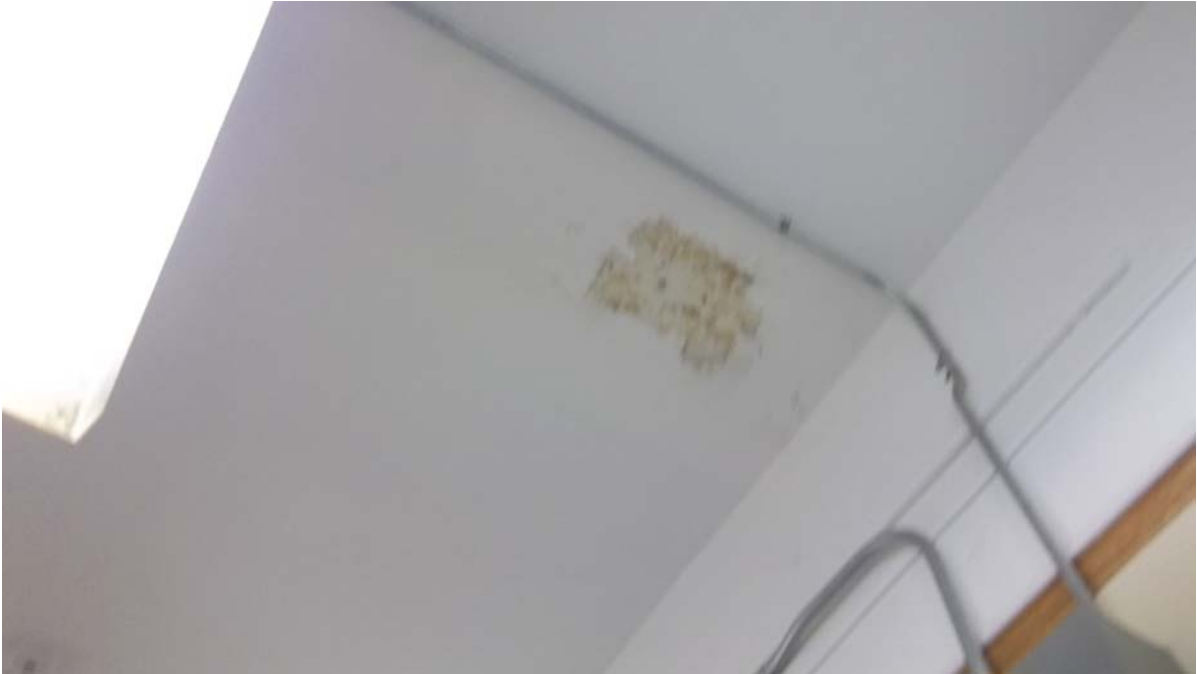
Photo 29 – Hallway outside Room 207
Flaking paint and water staining was observed on the ceiling.

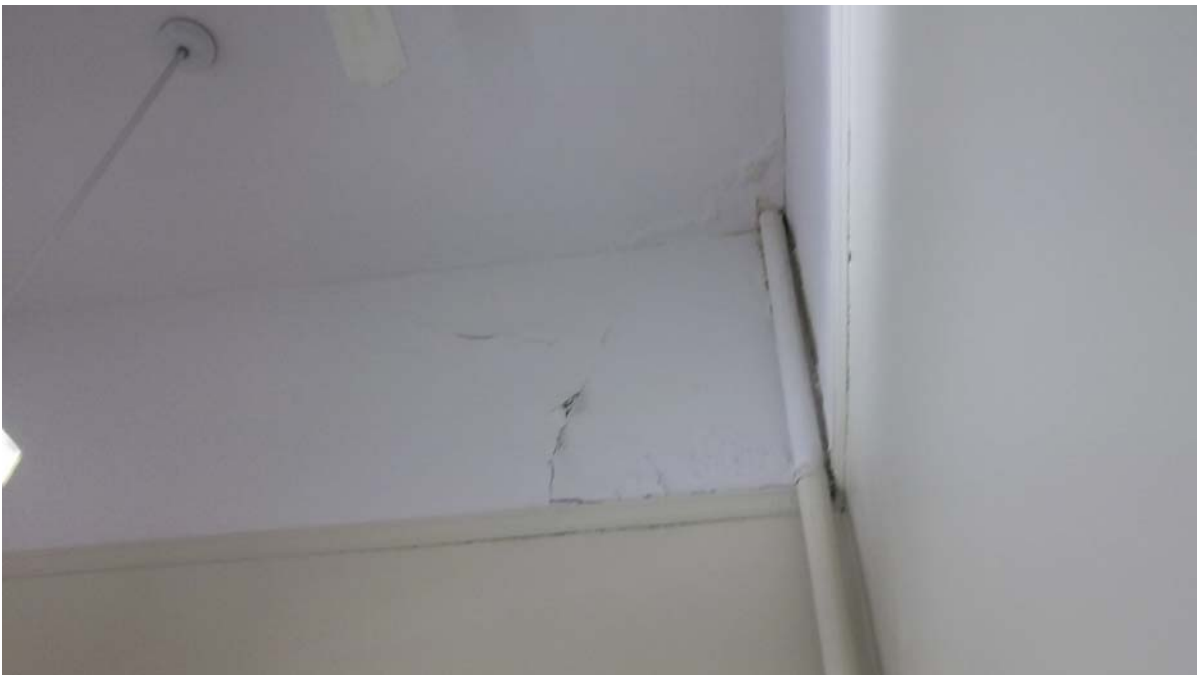
Photo 30 – Counselor's Office (2nd floor)
Moisture damaged plaster was observed on the upper wall section.

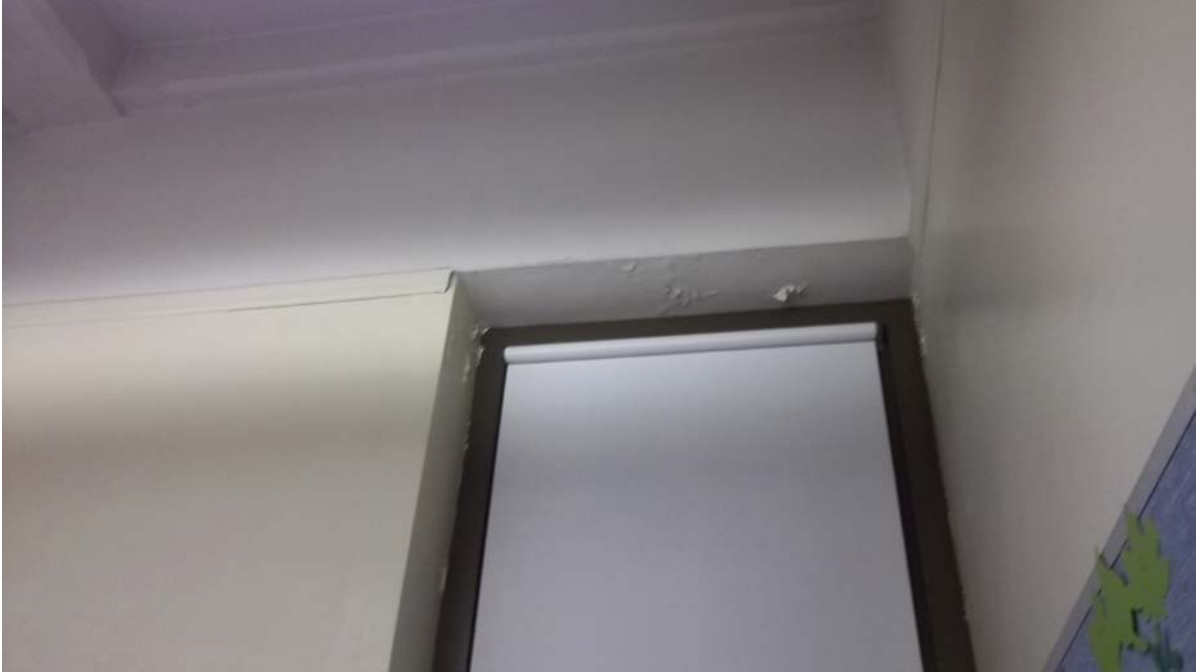
Photo 31 – Nurse's Office
Flaking paint was observed above 1 window.
