Date Inspected:  
12/1/16

# Asbestos Design Data Collection (DDC)

Name of Building: Jackson Elementary School

Address: 1213 S. 12<sup>th</sup> Street ULCS # 2510

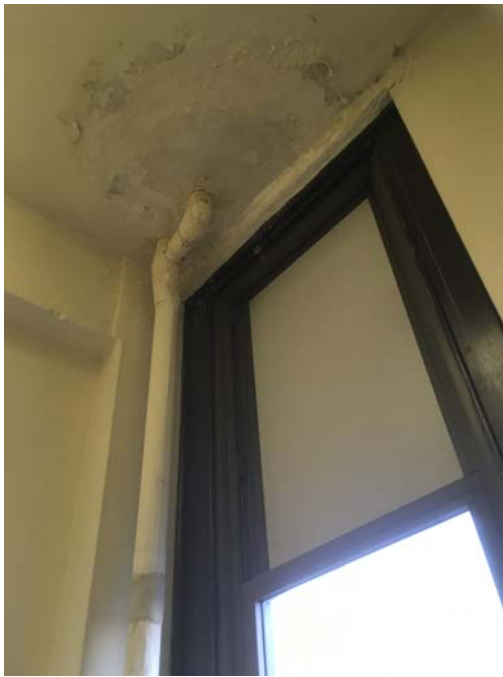
Photo 1 – Room 203 Closet

Work Location (1): Room 203 Closet				Imminent Hazard : Yes <input type="checkbox"/> No <input type="checkbox"/>			
Material(s) Requiring Abatement	Confirmed or Assumed (if assumed follow the assumed material directive)	Total Amount Present (LF or SF)	Amount with Damage (LF or SF)	Suggested Amount for Abatement Action (LF or SF)	Type of Abatement* (codes below)	Friable or Non-Friable Removal	Reason for Abatement
ACPI	12 LF	12 LF	0	12 LF	RMV	FRI	Removal needed to allow for plaster repair
Visible Debris (Yes or No)	Water or Steam Leak	Water or Steam Leak Isolated (Yes or No)	Student / Teacher Occupied (Yes or No)	Confined Space (Yes or No)	Work Area Securable (Yes or No)	Height of Ceiling (feet)	Height of Material (feet)
No	No	N/A	Yes	No	No	12	12
Type of Ventilation	Type of Ceiling	Type of Floor Substrate	Multiple Layers	Pipe Diameter (inches)	Fixed Objects	Movable Objects	Time Accessible
Radiant Heat/Window	Plaster	wood	N/A	1"	N/A	contents	3 PM

The insulation on this riser should be removed to allow for paint and plaster repair.

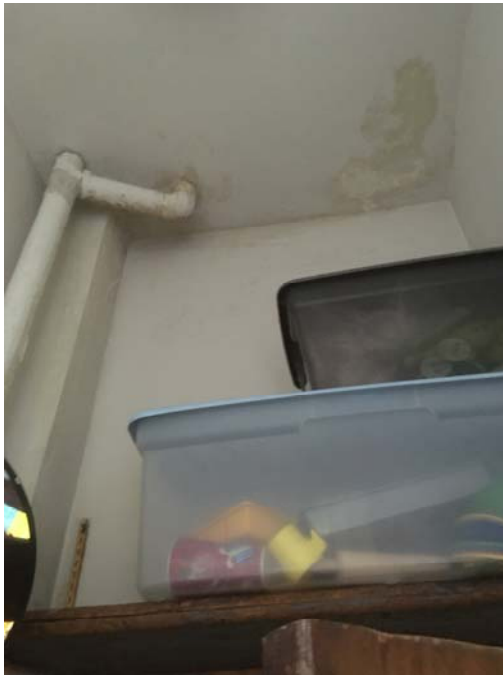
Photo 47 – Room 102 Closet

Work Location (2): Room 102 Closet				Imminent Hazard : Yes <input type="checkbox"/> No: <input type="checkbox"/>			
Material(s) Requiring Abatement	Confirmed or Assumed (if assumed follow the assumed material directive)	Total Amount Present (LF or SF)	Amount with Damage (LF or SF)	Suggested Amount for Abatement Action (LF or SF)	Type of Abatement* (codes below)	Friable or Non-Friable Removal	Reason for Abatement
ACPI	12 LF	12 LF	0	12 LF	RMV	FRI	Removal needed to allow for plaster repair
Visible Debris (Yes or No)	Water or Steam Leak	Water or Steam Leak Isolated (Yes or No)	Student / Teacher Occupied (Yes or No)	Confined Space (Yes or No)	Work Area Securable (Yes or No)	Height of Ceiling (feet)	Height of Material (feet)
No	No	N/A	Yes	No	No	12	12
Type of Ventilation	Type of Ceiling	Type of Floor Substrate	Multiple Layers	Pipe Diameter (inches)	Fixed Objects	Movable Objects	Time Accessible
Radiant Heat/Window	Plaster	wood	N/A	1"	N/A	contents	3 PM

The insulation on this riser should be removed to allow for paint and plaster repair.
