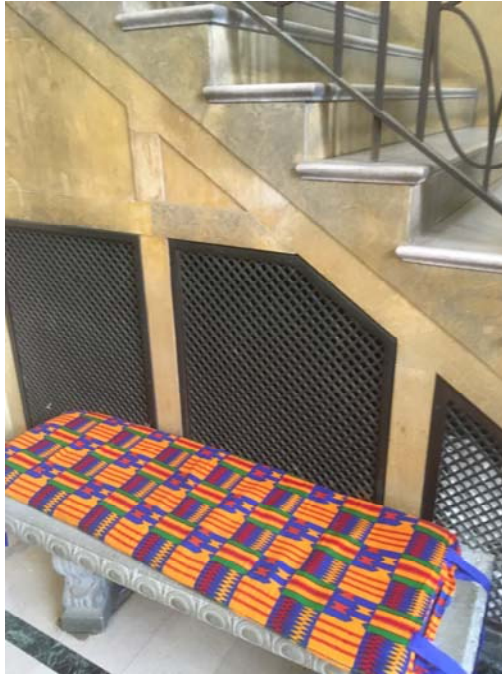
Photo 1 – Main Entrance
A steam leak was observed on the east side of the main entrance.

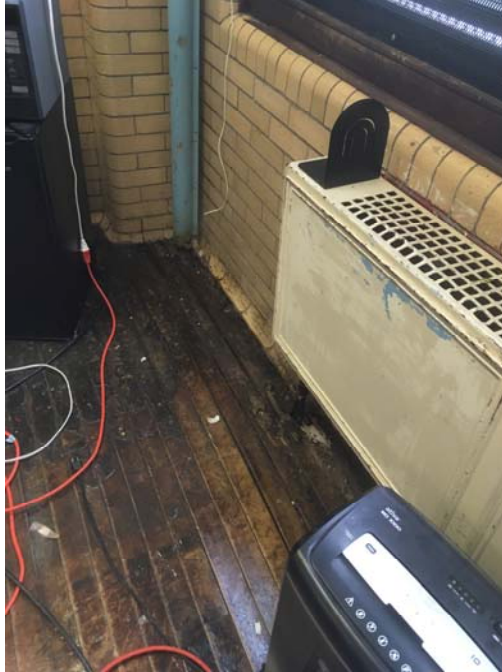
Photo 3 –Room 101

A steam leak in the crawlspace below impacted the hardwood flooring in the corner of the room.

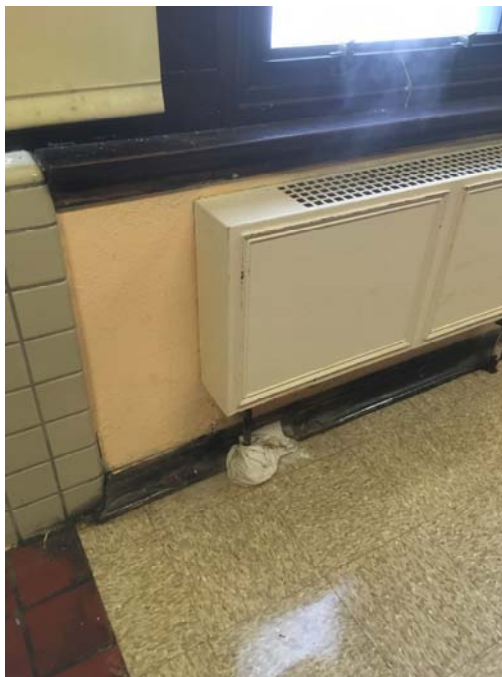
Photo 6 – Room 108

A steam leak occurred on the riser between the crawlspace and radiator.

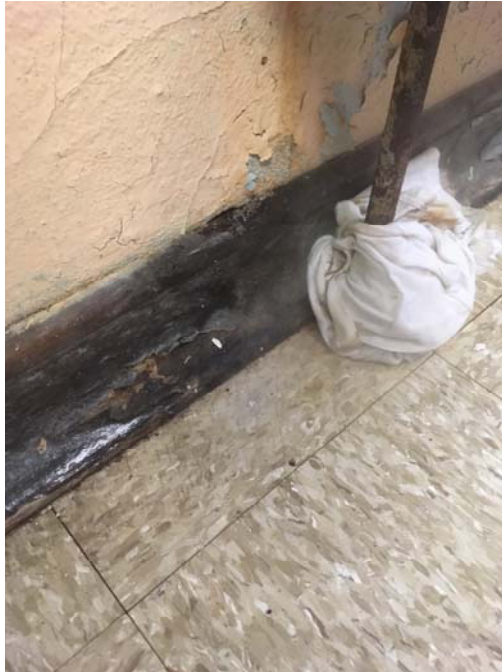
Photo 7 – Room 108

A steam leak occurred on the riser between the crawlspace and radiator. The wooden baseboard was impacted by the steam.

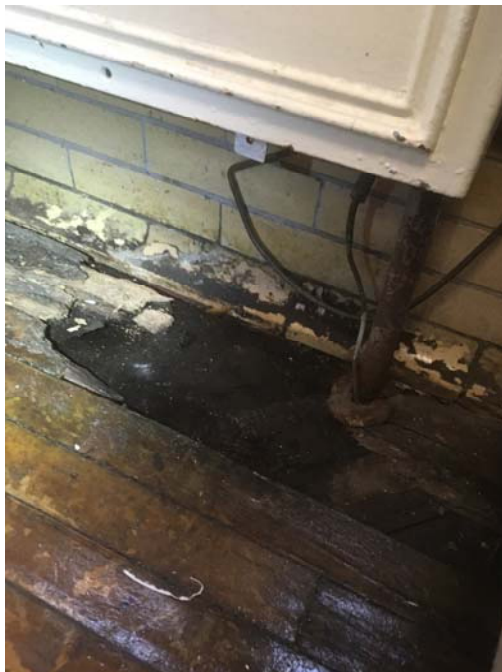
Photo 8 – Room 103

The hardwood flooring was impacted by a steam leak from this radiator.

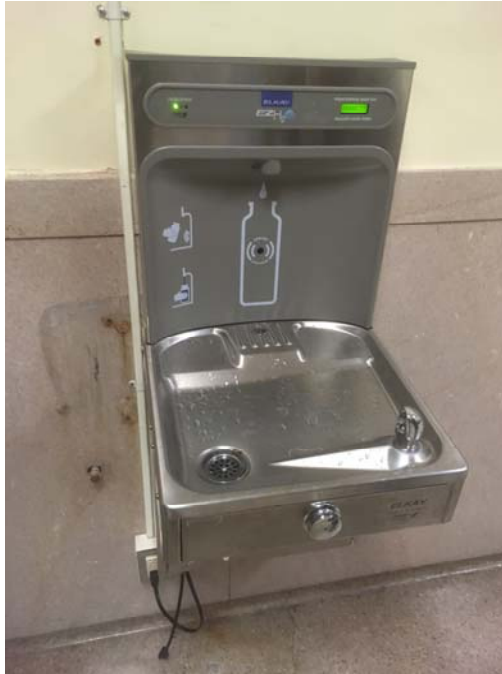
Photo 9 – 1st Floor Hallway
The compressor for the hydration station was making a very loud noise and was unplugged.
