UNITED STATES ENVIRONMENTAL PROTECTION AGENCY

Re: Final Remedial Investigation Report

August 21, 2012

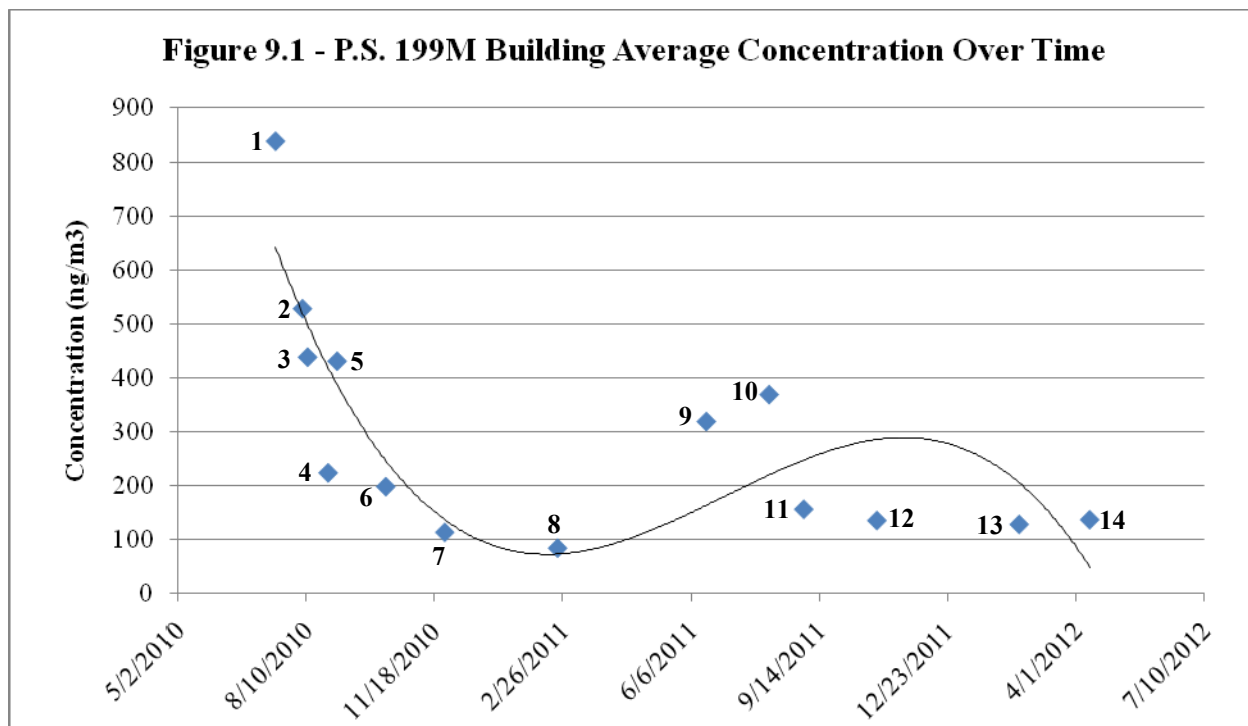
9.3 P.S. 199M Airborne PCB Concentrations Over Time

Between August 23, 2008, and April 12, 2012, twenty (20) rounds of wide-scale testing were performed in P.S. 199M. Four (4) of these rounds were performed prior to the initiation of the Pilot Study, and the other sixteen (16) rounds were performed as part of the Pilot Study. Eight (8) rounds of sampling were performed in August, three (3) rounds in October, two (2) rounds each in February and September, and one (1) round each in January, April, June, July and November. Building-wide monthly PCB averages ranged from a high of 839.67 ng/m^3 , measured in July, 2010, to a low of 78.06 ng/m^3 , in February 2011. Please refer to Figure 9.1 for a graphical representation of the building-wide airborne PCB average concentration trend since the beginning of the Pilot Study in June, 2010.

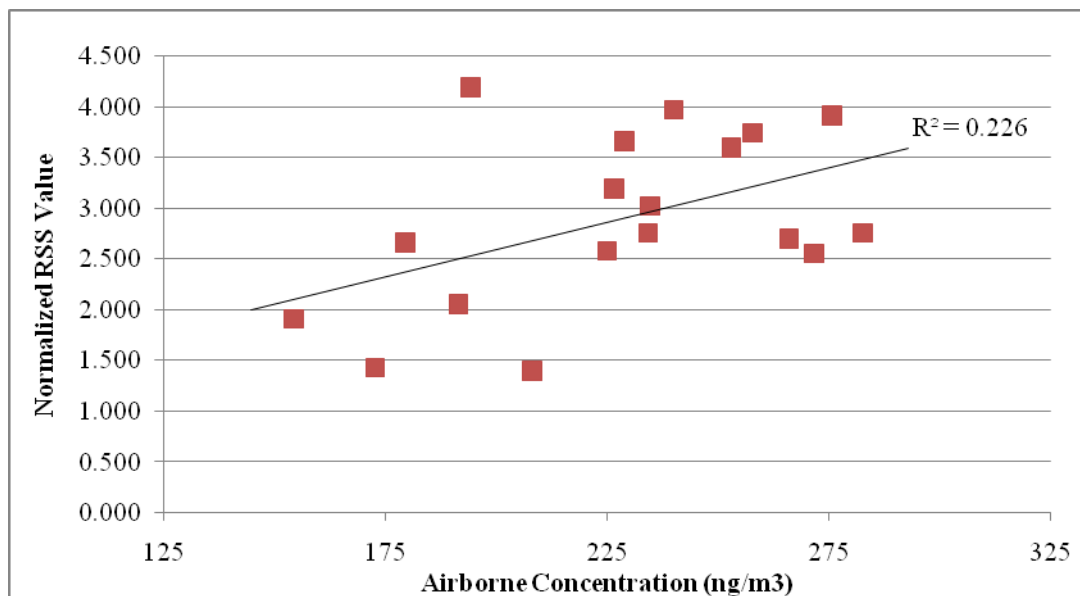
Figure 9.6 - Total Normalized Relative Source Strength versus Total Airborne PCB Concentration for Various Rooms Measured on 8/27/2010

The results suggest that there is no direct, positive correlation between the total quantity of other PCB containing materials in the various classrooms and the concentration of airborne PCBs measured within those rooms.

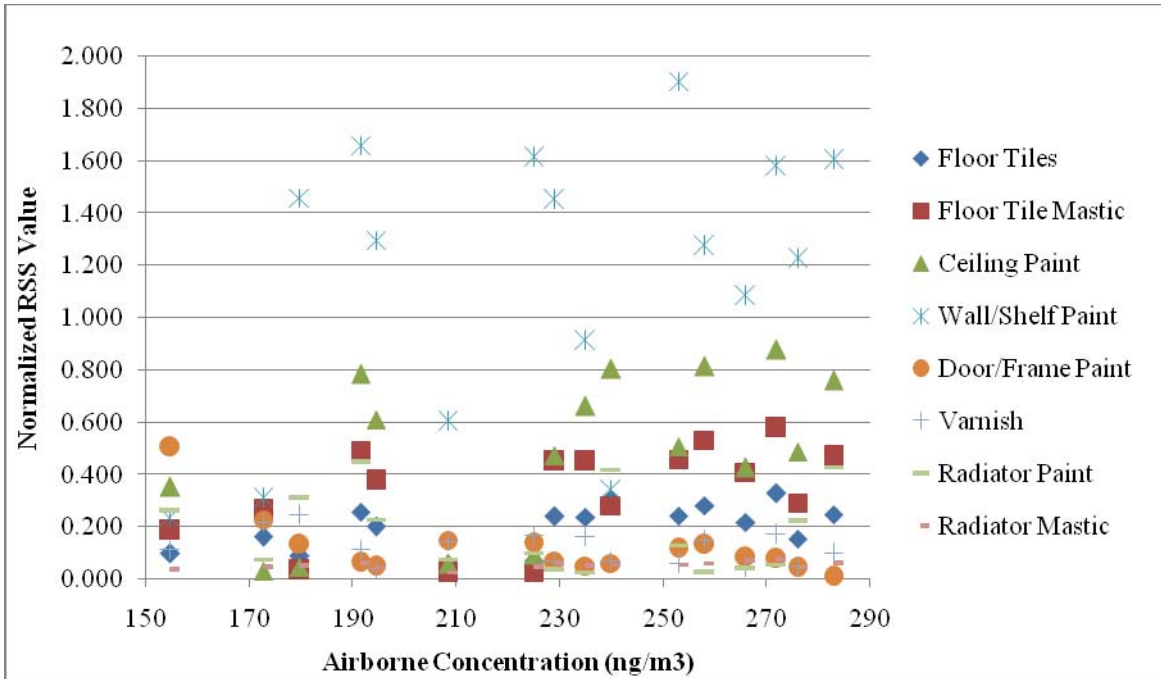
Figure 9.9 - Total Normalized Relative Source Strength versus Total Airborne PCB Concentration for Various Materials and Rooms Measured on 8/27/2010

The results suggest that there is no direct, positive correlation between the quantity of other, specific PCB containing materials in the various classrooms and the concentration of airborne PCBs measured within those rooms.

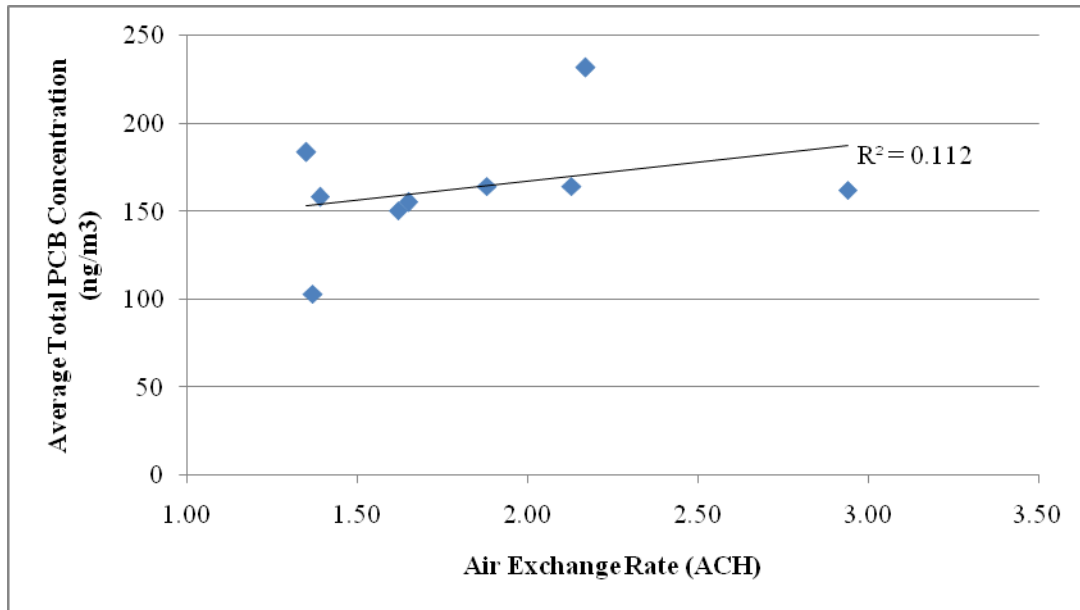
Figure 9.12 – 1st Floor Classroom Average Total Airborne PCB Concentrations versus Measured Air Exchange Rates at P.S. 199M

These particular data sets were selected because multiple rooms were sampled on each date, allowing a direct comparison between the results. In addition, all of the sampling events took place after the exhaust fans on the roof had been replaced, which was completed in September, 2008. As depicted in the following figures, no readily apparent correlation exists between the two (2) variables. Analysis of the airborne PCB concentration data versus the measured air exchange rates for both the first and third floor classrooms showed a slight positive correlation - as the air exchange rates increased, so too did the PCB concentrations. A slight negative correlation, however, was noted for the second floor classrooms.
