PhiladelphiaFederation of Teachers Health & Welfare Fund 1816 Chestnut Street

Evaluation of Indoor Environmental Quality [IEQ] at the JB Kelly E.S.

Evaluation Date: 11.25.2015

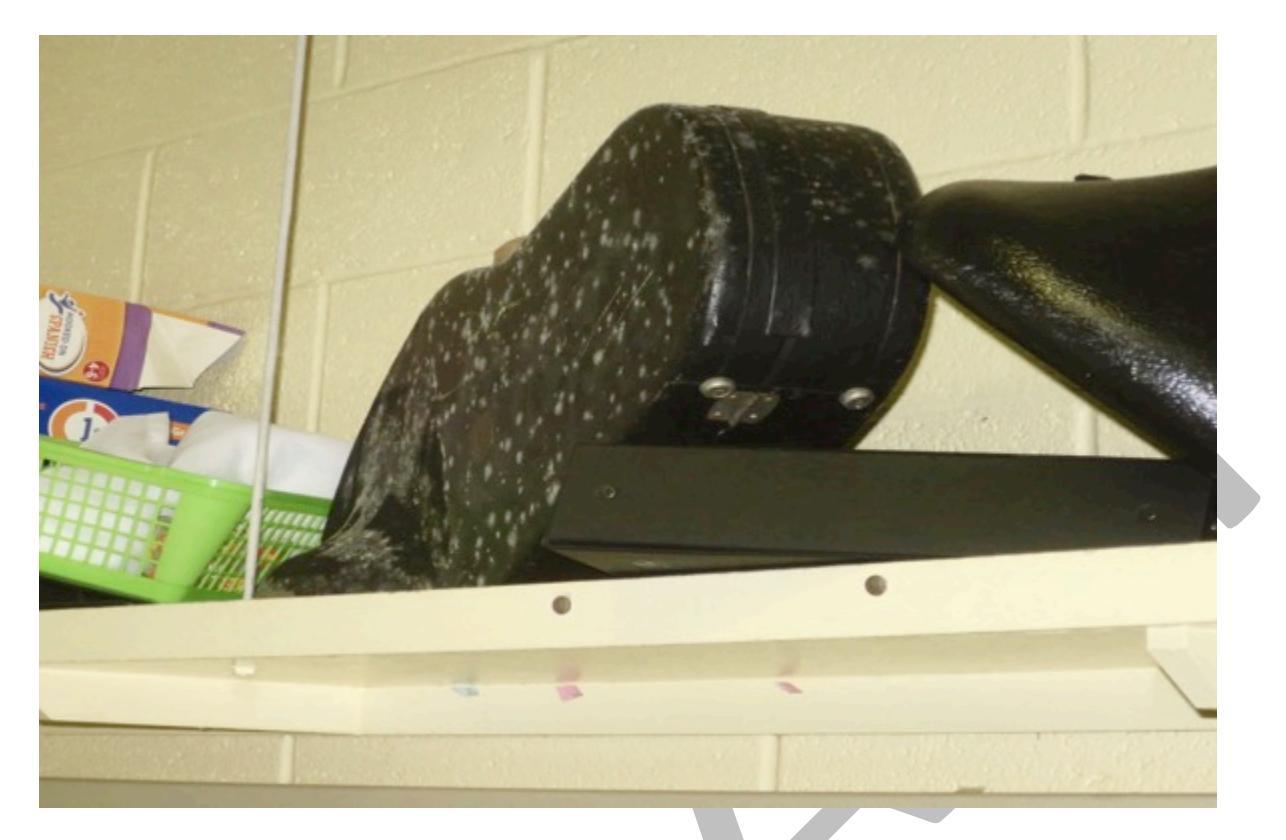
Photo 1: JB Kelly E.S. - 11.25.2015 - Music "Dressing Room D" - Mold Growth on Musical Instrument Case

- Immediately retrieve all musical instruments and cases that are in the possession of students and evaluate potential mold contamination & decontaminate as necessary;

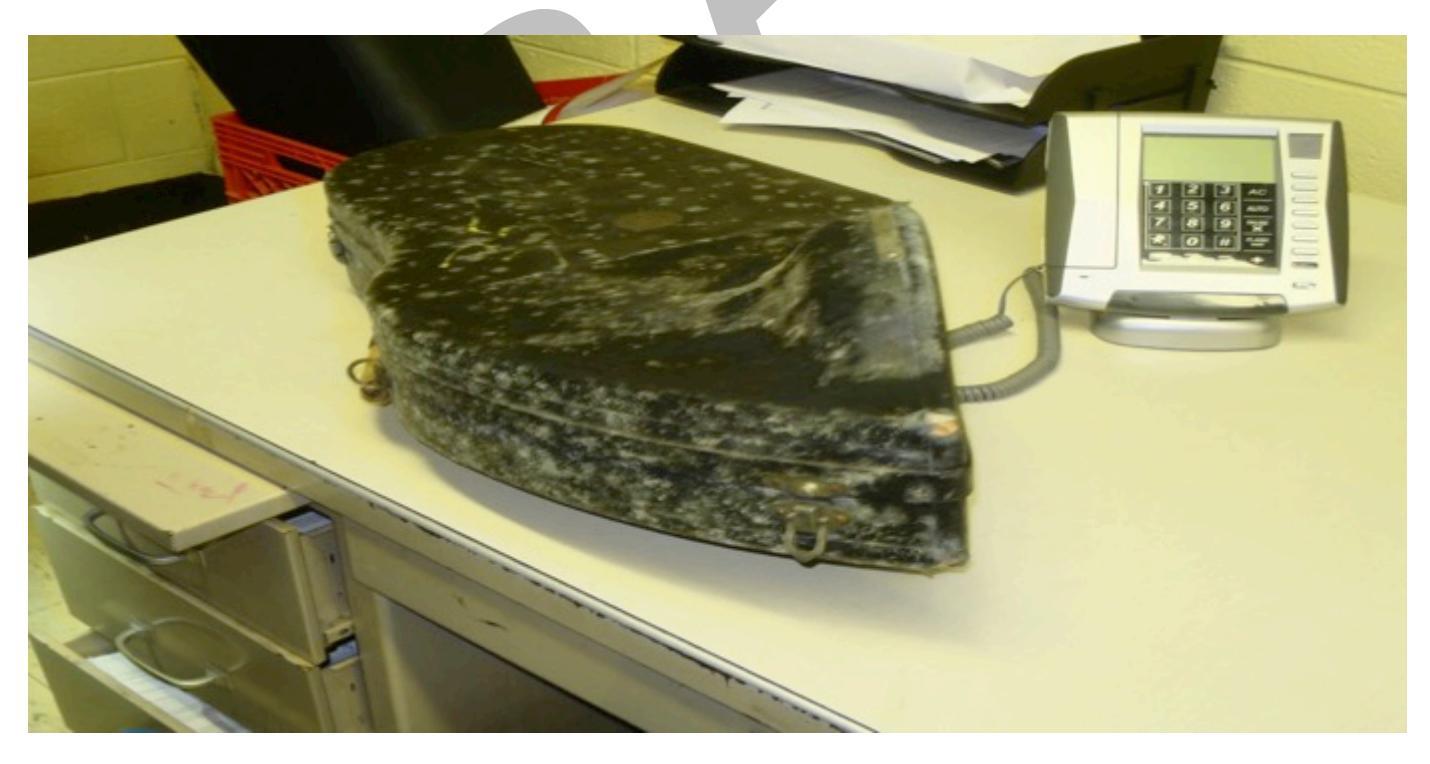
Photo 2: JB Kelly E.S. - 11.25.2015 - Music "Dressing Room D" - Mold Growth on Musical Instrument Case

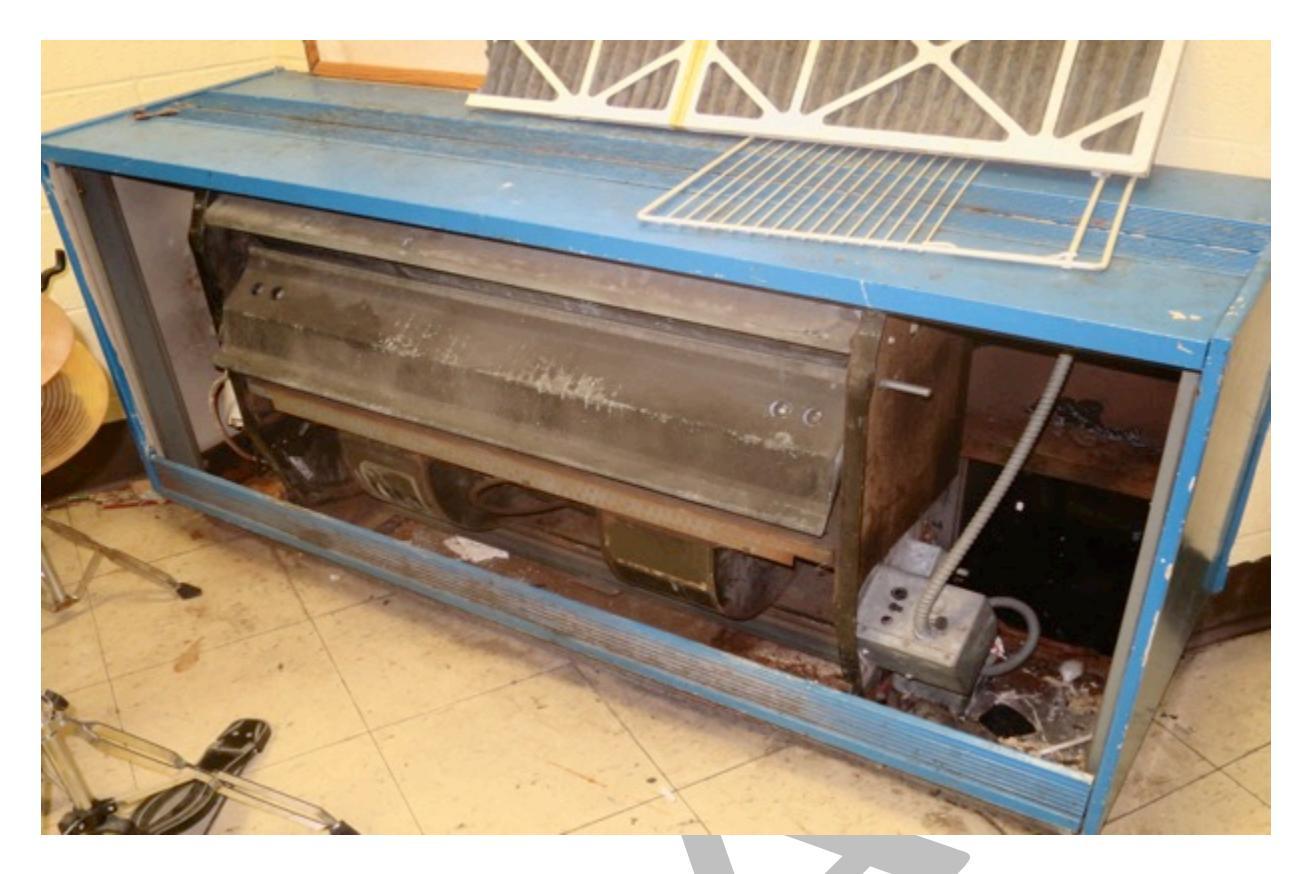
- Persistent respiratory symptoms and illness requiring ongoing medical evaluation & care.
- The classroom unit ventilator [CUV] in the music room was very dirty and, as reported, CUV air filters had been clogged with dust, dirt and debris and/or were missing.

Photo 3: JB Kelly E.S. - 11.25.2015 - Classroom Unit Ventilator [CUV] - Dirty

- Assess all school CUVs for filter status & unit cleanliness & address as necessary;
- Conduct comprehensive follow-up inspection activities in order to evaluate IEQ, moisture, dampness and mold problems throughout the school;

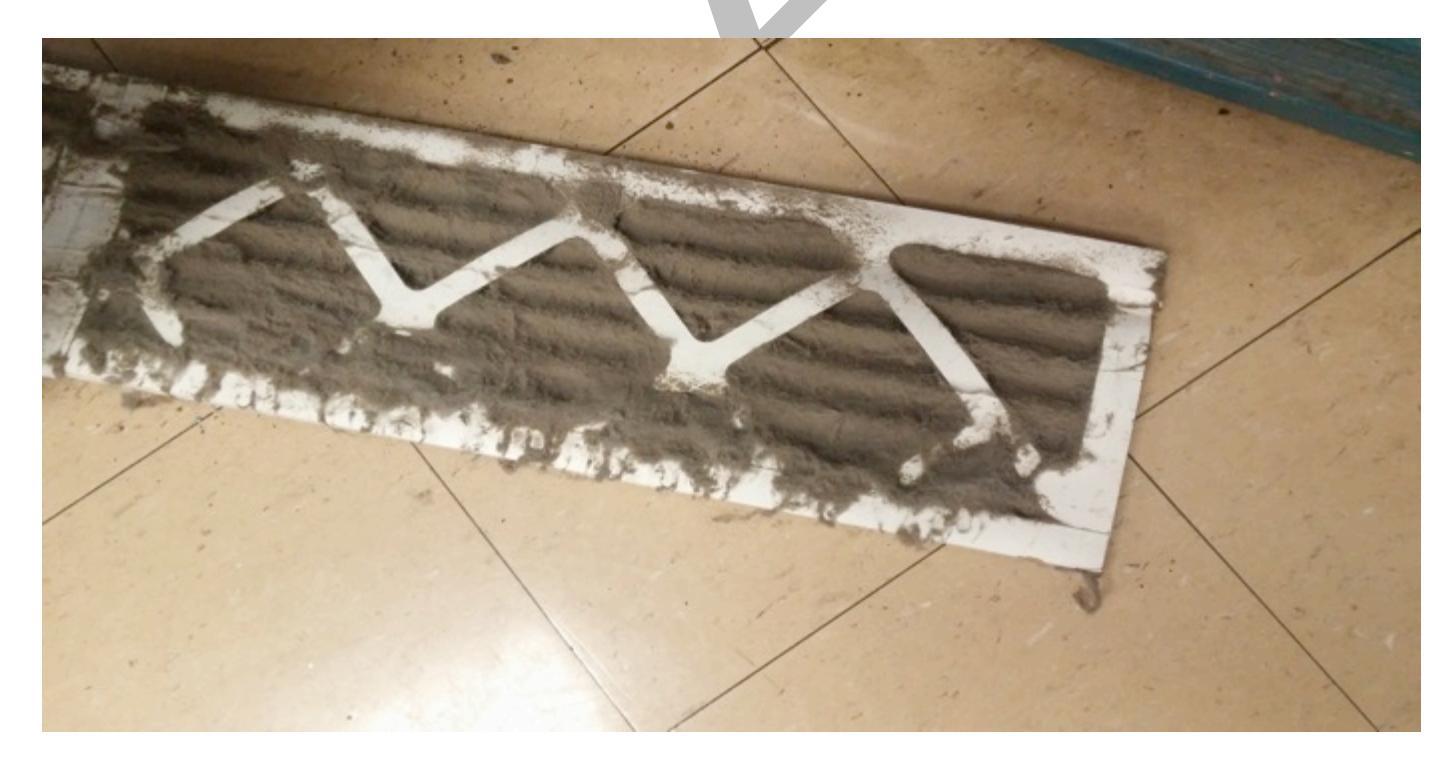
We explained that we had received a health-related concern from the music room teacher and been asked to conduct a site visit related to the condition of filters in some of the school CUVs. [Photo 1 represents the air filter removed from the CUV in classroom]. The BE told us that he was informed about the dirty filter and that he replaced it and one other filter as well.

Photo 4: JB Kelly E.S. - 11.25.2015 - CUV Filter

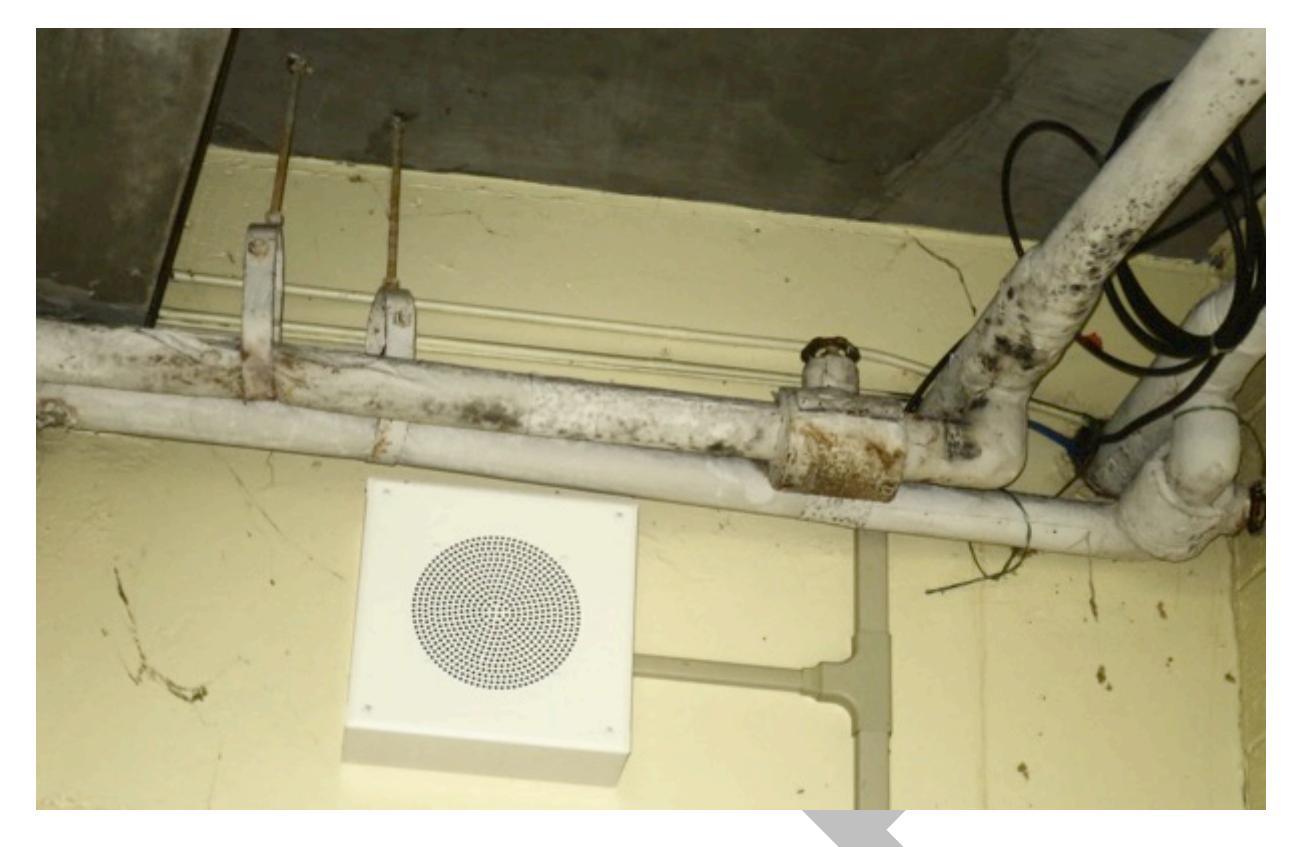
Photo 5: JB Kelly E.S. - 11.25.2015 - Music "Dressing Room D" - Mold Growth on Pipe Insulation

- Remove all visible mold from surfaces indicated as "contaminated" in this report & in any/all additional reports from SDP-OEMS;
- Follow the methods & approaches used to address the mold contamination of musical instruments at Shawmont E.S. in 2012;

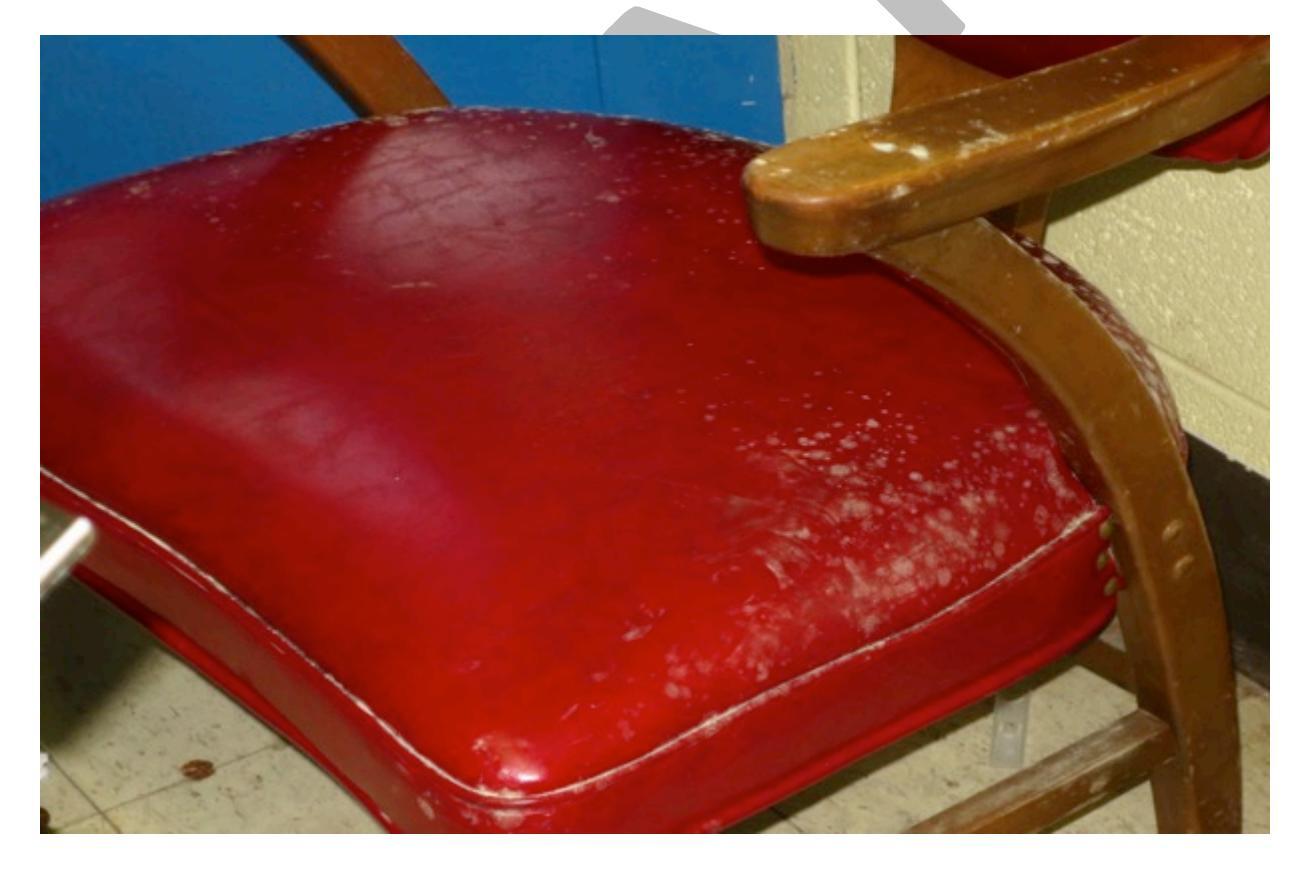
Photo 6: JB Kelly E.S. - 11.25.2015 - Music "Dressing Room D" - Mold Growth on Chair

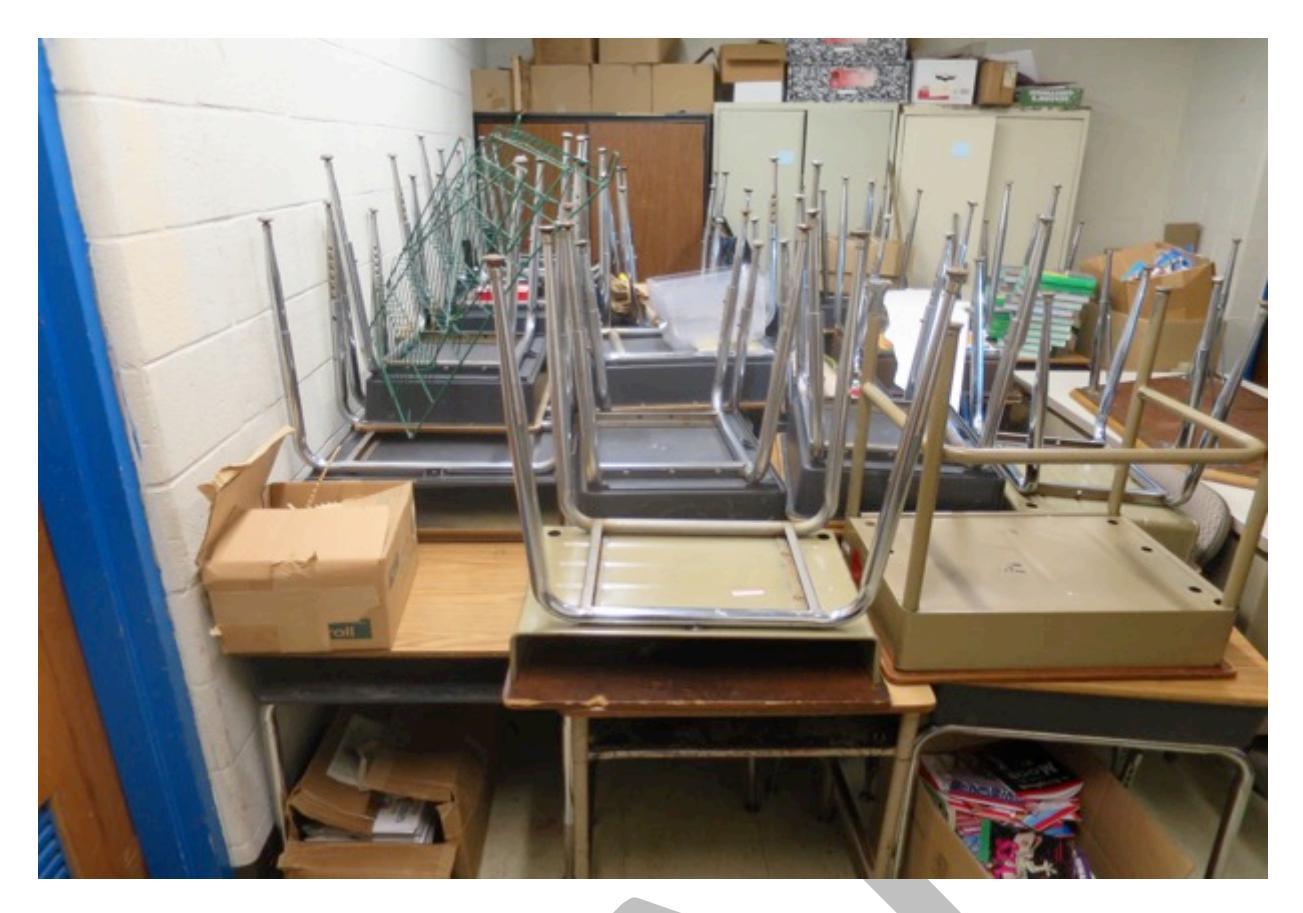
Photo 7: JB Kelly E.S. - 11.25.2015 - Music Suite Closet - Mold Growth on/in Student Desks

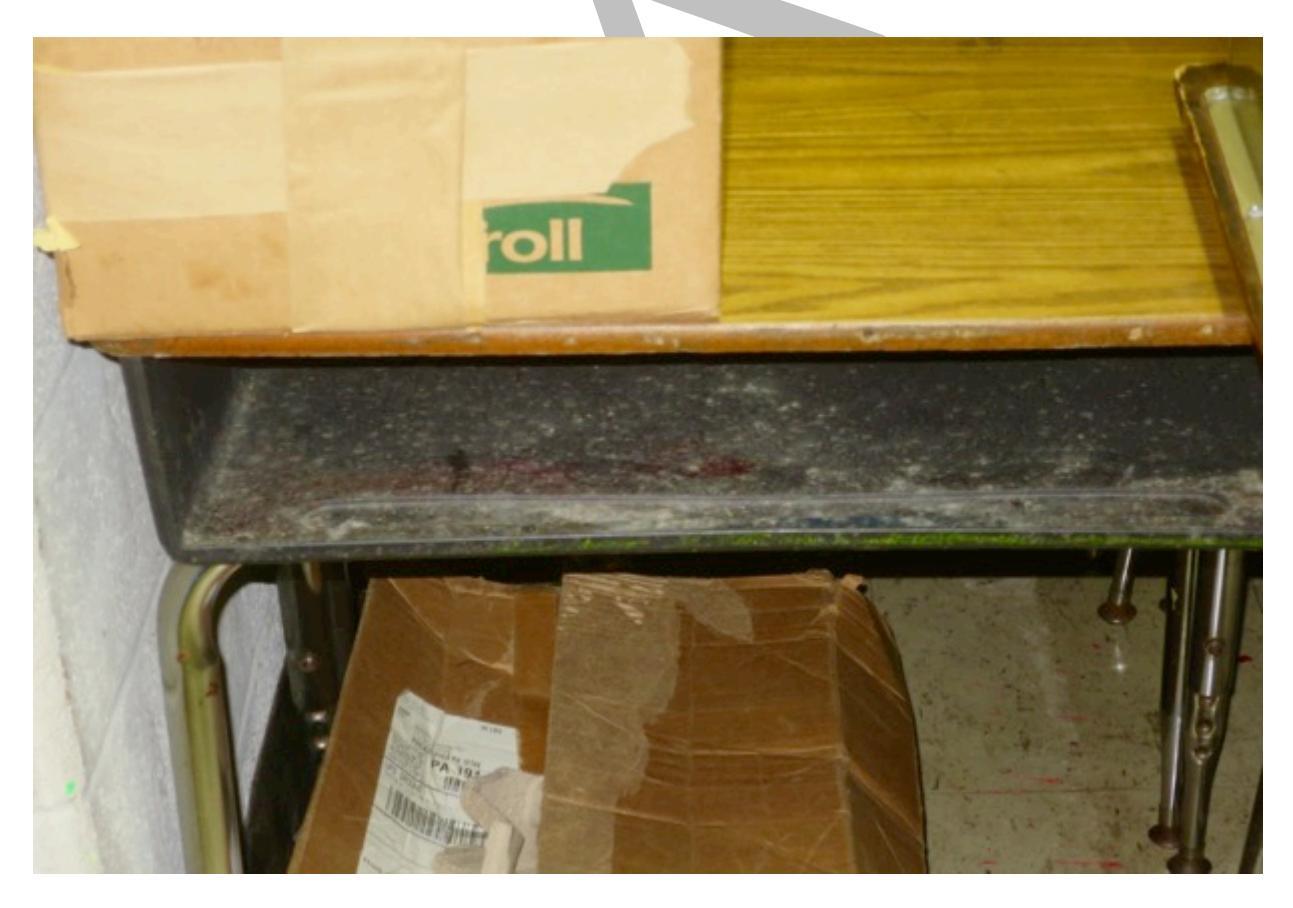
Photo 8 JB Kelly E.S. 11.25.2015 - Music Suite Closet - Mold Growth on/in Student Desks [Close-Up]
