School District of Philadelphia
Office of Environmental Management Services
440 North Broad St.
Philadelphia, PA 19030

Mold Design Data Collection (DDC)

Name of Building: J.B. Kelly Elementary School

Address: 5116 Pulaski Avenue ULCS # 6470

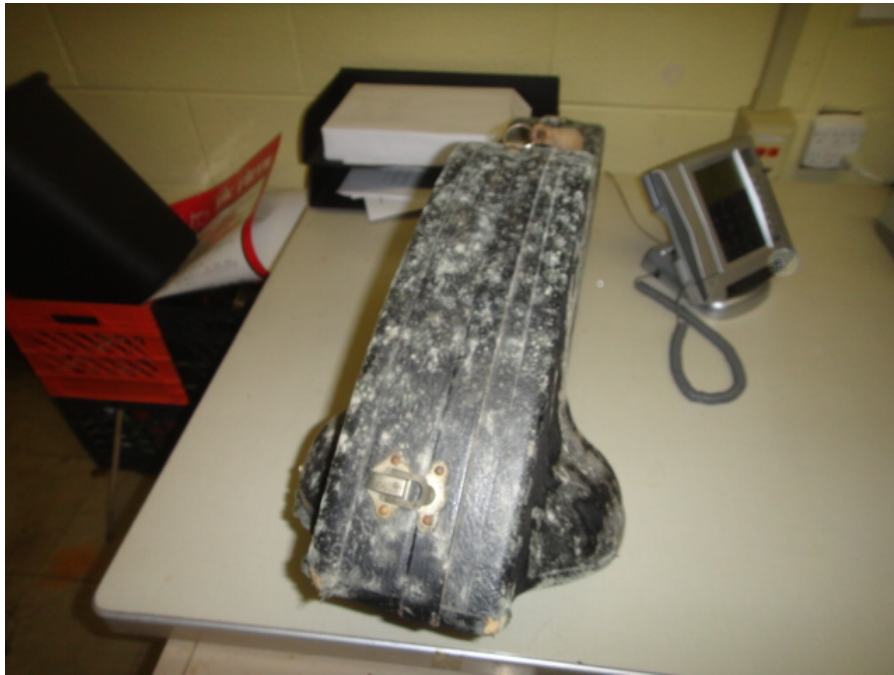
Action Item	Affected Material(s)	Total Quantity	Remediation*	Source of Moisture	Comments/Condition (i.e. dry/wet)
1	Mold growth was observed on sections of the musical instrument cases. Suspect mold growth was observed on the interior lining of the cases.	16 EA	CLN	Active pipe leak and presumed A/C condensation issue during the cooling season	Reference cleaning protocol on page 4
2	Mold growth was observed on fiberglass pipe insulation.	12 LF	RMV, RPL		Remove the impacted fiberglass pipe insulation. Water was observed on the floor below this line, this line may have a slow leak and will need to be evaluated and repaired before it can be re-insulated.
3	Mold growth was observed on the vinyl covered chairs.	2 EA	CLN, or DIS		Either clean or discard the impacted vinyl covered chairs.
4	Non-mold task - General cleaning of contents, i.e. music stands, drums and other non-porous materials.	N/A	CLN		A general cleaning/wet wiping of all non-porous materials should be performed.

Photo 1 – Dressing Room D
Mold growth was observed on the instrument cases.

Musical Instrument Remediation Recommend Cleaning Protocol

1. Remove the instrument from the case. HEPA vacuum exterior of instrument. Use an air compressor along with the HEPA vacuum to remove any particulates located on the interior.
2. Using a detergent solution and a damp cloth or soft bristle brush gently clean exterior of instrument. Immediately dry instrument with a soft cloth.
3. Once the instrument has been inspected for cleanliness and approved, wipe exterior with a Murphy's Oil Soap moist towelette.
4. HEPA vacuum the interior fabric and exterior of the case to remove any visible mold growth. Once inspected for cleanliness and approved, wipe both exterior and interior with a Lysol disinfectant wipe.
5. Leave empty case open until interior is completely dry (in staging area with dehumidifier and fans). Insert desiccant packs prior to packing cleaned and dried string instrument and move to the clean area.

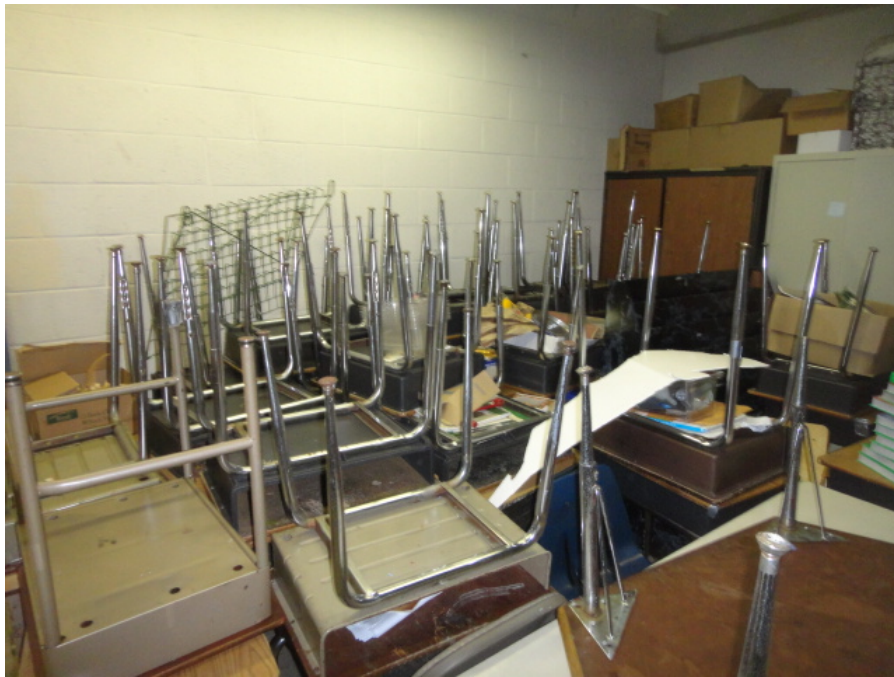
Photo 11– Storage outside Dressing Room D

Action Item	Affected Material(s)	Total Quantity	Remediation*	Source of Moisture	Comments/Condition (i.e. dry/wet)
12	Mold growth was observed inside the student desks in the storage area.	Approx. 40 EA	CLN or DIS	Presumed A/C condensation issue during the cooling season	The impacted student desks should HEPA vacuumed and cleaned or discarded.

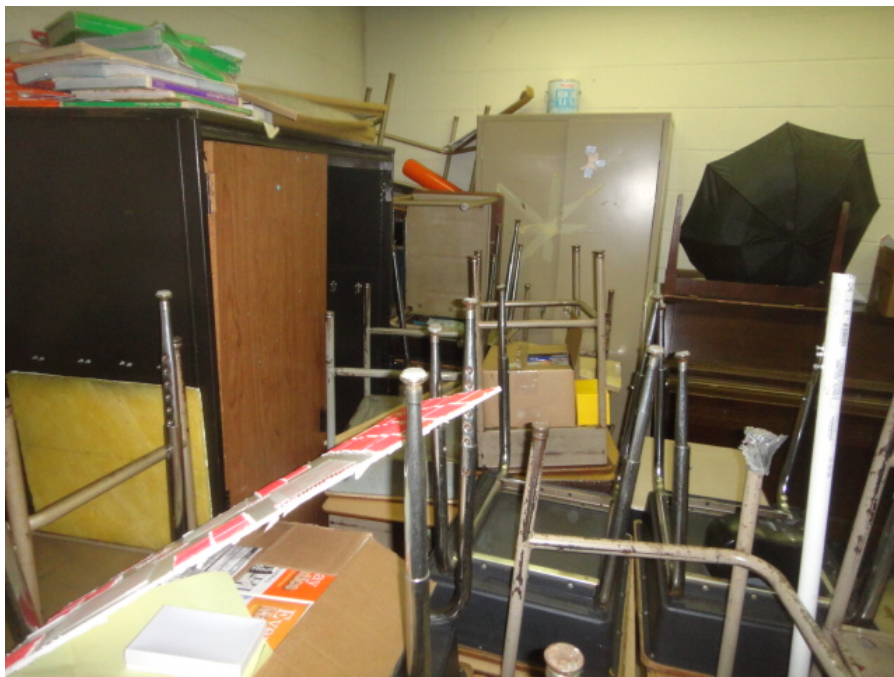
Photo 14 – Storage outside Dressing Room A

Action Item	Affected Material(s)	Total Quantity	Remediation*	Source of Moisture	Comments/Condition (i.e. dry/wet)
13	Mold growth was observed inside the student desks in the storage area.	Approx. 20 EA	CLN or DIS	Presumed A/C condensation issue during the cooling season	The impacted student desks should HEPA vacuumed and cleaned or discarded.
14	Suspect mold growth was observed on the roof drain pipe fitting insulation located at the ceiling.	1 EA	CLN, ENP		The impacted pipe fitting insulation should be cleaned and encapsulated.
