2012 Facilities Condition Assessment & Building Data Collection Project

Wyoming School Facilities Department

**WSFD RFQ PS 0625
FEA Project # R05.2011.000700
September 28, 2012**

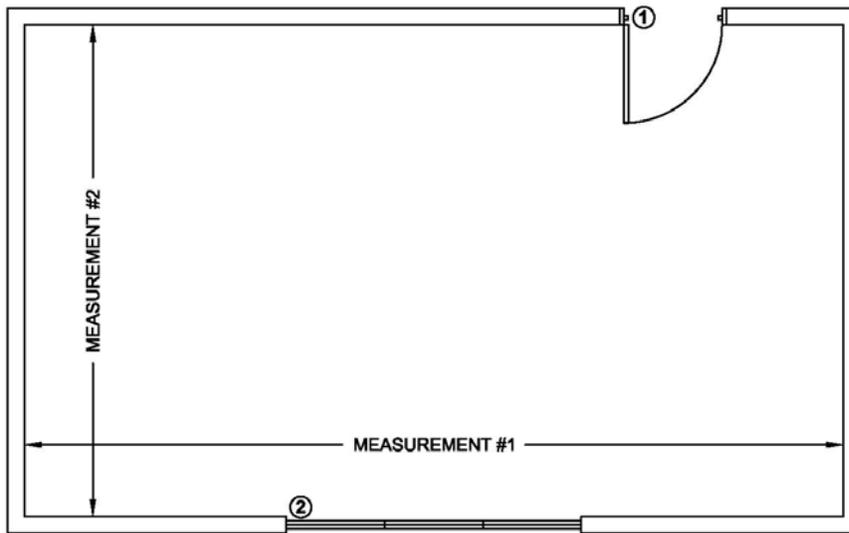
Figure 1: Rectangular Classroom

1. Width of interior walls typically measured at doorways.
2. Width of exterior walls can be measured at windows or doorways.

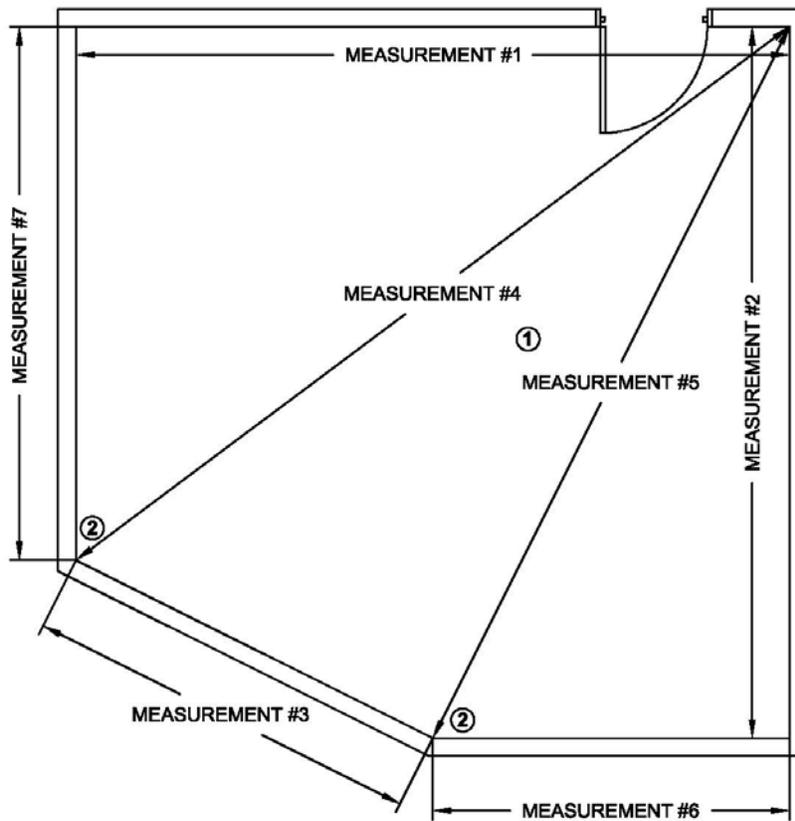
Figure 2: Non-rectangular Classroom

1. Measure diagonal segments such that the room can be drawn using basic geometry.
2. If possible, measure interior angles for confirmation.

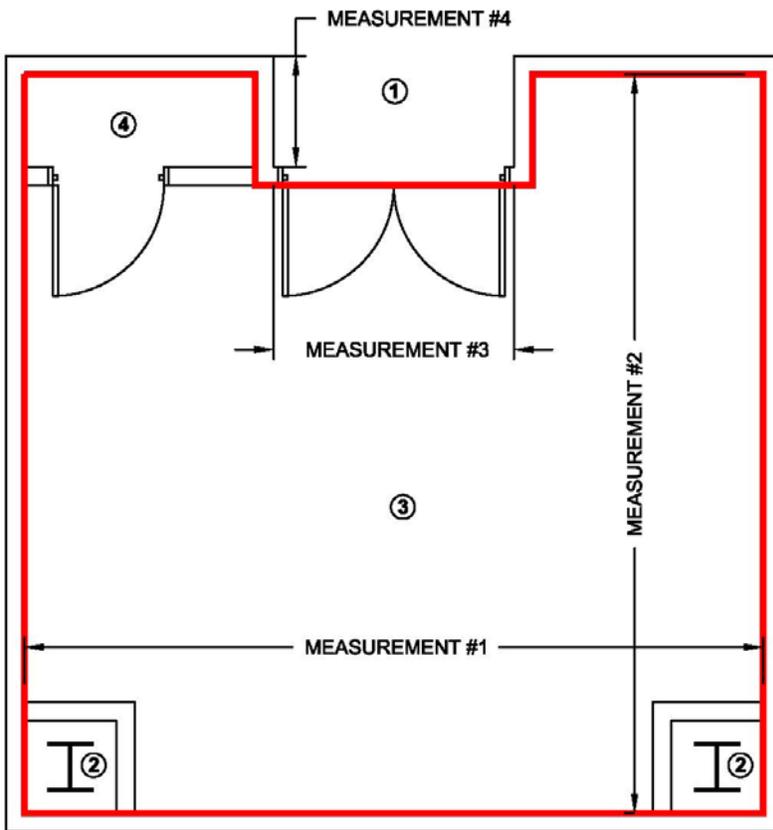
Figure 3: Classroom with Column Bump-out and Space-Specific Closet

1. The area in front of a recessed doorway is measured and counted as part of the area outside (typically a hallway) of the space.
2. Column bump-outs were not measured or removed from the overall square footage of the space.
3. The main space is measured as a rectangle.
4. This space is included in the main space if the closet is used specifically for the main space.

The total square footage of this space is shown by the area outlined in red.

Note that the walls will only be reflected in the gross square footage.

While measuring each room, interior column bump-outs and non accessible mechanical chases were not removed from the overall square footage of the space. Additionally, storage closets or built-in cabinets used by only that space were not removed from the overall square footage of the space. However, built-in bathrooms or storage not used for the main space were classified separately. Built-in lockers in hallways were measured, classified separately from the hallway, and assigned their own room or space designation. Examples of these cases are illustrated in Figure 3 thru Figure 6.

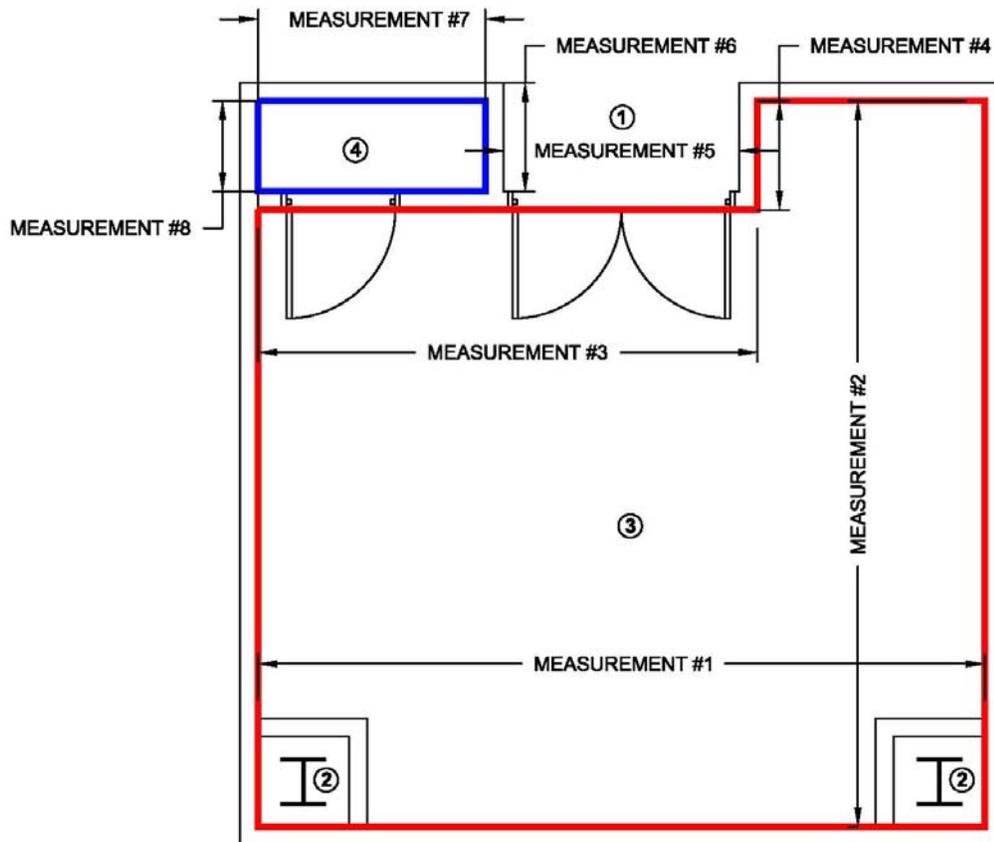
Figure 4: Classroom with Column Bump-out and Non-Space-Specific Closet

1. The area in front of a recessed doorway is measured and counted as part of the area outside (typically a hallway) of the space.
2. Column bump-outs were not measured or removed from the overall square footage of the space.
3. The main space is measured as a rectangle.
4. If this space is not used by the main space (example: IT closet in a general classroom) then it is counted as its own space with its own square footage

The total square footage of the main space is shown by the red outline and the total square footage of the non-space-specific closet space is shown by the blue outline.

Note that the walls will only be reflected in the gross square footage.

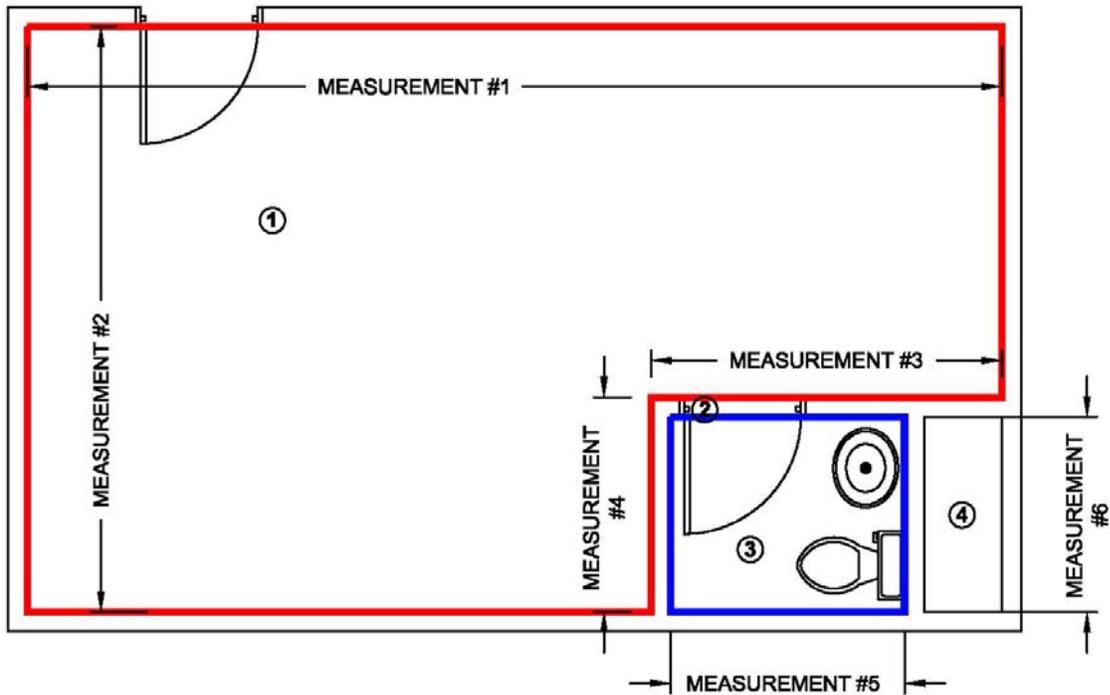
Figure 5: Classroom with Bathroom and Mechanical Chase

1. Measure and classify the main space.
2. Obtain wall thickness at the doorway as usual.
3. Measure the restroom and classify it as a separate space.
4. The plumbing/mechanical chase is not accessible and not measured or included in the overall square footage of either the main space or the restroom. This area is included in the building gross square footage.

The total square footage of the main space is shown by the red outline and the total square footage of the bathroom is shown by the blue outline.

Note that the walls and the plumbing/mechanical chase will only be reflected in the gross square footage.

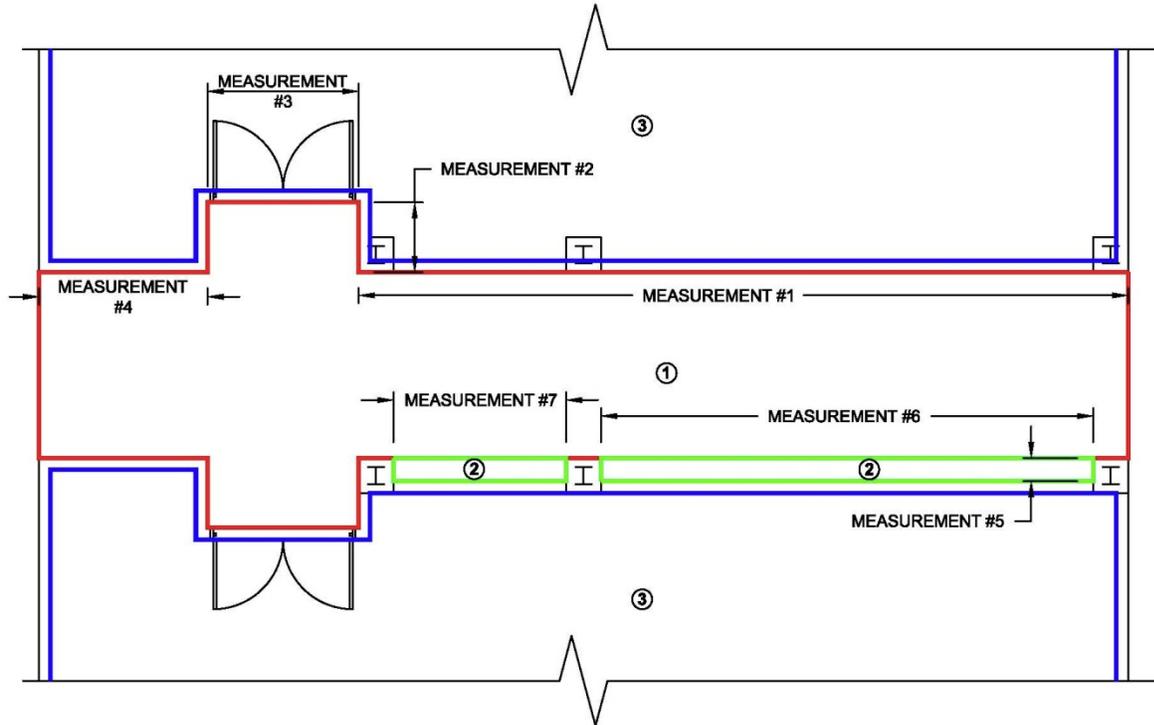
Figure 6: Hallway with Built-In Lockers

1. The overall hallway measured and classified as horizontal circulation (outlined in red).
2. The built-in lockers measured separately from the hallway space and classified as assigned storage (outlined in green). Their square footage is not included within the hallway total.
3. The rooms are still measured from the interior face and are not affected by the built-in lockers (outlined in blue).

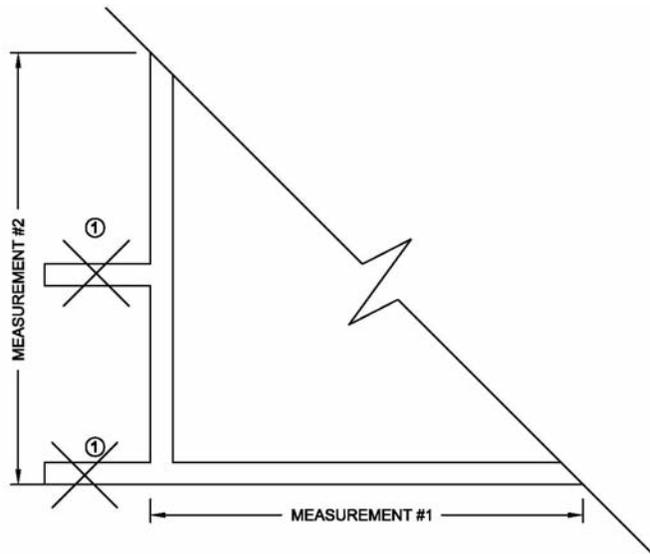
Figure 7: Exterior Perimeter Wing Wall

1. Exterior wing walls were not measured or shown on drawings.

The perimeter of the facility was typically measured using the 100-foot tape measure and/or Disto. The team would work their way around the building measuring the overall length of each of the perimeter walls. Wing walls or architectural bump-outs that did not contain any interior space that could be occupied were not measured (Refer to Figure 7 for clarification).
