City of Long Beach
2013 Update of Select Facilities
Facilities Condition Assessment Report

September 17, 2013

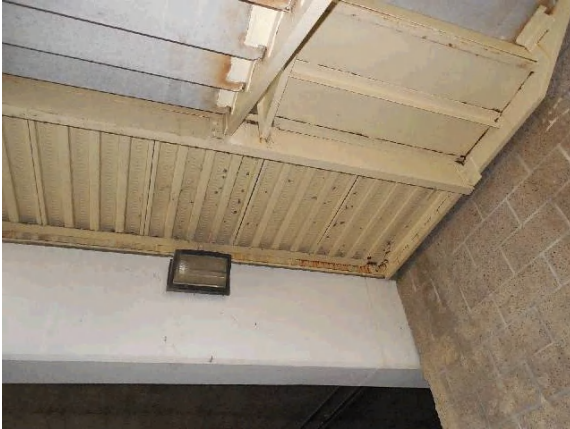
System: C2010 - Stair Construction

Analysis: The system is in good condition. The system was installed in 1984. It has a 50-year service life. However, in the assessment, it was found to be currently deficient.

Material: Stairs

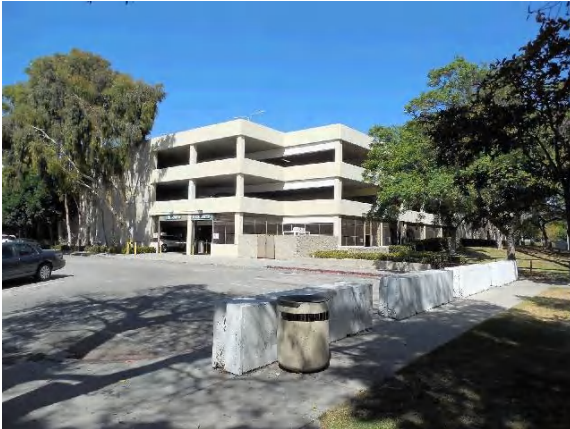
System: C3010 - Wall Finishes

Analysis: The system is in poor condition. The system was installed in 1984. It has a 5-year service life which expired in 1989.

Location: Building Systems
Material: Exterior Walls - Paint
Distress: Beyond Useful Life
Category: Capital Renewal
Priority: 4 - Recommended
Correction: Paint exterior concrete walls at parking structure
Qty: 50,000-S.F.
Estimate: \$98,195.62
Assessor Name: Tom Moe
Date Created: 09/12/2013

Notes: Paint exterior concrete walls and precast concrete walls

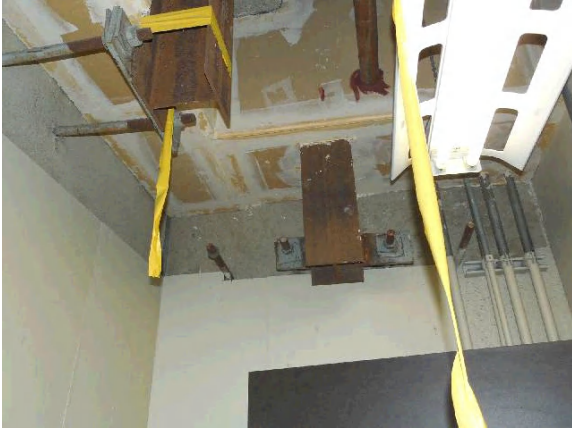
System: B1000 - Siesmic Upgrade

Analysis: The system The system was installed at an unknown date.

Material: Steel Joists Beams and Deck on column

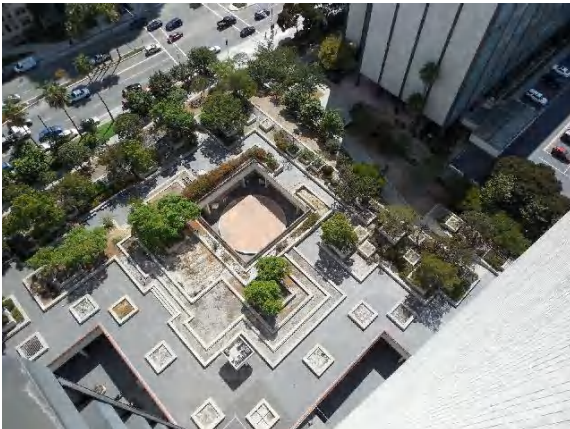
System: B3010 - Roof Coverings

Analysis: The system is in poor condition. The system was installed at an unknown date. It has a 25-year service life.

Location: Building Systems
Material: System
Distress: Beyond Useful Life
Category: Capital Renewal
Priority: 4 - Recommended
Correction: Renew System
Qty: 1-Ea.
Estimate: \$10,572,430.26
Assessor Name: Tom Moe
Date Created: 09/10/2013

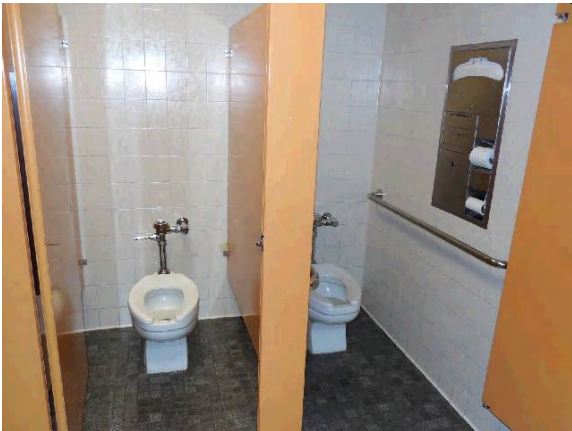
System: C1000 - ADA Restroom Upgrades

Analysis: The system The system was installed at an unknown date.

Material: ADQ Restroom Upgrades - Per Restroom

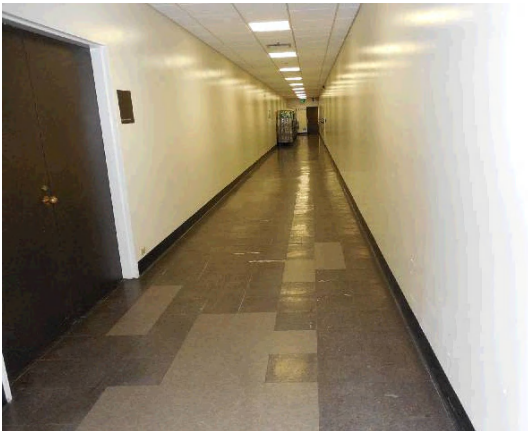
System: C3020410 - VCT

Analysis: The system is in poor condition. The system was installed in 1997. It has a 12-year service life which expired in 2009.

Location: Building Systems
Material: System
Distress: Beyond Useful Life
Category: Capital Renewal
Priority: 4 - Recommended
Correction: Renew System
Qty: 1-Ea.

Estimate: \$698,070.50

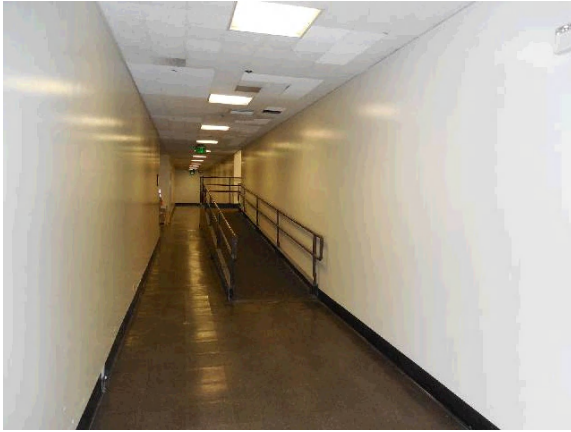
System: C3030 - Ceiling Finishes

Analysis: The system is in good condition. The system was installed in 1997. It has a 25-year service life. However, in the assessment, it was found to be currently deficient.

Material: Ceilings Suspended ACT-Tile Only/SF

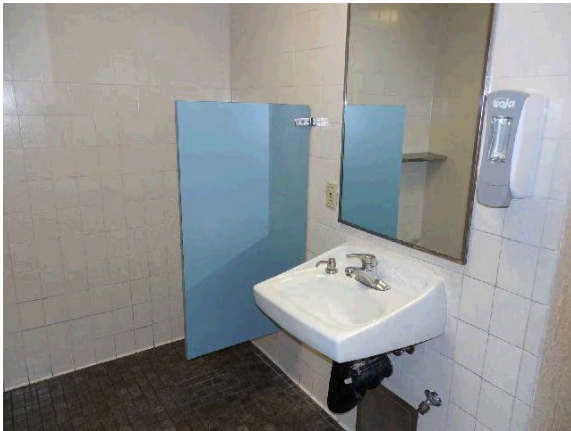
System: D2010 - Plumbing Fixtures

Analysis: The system is in poor condition. The system was installed in 1976. It has a 30-year service life which expired in 2006.

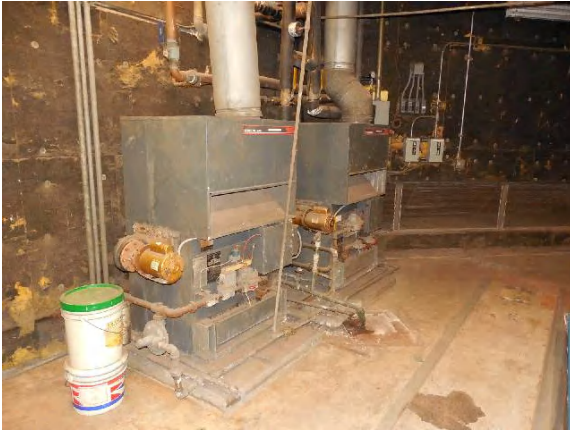
System: D2020 - Domestic Water Distribution

Analysis: The system is in poor condition. The system was installed at an unknown date. It has a 30-year service life.

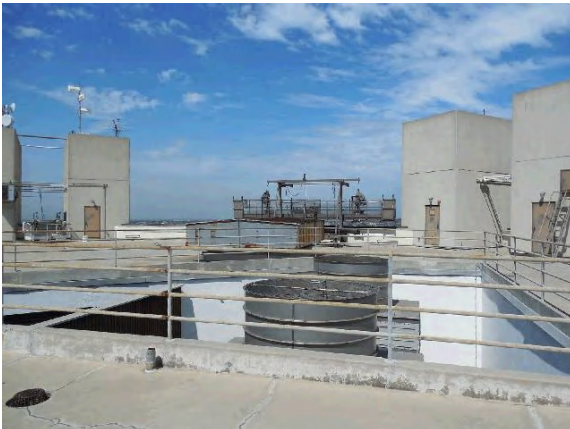
System: D2040 - Rain Water Drainage

Analysis: The system is in poor condition. The system was installed in 1976. It has a 30-year service life which expired in 2006.

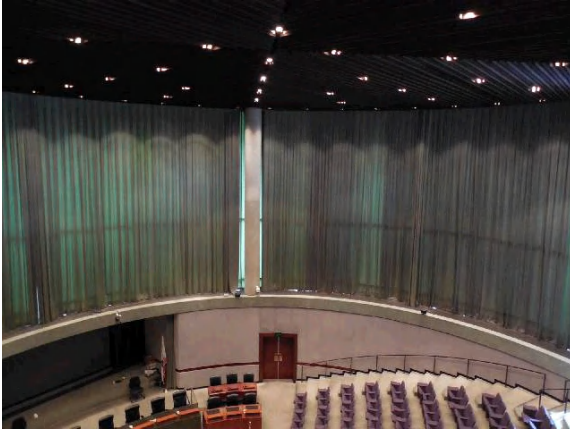
System: D5020 - Lighting and Branch Wiring

Analysis: The system is in poor condition. The system was installed in 1976. It has a 30-year service life which expired in 2006.

Location: Building Systems
Material: System
Distress: Beyond Useful Life
Category: Capital Renewal
Priority: 4 - Recommended
Correction: Renew System
Qty: 1-Ea.
Estimate: \$5,229,347.52
Assessor Name: John Oualline
Date Created: 09/12/2013

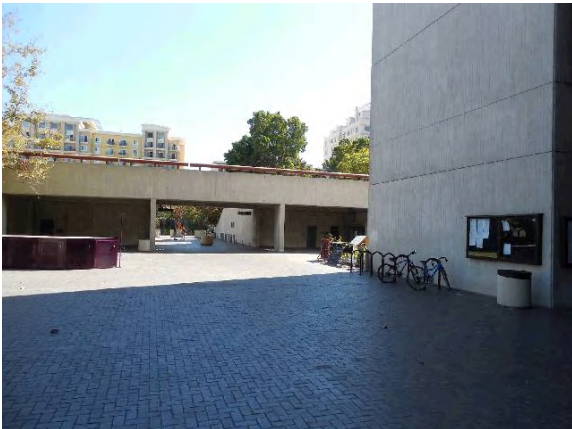
System: B3020 - Roof Openings

Analysis: The system is in poor condition. The system was installed in 1977. It has a 0-year service life which expired in 1977.

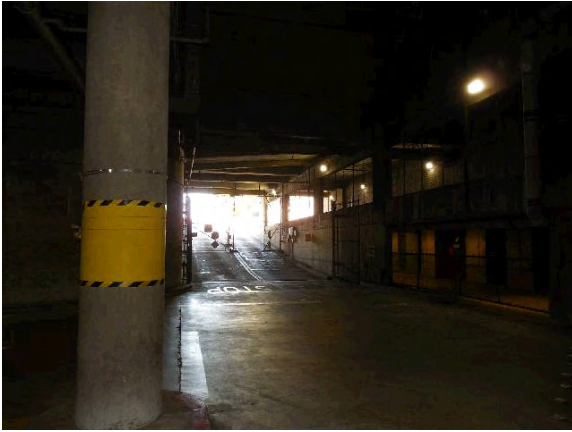
System: D5020 - Lighting and Branch Wiring

Analysis: The system is in poor condition. The system was installed in 1977. It has a 30-year service life which expired in 2007.

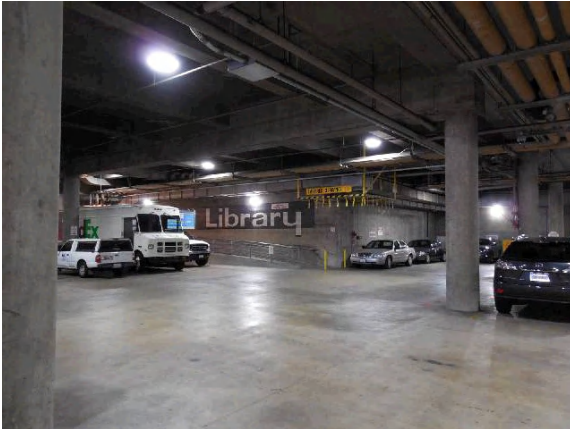
System: D5090 - Other Electrical Systems

Analysis: The system is in poor condition. The system was installed in 1977. It has a 15-year service life which expired in 1992.

Location: Building Systems
Material: System
Distress: Beyond Useful Life
Category: Capital Renewal
Priority: 4 - Recommended
Correction: Renew System
Qty: 1-Ea.
Estimate: \$23,065.58
Assessor Name: John Oualline
Date Created: 09/12/2013

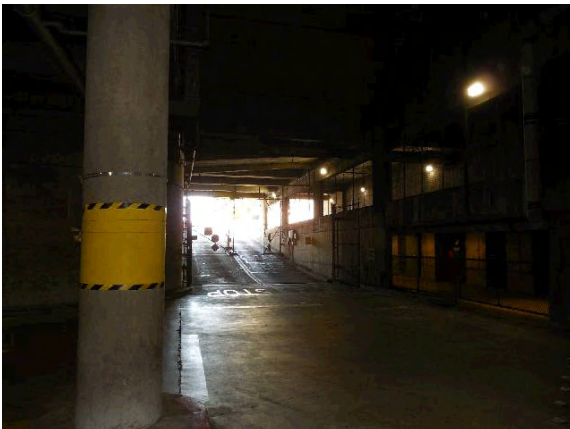
System: E1030 - Vehicular Equipment

Analysis: The system is in poor condition. The system was installed in 1977. It has a 15-year service life which expired in 1992.

Location: Building Systems
Material: System
Distress: Beyond Useful Life
Category: Capital Renewal
Priority: 4 - Recommended
Correction: Renew System
Qty: 1-Ea.
Estimate: \$29,552.78
Assessor Name: John Oualline
Date Created: 09/12/2013

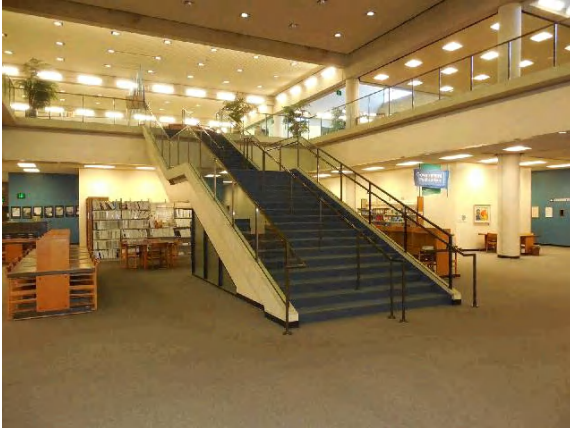
System: B1000 - Seismic Upgrade

Analysis: The system The system was installed at an unknown date.

Material: Steel Joists Beams and Deck on column

Distress: Inadequate

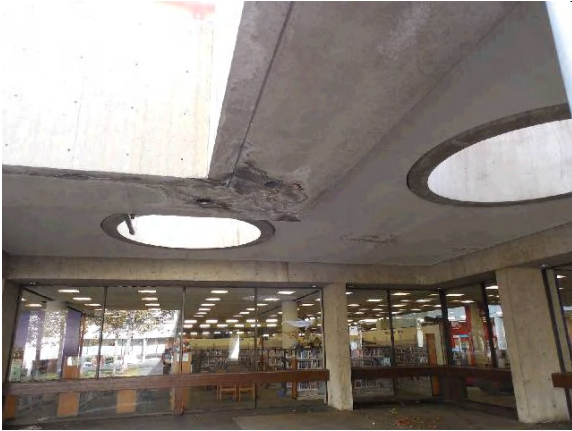
System: B2020 - Exterior Windows

Analysis: The system is in poor condition. The system was installed in 1977. It has a 30-year service life which expired in 2007.

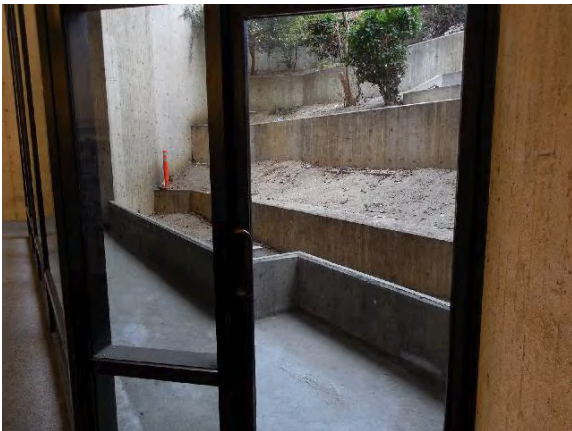
System: B2030 - Exterior Doors

Analysis: The system is in poor condition. The system was installed in 1977. It has a 30-year service life which expired in 2007.

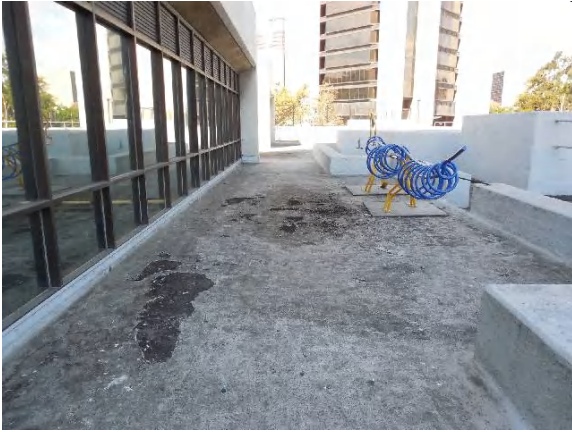
System: B3010 - Roof Coverings

Analysis: The system is in poor condition. The system was installed in 1977. It has a 25-year service life which expired in 2002.

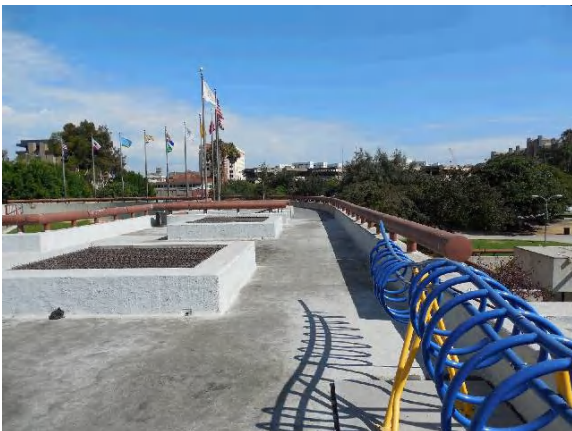
System: B3020 - Roof Openings

Analysis: The system is in poor condition. The system was installed in 1977. It has a 25-year service life which expired in 2002.

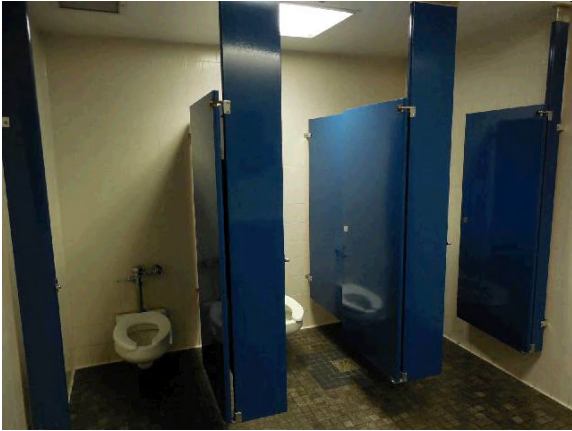
System: C1000 - ADA Restroom Upgrade

Analysis: The system The system was installed at an unknown date.

Material: ADQ Restroom Upgrades - Per Restroom

Distress: Inadequate

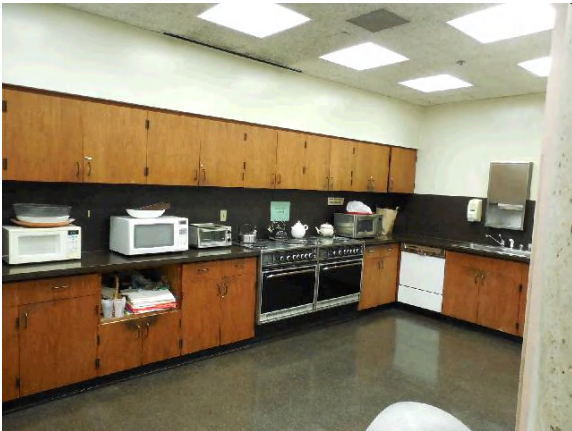
System: C1030 - Fittings/Specialties

Analysis: The system is in poor condition. The system was installed in 1977. It has a 20-year service life which expired in 1997.

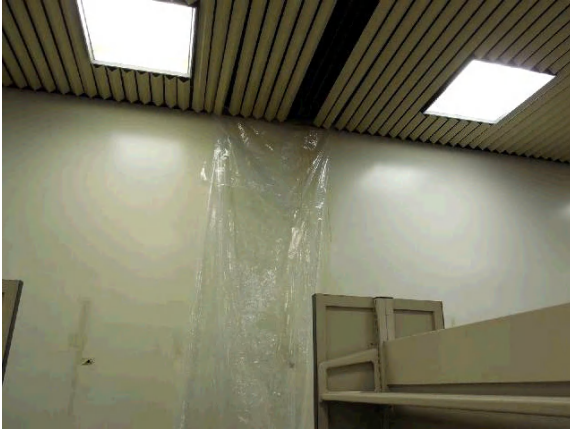
System: C3010 - Wall Finishes

Analysis: The system is in poor condition. The system was installed in 1977. It has a 5-year service life which expired in 1982.

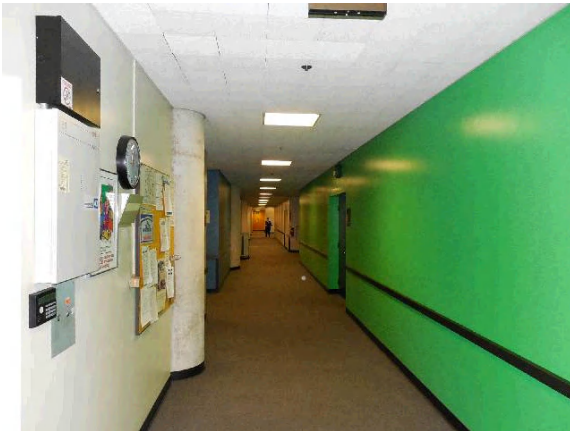
System: C3020410 - Carpet - 50%

Analysis: The system is in poor condition. The system was installed in 1977. It has a 7-year service life which expired in 1984.

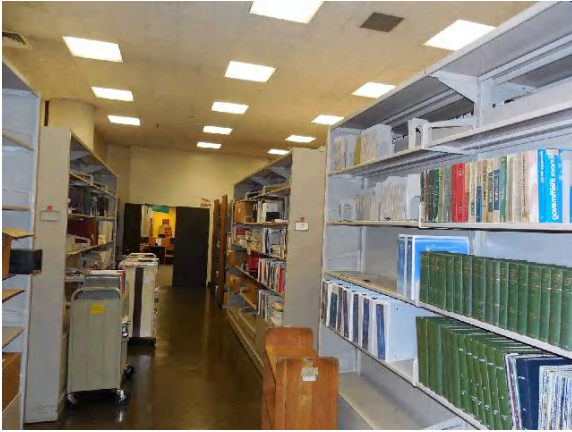
System: C3020410 - VCT - 50%

Analysis: The system is in poor condition. The system was installed in 1977. It has a 12-year service life which expired in 1989.

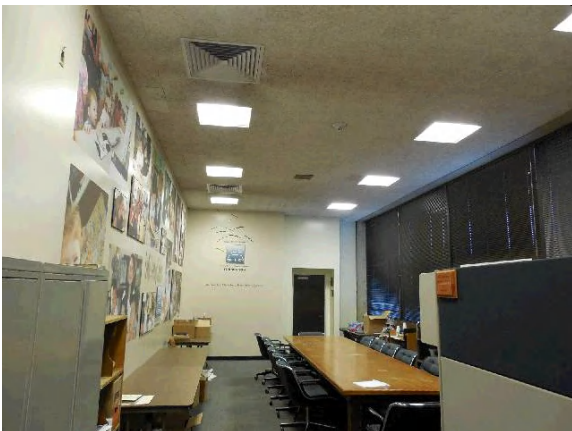
System: C3030 - Ceiling Finishes

Analysis: The system is in poor condition. The system was installed in 1977. It has a 25-year service life which expired in 2002.

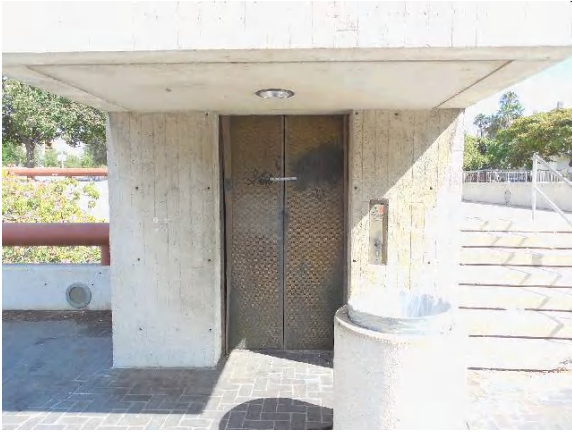
System: D1010 - Elevators and Lifts

Conveying: The building has a total of four elevators. The elevators and their controls appear to be original 1977 equipment that is worn and aged with one of the elevators being inoperable at the time of the assessment. It is recommended that the elevators be overhauled and upgraded.

Analysis: The system is in poor condition. The system was installed in 1977. It has a 30-year service life which expired in 2007.

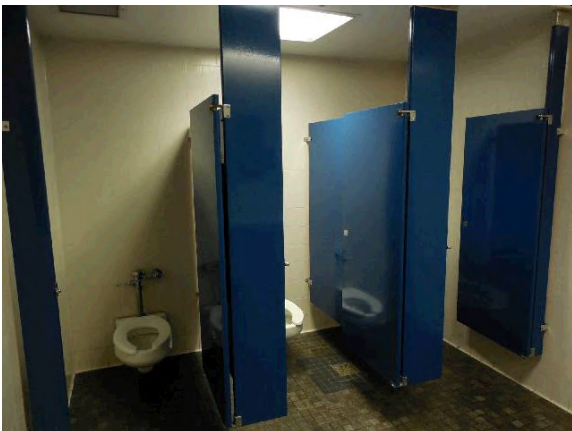
System: D2010 - Plumbing Fixtures

Analysis: The system is in poor condition. The system was installed in 1977. It has a 30-year service life which expired in 2007.

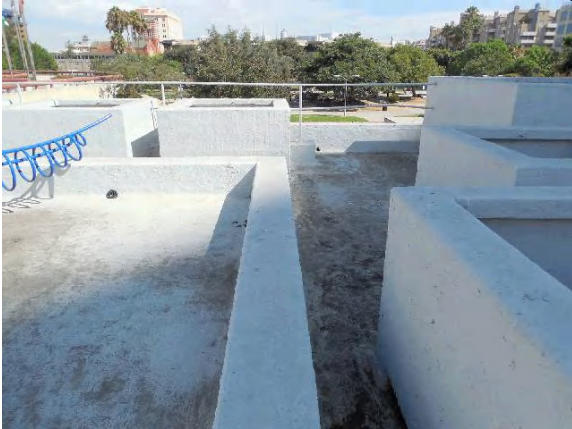
System: D2040 - Rain Water Drainage

Analysis: The system is in poor condition. The system was installed in 1977. It has a 30-year service life which expired in 2007.

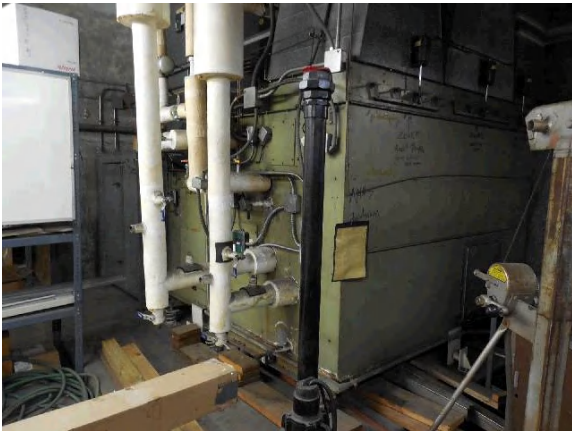
System: D3030 - Cooling Generating Systems

Analysis: The system is in poor condition. The system was installed in 1977. It has a 20-year service life which expired in 1997.

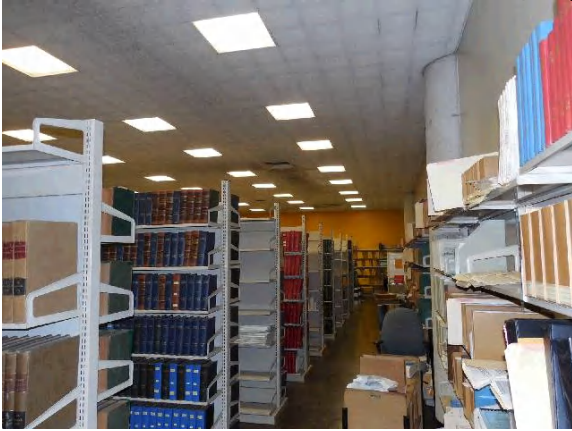
System: D4010 - Sprinklers - Areas Not Sprinkled

Analysis: The system is in poor condition. The system was installed at an unknown date. It has a 20-year service life.

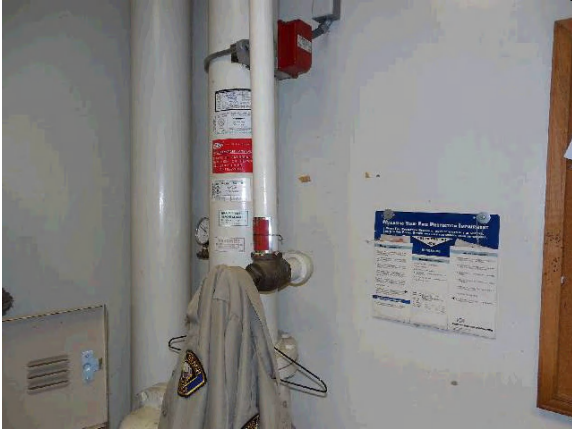
System: D4010 - Sprinklers - Sprinkled Areas

Analysis: The system is in poor condition. The system was installed in 1977. It has a 30-year service life which expired in 2007.

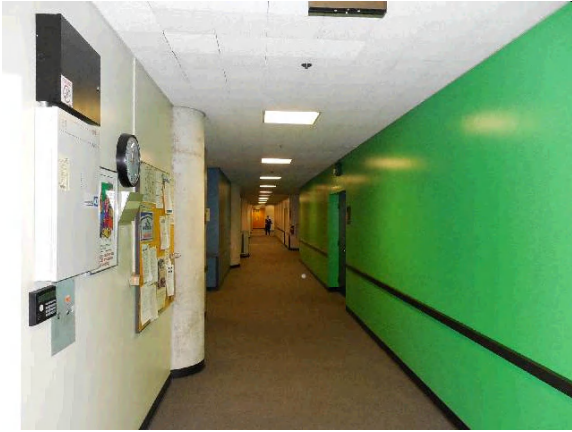
System: D5030 - Communications and Security

Analysis: The system is in poor condition. The system was installed in 1977. It has a 15-year service life which expired in 1992.

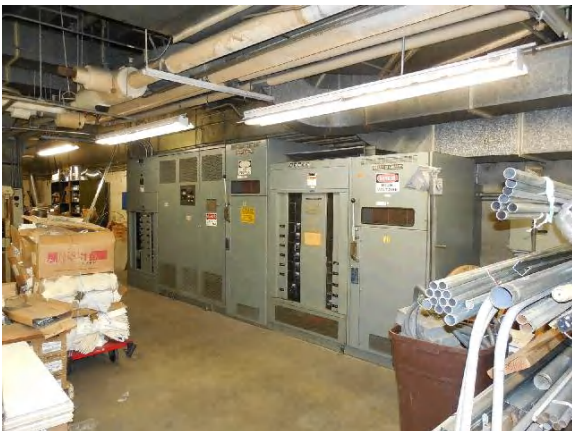
System: D5090 - Other Electrical Systems

Analysis: The system is in poor condition. The system was installed in 1977. It has a 30-year service life which expired in 2007.

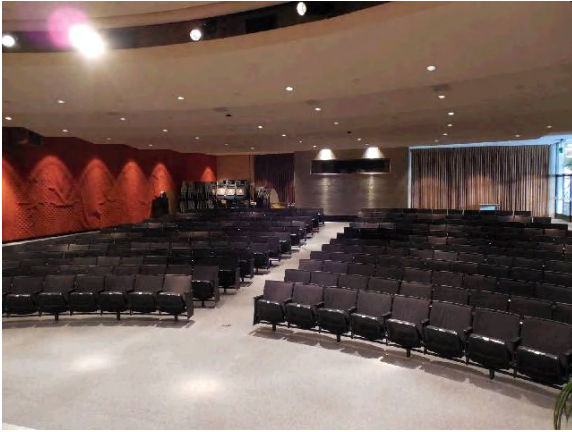
System: E1020 - Institutional Equipment

Analysis: The system is in poor condition. The system was installed in 1977. It has a 30-year service life which expired in 2007.

Notes: Replace auditorium seating.

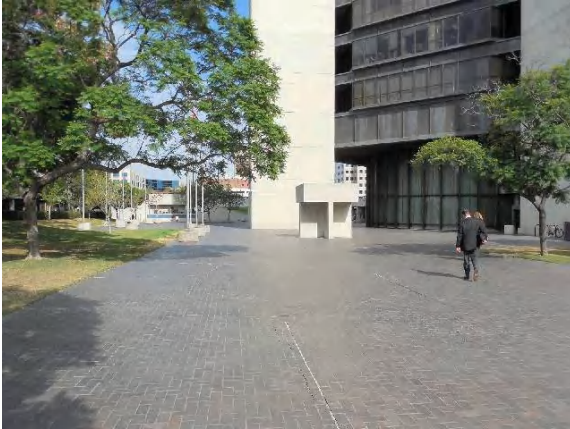
System: G2030 - Pedestrian Paving

Analysis: The system is in poor condition. The system was installed in 1976. It has a 30-year service life which expired in 2006.

Notes: The pedestrian paving, both interlocking pavers and sidewalks, have reached the end of the expected life and should be replaced. There is evidence of cracking and many of the pavers are over the concourse parking structure which may lead to leaking. There is also an area that ponds on the Broadway side of the site near the Broadway Parking Structure.

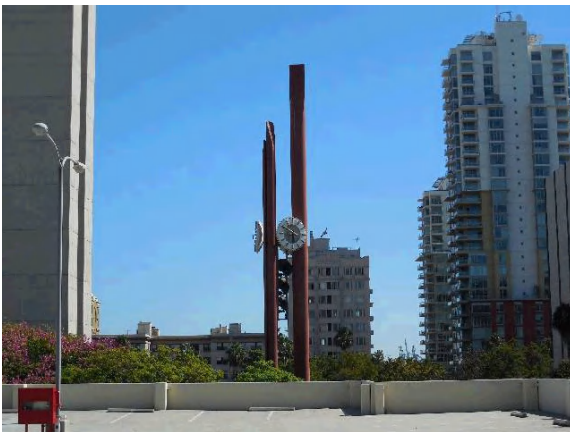
System: G2040 - Site Development

Analysis: The system is in good condition. The system was installed in 1976. It has a 50-year service life. However, in the assessment, it was found to be currently deficient.

Material: Clock Tower

Distress: Failing

Notes: The clock has stopped on the clock tower. Repair clock mechanism to make it functional.

Correction: Repair stopped clock on clock tower
