Nathan Clifford School Building

Conditions Assessment Report

The City of Portland
April 12, 2013

**Winton Scott Architects
Becker Structural Engineers, Inc.
Wright Ryan Construction**

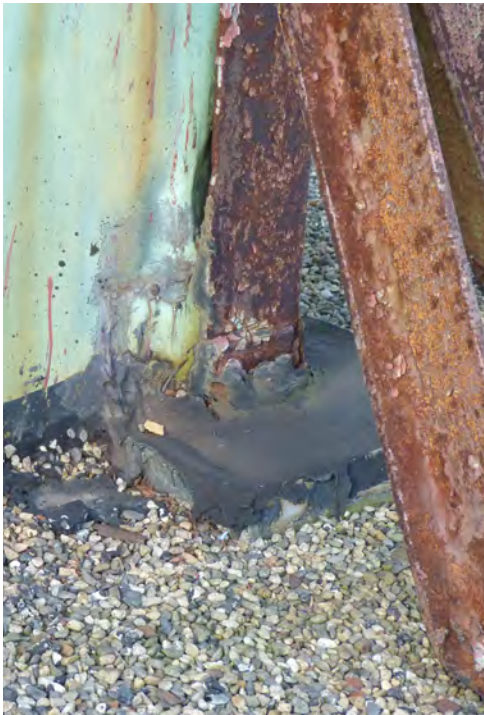
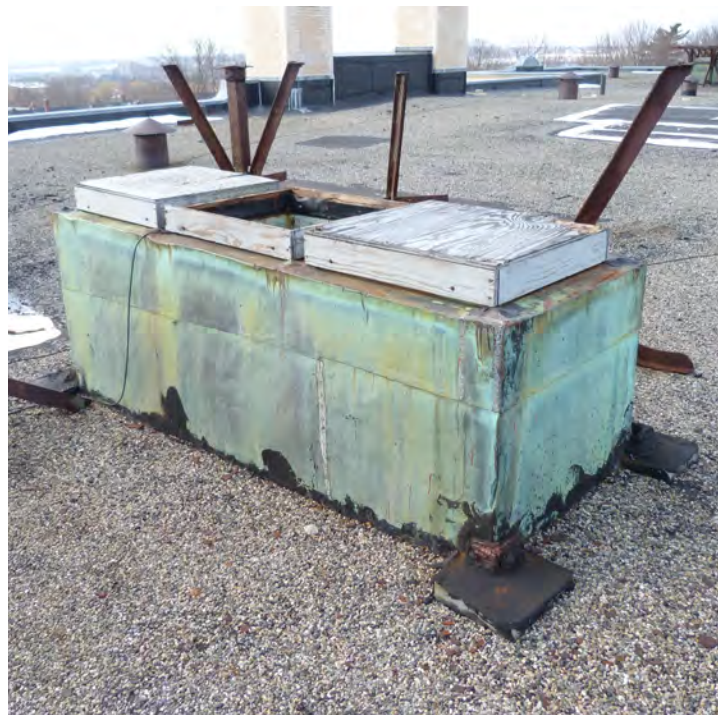
Ventilation hoods and close up detail of deteriorated pitch pocket where steel supports penetrate roof to fasten to underlying structure.
