Prince George's County Public Schools
**Updated Facility Condition
Assessment Final Report**

September 12, 2012

Facility Condition Assessment Update for Prince George's County Public Schools

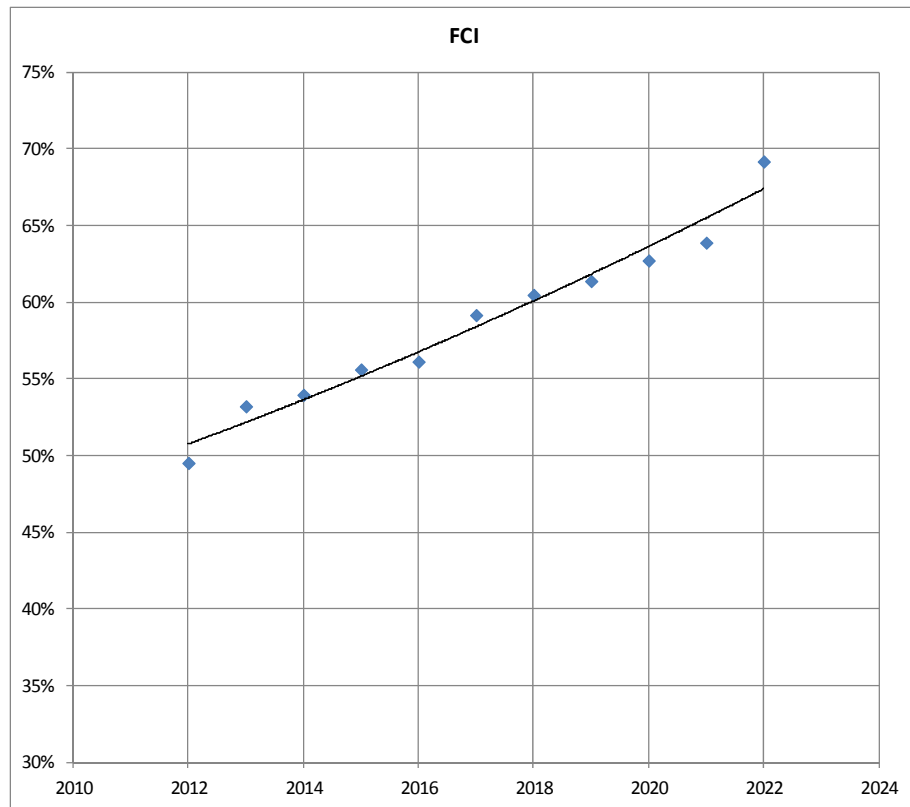
Figure 6 – Increase in the FCI of Schools if No Money is Spent in Next 10 Years

If no money is spent on the schools to renew the expiring or failing systems for the next 10 years, the FCI of the Prince George's County schools would deteriorate from the existing value of 49.52% to 69.18% as shown in the Figure 6.

Capital Renewal Funding Need: In addition to the current backlog, the future continuing aging of facilities and their systems will add approximately \$715 million in additional funding needed over the next 10 years. The current FCI of 49.52% would deteriorate to 69.18% if no funding was applied to renew expiring facility systems, as shown in Figure 6 at the end of this report.
